# FY03 BIENNIAL FACILITY ASSESSMENT POINT PINOS LIGHTHOUSE

**Civil Engineering Unit Oakland  
Reserve Engineering  
2000 Embarcadero, Suite 200  
Oakland, CA 94606-5337**

January 18, 2003

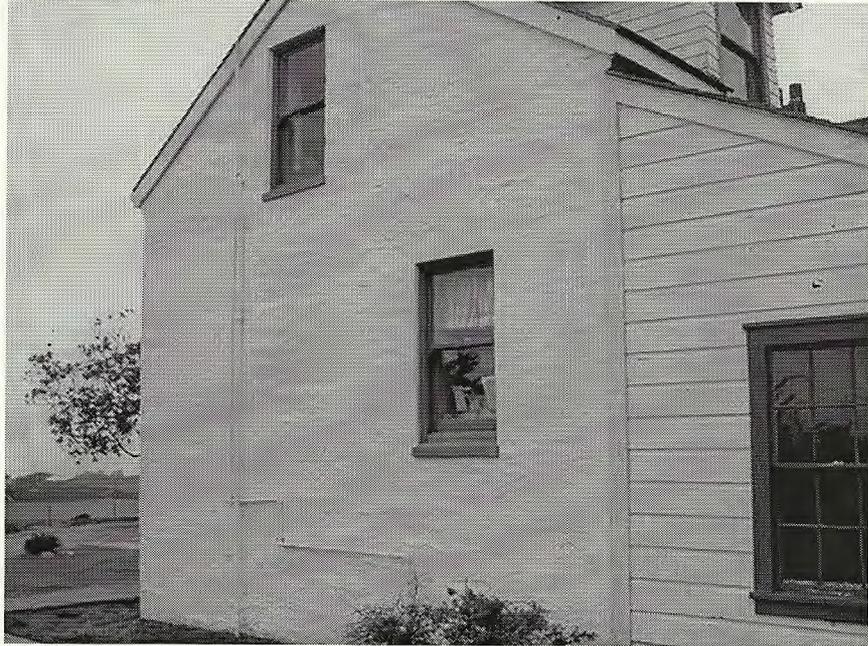
- Photo #1 shows the exterior of the structure to be in very good condition. The facility is in constant use by the Pacific Grove Museum of Natural History. The museum performs general maintenance and upkeep on the grounds and the light is open to the public for tours (300 people per weekend).

Photo#1 Shows the exterior of the light to be in good condition.

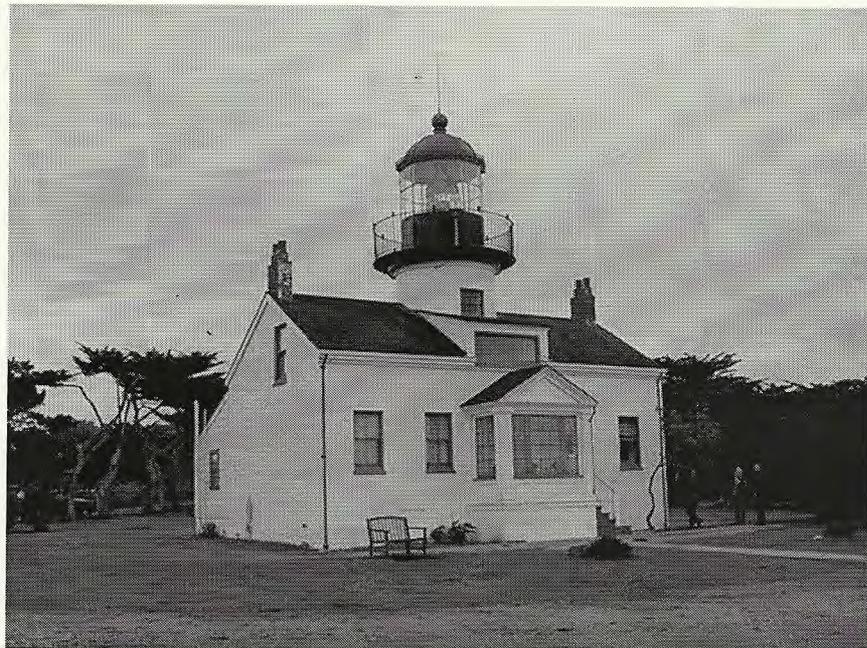
- Photo #2 shows the roof and windows to be in good condition.
- Photo #3 shows some moisture under the upstairs window. This may be due to minor cracks to the exterior finish of the light.
- This building has a ventilation problem which causing vapor flow through the walls. Vapor condensation within walls can cause extensive damage to many types of building materials. Wood framing members can warp or decay in the presence of moisture; metal can corrode; insulation

Photo #2 shows the roof and windows to be in good condition.

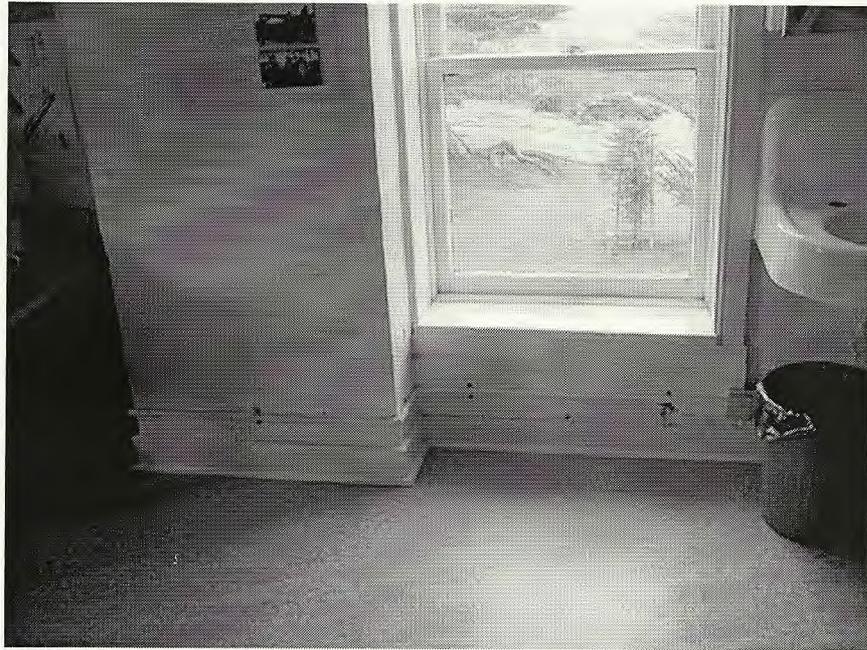
can lose its effectiveness; concrete and concrete masonry products can undergo volumetric changes; and freeze-thaw cycle under moist conditions can deteriorate both clay and concrete masonry as well as stone.

Photo #3 shows some moisture under the upstairs window..

There are three methods to help eliminate wall surface condensation:

- 1: Reducing the humidity of the inside air by ventilation;
- 2: Increase the surface temperature of the interior wall by air movement by mechanical means (fan).
- 3: Increase the heat resistance of the wall by adding an air space or insulation.

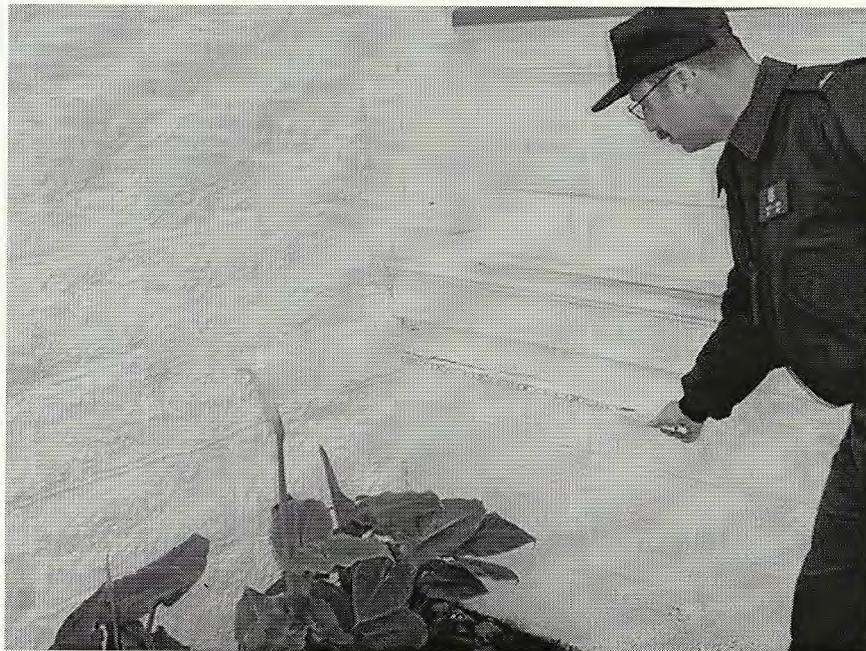
- Photo #4 shows the exterior of the front porch with a settlement crack, approximately 2' long, and 1/8" in width.
- Photo #5 shows the entry room in good condition and in active use.
- Photo #6 shows the exterior of the oil building with some rust on the doorframe and dry rot in the eaves.

Photo #4 shows the exterior of the front porch with a settlement crack.

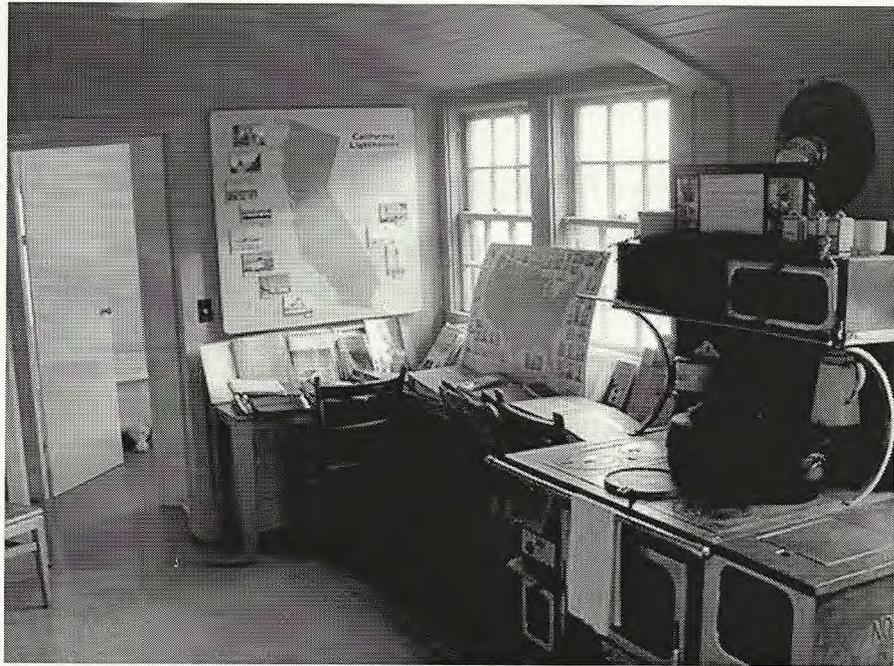
Photo #5 shows the main entry room in good active condition.

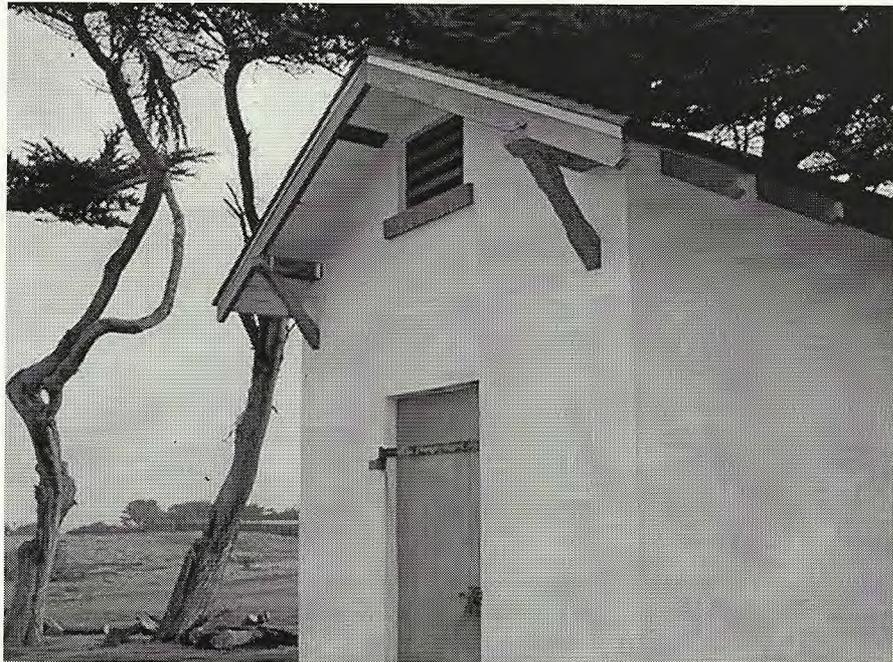
Photo #6 shows the exterior of the oil building with some rust on the doorframe and dry rot in the eaves.
