Point Pinos Lighthouse

Historic Preservation Report

Documentation and Treatment Planning

2004

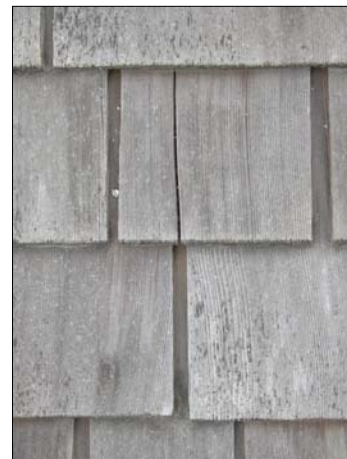
During the preliminary survey the current cedar shingle roof was inspected and found to be in marginal condition with many of the shingles cracked above the spaces between the shingles below. This condition allows for possible moisture penetration into the building that could result in costly repairs and a loss of historic fabric. In addition, some shingles were missing from the ridges and others showed signs of fungus damage. The roof appears to have been installed using steel staples. Some of the staples were noted to be partially corroded. The staples will continue to corrode and ultimately lose their fastening strength, a condition that could result in catastrophic loss of shingles during a significant weather event, and subsequent damage to or loss of historic fabric.

It is recommended that the cedar shingle roof be replaced as soon as possible.

The first step in reroofing is to strip and dispose of the existing roof system. During this process care should be taken not to damage the roof sheathing boards. Once all of the roofing and underlayment, if present, is removed the sheathing and fascias should be carefully inspected. If any deteriorated wood is discovered, it should be repaired in a manner consistent with the methods established in a formal scope of work or design specifications. In addition, any new material introduced should be date stamped with the current date such as "10-2004" to indicate the material was installed in October of 2004.

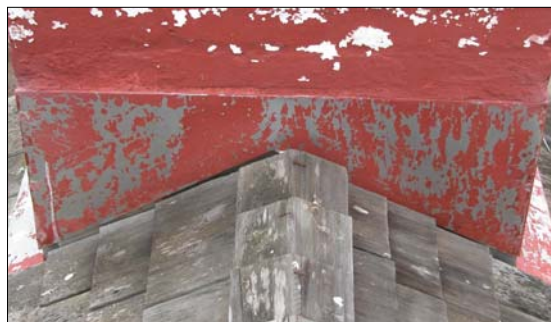
The flashings details of the roof system were also inspected and found to be in stable condition, but in the areas around the chimneys and the dormers, and at the transition between the original structure and the addition, stainless steel was used. Besides being susceptible to corrosion, stainless steel even when painted is historically inaccurate. The lead flashing at the base of the lantern tower is in good condition; however, cracks were observed at several of the soldered joints that bond together individual pieces.

New flashing should be installed during the roof replacement and should be 16 ounce (per square foot) cold rolled copper. Flashing replacement should follow standard practice as illustrated in *Standard Practice in Sheet Metal Work* (NASMC 1929; <http://www.smacna.org>). Where the stainless steel flashing has been integrated into the historic masonry of the chimneys and walls, it must be removed gently with care taken not to further disturb the masonry. Once the flashing is removed, any areas where the masonry has deteriorated, such as at the transition between the main structure and the addition, should be repaired using appropriate materials. Once the repairs are completed, the reglets should be recut to a depth of 1 to 1-1/2 inches and no wider than the existing mortar joints.

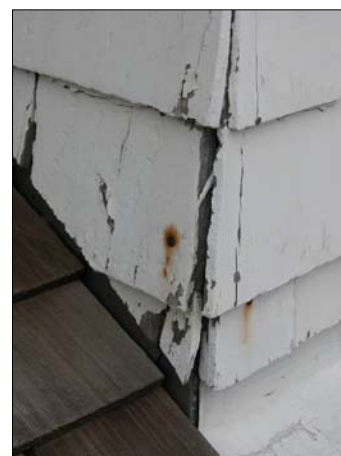
During the inspection of the roof some damage was noted to the cedar shingle vertical siding at the bottom distal corners of the east elevation dormers. This condition should be remedied during the roof replacement by carefully lacing in new shingles and following the fastening instructions for the rest of the roof surfaces. Once the new shingles have been installed they should be primed with a good quality oil-base primer and given a color coat to match the existing color.

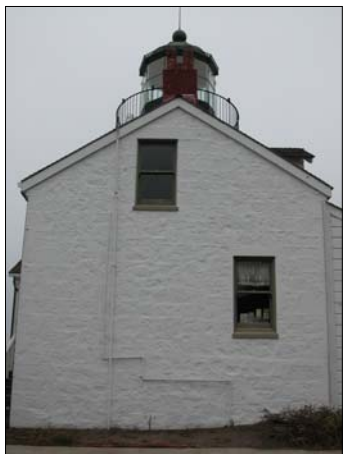
During the inspection, paint failure was noted on all of the windows and in some case there were areas of exposed wood on the sashes. Some paint failure was also noted at the base of the north elevation stone wall of the main part of the building. This failure appears to be occurring at the interface between the accumulated layers of paint and what initially appears to be a lime wash. The exact cause of the paint separation has not been determined.

As the main part of the structure was constructed primarily of what appears to be local granite, the historic finish was likely a form of lime wash or lime plaster. The finishes study would answer this question. Granite walls appear to extend below grade forming the basement of the structure. It is unknown if there is any type of finish on the stonework extending below grade; however it is very unlikely. Depending on the composition and porosity of the stone, there is a high potential for moisture to be absorbed by the stone and for the moisture to migrate into the interior of the building. This condition may cause two affects: the stone itself may be subject to accelerated decomposition, and the moisture levels in the interior of the building might also be increased. The latter possibility might help to explain the increased moisture levels observed during the inspection of the building by the Facility Management Team of the United States Coast Guard on January 11, 2003 (USCG 2003:2-3). Similar problems have also been observed at a sister lighthouse, the Old Point Loma Lighthouse at Cabrillo National Monument in San Diego, California (NPS 1981:174). This building, however, was constructed primarily of sandstone, which is generally more susceptible to an increased rate of deterioration caused by migrating moisture trapped within painted walls. Prior to any restoration of the finishes, these conditions should be thoroughly investigated.

Based on the conditions observed, NPS recommends the exterior finishes be restored as soon as possible, but after an HSR has been completed for the lighthouse. Deterioration of the window sashes is increasing as the finishes fail. Similarly, the steel fasteners will continue to deteriorate at a rapid rate until the finishes can be restored. The deteriorated cornice flashing on the west wall of the west porch should be replaced with a piece of 16 ounce (per square foot) cold rolled copper fabricated to match the existing steel flashing.

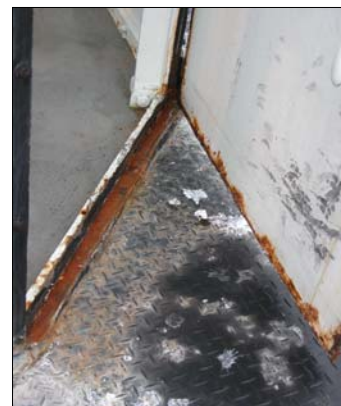
The walls of the lantern room are made from sheet iron and are held in place by brass astragals. The exterior paint finishes are breaking down and in some areas the iron is exposed and corroding. The access door through the lantern room wall to the balcony exhibits the most deterioration, particularly at the bottom where, due to scragging at the hinges, it is scragging the base of the opening.

The most curious condition observed was that of the interface between the diamond steel balcony floor plates and the support brackets. The floor plates and support brackets appear to be non-historic reconstructions probably installed by the USCG within the last 20 years. At the butt joints of the floor plates directly above the brackets, the plates are buckling upward from what appears to be corrosive expansion or 'rust-jacking'; however, on inspection of the brackets, no rust streaks were observed below areas where they would be expected such as at fastener holes and joints in the steel. Rather, in these areas, there were moist pasty deposits at the fastener holes that were possibly damp salt formations or the residue from galvanic corrosion resulting from a breakdown in the non-reactive material that isolates the sheet iron wall plates from the brass astragals. More likely it is the former condition, but has not yet advanced to the point where corrosion is visible. In either case it appears that water is penetrating through joints between the steel balcony floor plates is causing some sort of expansive corrosion. Further inspection of these joints is required to determine the exact cause of the condition observed.

NPS recommends that the metal domed roof of the lantern room be thoroughly inspected to identify any additional areas of metals deterioration. Further, the metals that were inspected and found to exhibit varying signs of corrosion should be stripped, conserved and recoated with an appropriate coating. As the lantern room was designed and built as a package, many of its historic components were numbered at each joint or corner to assist in rapid assembly. The process of correcting the moisture penetration and finish failure will require careful and systematic

disassembly of constituent components. The balcony floor plates and support brackets, railings, access door, and walls of the lantern room should not be surface painted without first being removed and conserved, and individually finished. Once individually conserved and refinished, they could be reinstalled and then surface painted with a final coat. This work is best defined as part of the HSR, which would provide a thorough study of the conditions and their causes, and define the best method for conservation. Any metals restoration work should be completed by or in consultation with a qualified historic metals conservation specialist.
