**TO:** HONORABLE MAYOR AND MEMBERS OF CITY COUNCIL  
**FROM:** Paul M. Finnegan  
**MEETING DATE:** February 21, 2007  
**SUBJECT:** MAINTENANCE REPORT ON THE POINT PINOS LIGHTHOUSE AND CONSIDER THE FORMATION OF A POINT PINOS LIGHTHOUSE ADVISORY BOARD

# Point Pinos Lighthouse

Historic Preservation Report

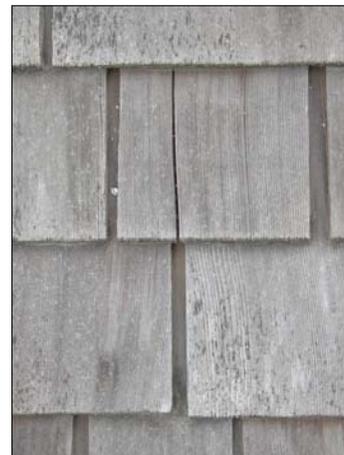
During the preliminary survey the current cedar shingle roof was inspected and found to be in marginal condition with many of the shingles cracked above the spaces between the shingles below. This condition allows for possible moisture penetration into the building that could result in costly repairs and a loss of historic fabric. In addition, some shingles were missing from the ridges and others showed signs of fungus damage. The roof appears to have been installed using steel staples. Some of the staples were noted to be partially corroded. The staples will continue to corrode and ultimately lose their fastening strength, a condition that could result in catastrophic loss of shingles during a significant weather event, and subsequent damage to or loss of historic fabric.

It is recommended that the cedar shingle roof be replaced as soon as possible.

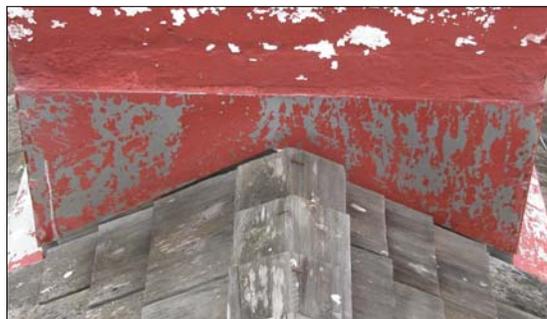
The flashings details of the roof system were also inspected and found to be in stable condition, but in the areas around the chimneys and the dormers, and at the transition between the original structure and the addition, stainless steel was used. Besides being susceptible to corrosion, stainless steel even when painted is historically inaccurate. The lead flashing at the base of the lantern tower is in good condition; however, cracks were observed at several of the soldered joints that bond together individual pieces.

New flashing should be installed during the roof replacement and should be 16 ounce (per square foot) cold rolled copper. Flashing replacement should follow standard practice as illustrated in *Standard Practice in Sheet Metal Work* (NASMC 1929; <http://www.smacna.org>). Where the stainless steel flashing has been integrated into the historic masonry of the chimneys and walls, it must be removed gently with care taken not to further disturb the masonry. Once the flashing is removed, any areas where the masonry has deteriorated, such as at the transition between the main structure and the addition, should be repaired using appropriate materials. Once the repairs are completed, the reglets should be recut to a depth of 1 to 1-1/2 inches and no wider than the existing mortar joints.

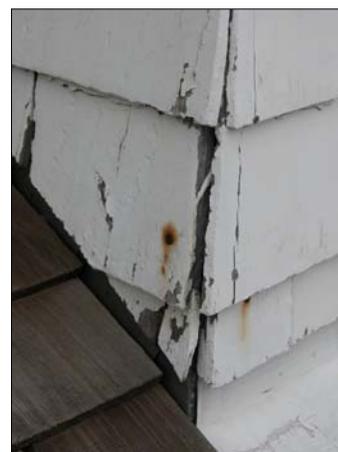
During the inspection of the roof some damage was noted to the cedar shingle vertical siding at the bottom distal corners of the east elevation dormers. This condition should be remedied during the roof replacement by carefully lacing in new shingles and following the fastening instructions for the rest of the roof surfaces. Once the new shingles have been installed they should be primed with a good quality oil-base primer and given a color coat to match the existing color.

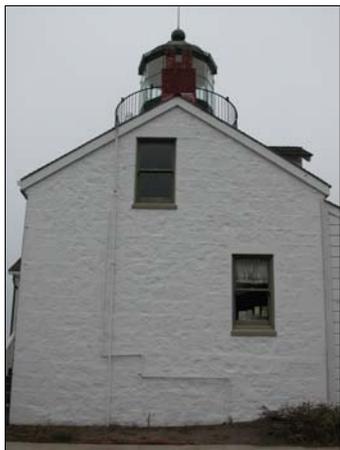
During the inspection, paint failure was noted on all of the windows and in some case there were areas of exposed wood on the sashes. Some paint failure was also noted at the base of the north elevation stone wall of the main part of the building. This failure appears to be occurring at the interface between the accumulated layers of paint and what initially appears to be a lime wash. The exact cause of the paint separation has not been determined.

As the main part of the structure was constructed primarily of what appears to be local granite, the historic finish was likely a form of lime wash or lime plaster. The finishes study would answer this question. Granite walls appear to extend below grade forming the basement of the structure. It is unknown if there is any type of finish on the stonework extending below grade; however it is very unlikely. Depending on the composition and porosity of the stone, there is a high potential for moisture to be absorbed by the stone and for the moisture to migrate into the interior of the building. This condition may cause two affects: the stone itself may be subject to accelerated decomposition, and the moisture levels in the interior of the building might also be increased. The latter possibility might help to explain the increased moisture levels observed during the inspection of the building by the Facility Management Team of the United States Coast Guard on January 11, 2003 (USCG 2003:2-3). Similar problems have also been observed at a sister lighthouse, the Old Point Loma Lighthouse at Cabrillo National Monument in San Diego, California (NPS 1981:174). This building, however, was constructed primarily of sandstone, which is generally more susceptible to an increased rate of deterioration caused by migrating moisture trapped within painted walls. Prior to any restoration of the finishes, these conditions should be thoroughly investigated.

Based on the conditions observed, NPS recommends the exterior finishes be restored as soon as possible, but after an HSR has been completed for the lighthouse. Deterioration of the window sashes is increasing as the finishes fail. Similarly, the steel fasteners will continue to deteriorate at a rapid rate until the finishes can be restored. The deteriorated cornice flashing on the west wall of the west porch should be replaced with a piece of 16 ounce (per square foot) cold rolled copper fabricated to match the existing steel flashing.

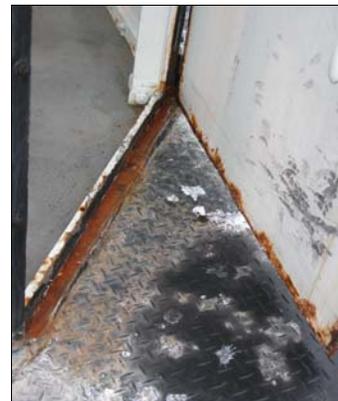
The walls of the lantern room are made from sheet iron and are held in place by brass astragals. The exterior paint finishes are breaking down and in some areas the iron is exposed and corroding. The access door through the lantern room wall to the balcony exhibits the most deterioration, particularly at the bottom where, due to scragging at the hinges, it is scragging the base of the opening.

The most curious condition observed was that of the interface between the diamond steel balcony floor plates and the support brackets. The floor plates and support brackets appear to be non-historic reconstructions probably installed by the USCG within the last 20 years. At the butt joints of the floor plates directly above the brackets, the plates are buckling upward from what appears to be corrosive expansion or 'rust-jacking'; however, on inspection of the brackets, no rust streaks were observed below areas where they would be expected such as at fastener holes and joints in the steel. Rather, in these areas, there were moist pasty deposits at the fastener holes that were possibly damp salt formations or the residue from galvanic corrosion resulting from a breakdown in the non-reactive material that isolates the sheet iron wall plates from the brass astragals. More likely it is the former condition, but has not yet advanced to the point where corrosion is visible. In either case it appears that water is penetrating through joints between the steel balcony floor plates is causing some sort of expansive corrosion. Further inspection of these joints is required to determine the exact cause of the condition observed.

NPS recommends that the metal domed roof of the lantern room be thoroughly inspected to identify any additional areas of metals deterioration. Further, the metals that were inspected and found to exhibit varying signs of corrosion should be stripped, conserved and recoated with an appropriate coating. As the lantern room was designed and built as a package, many of its historic components were numbered at each joint or corner to assist in rapid assembly. The process of correcting the moisture penetration and finish failure will require careful and systematic

disassembly of constituent components. The balcony floor plates and support brackets, railings, access door, and walls of the lantern room should not be surface painted without first being removed and conserved, and individually finished. Once individually conserved and refinished, they could be reinstalled and then surface painted with a final coat. This work is best defined as part of the HSR, which would provide a thorough study of the conditions and their causes, and define the best method for conservation. Any metals restoration work should be completed by or in consultation with a qualified historic metals conservation specialist.
