POINT PINOS LIGHTHOUSE

PACIFIC GROVE CALIFORNIA

PRESERVATION PLAN

SUBMITTED BY: LIGHTHOUSE
PRESERVATIONIST, LLC.

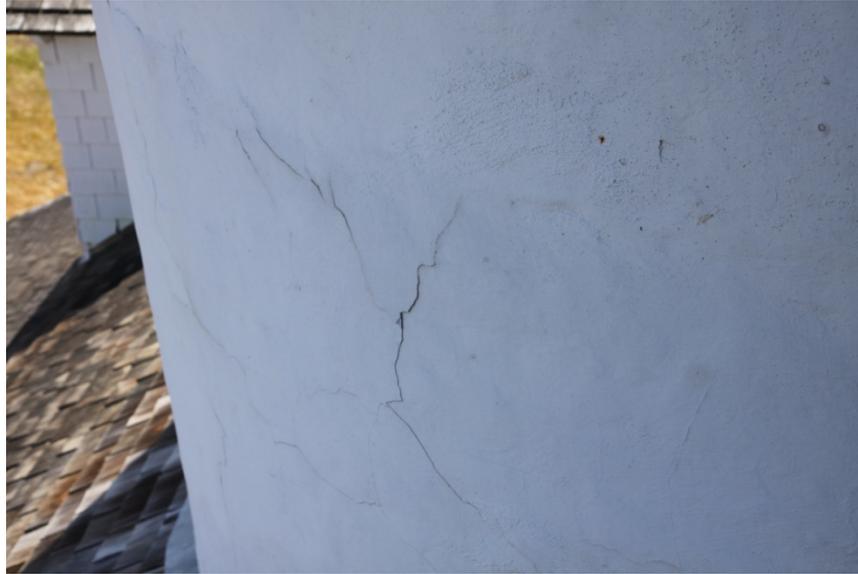
Figure 3: Cracks in stucco.

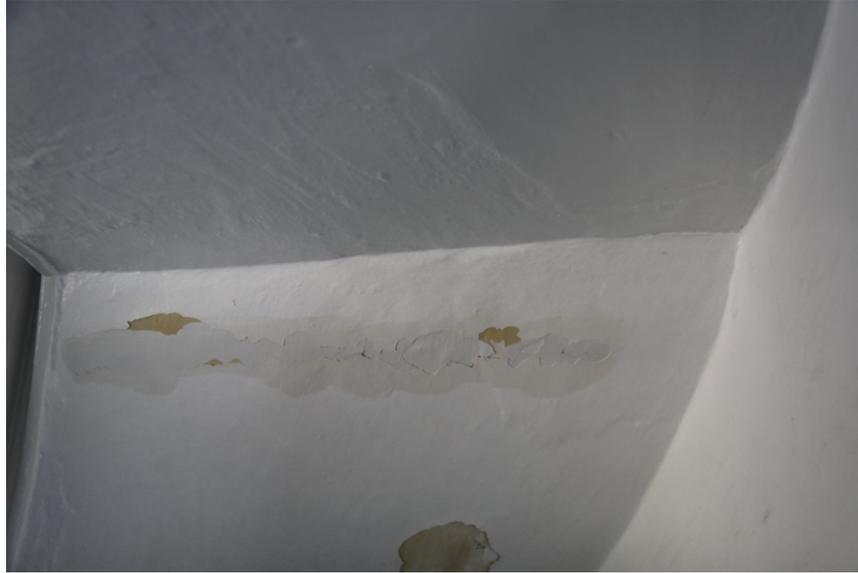
Figure3: Evidence of moisture damage from exterior cracks in stucco.

There has been a resultant moisture entry into the porous stucco coat which has permeated into the interior of the lighthouse with resultant damage to the historic fabric, including plaster. Whether due to improper application or moisture damage, there is widespread failure of the adhesion of the stucco coat to the exterior concrete which produces a hollow sound when we tested the circumference of the exterior lighthouse cylinder. There are also numerous hairline cracks or separations throughout the exterior surfaces of the stucco coat which has provided additional moisture entry into the hollows between the stucco coat and the exterior concrete surface. The extent of the damage ranges from hairline cracks to actual failure of sections of stucco coats with resultant large openings into the stucco coat and higher levels of moisture entrapment and damage.

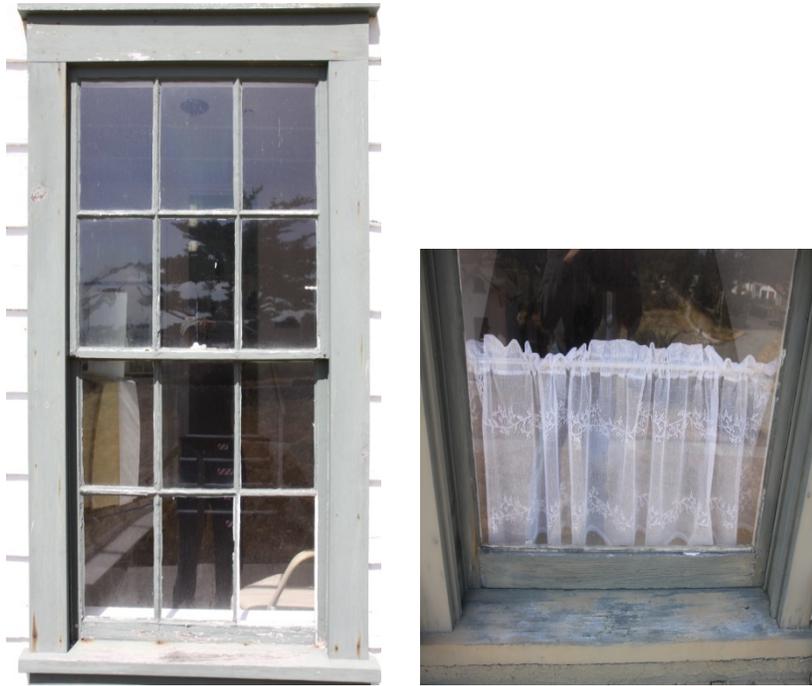
Figure 14 & 15: Example of damage to window trim and window - sill.

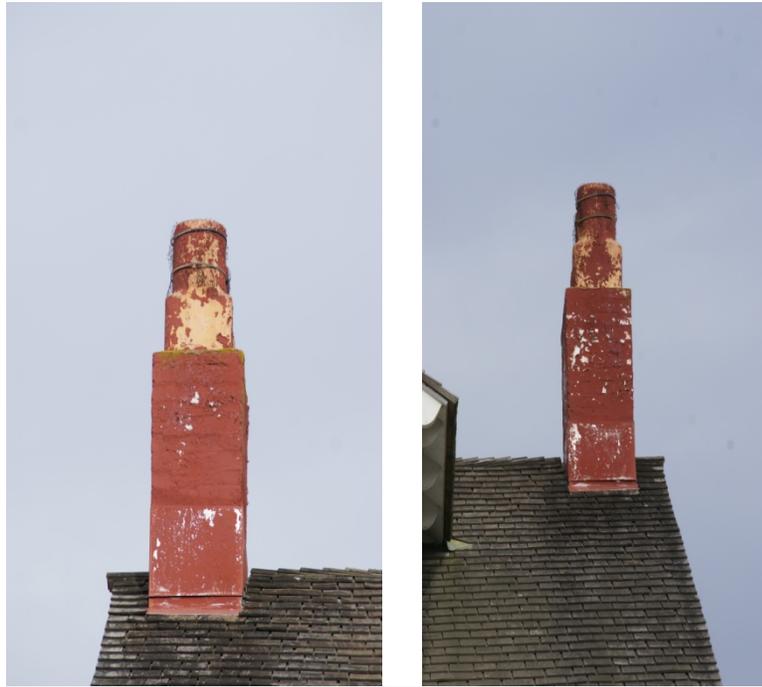
Figure 26 & 27: North and South chimney systems

CHIMNEYS: The end gable chimneys are constructed of fired red brick with a protective stucco coating. They are topped by clay pipe flues which have wire screening to prevent bird entry. There is a metal flashing at the base of the chimneys as they meet the cedar shake shingle roof. (Flashing material appears to be metal other than copper which would have been used historically and which has a longer life span in hostile coastal environments.) The overall condition of both brick chimney systems is rated **POOR**. Most of the protective paint coating has failed and there is widespread loss of the protective stucco as well. We noted extensive loss of mortar joints on both chimney systems which could result in loss of structural integrity, especially during a high wind event. The repair to the chimney systems should be performed by qualified contractors.

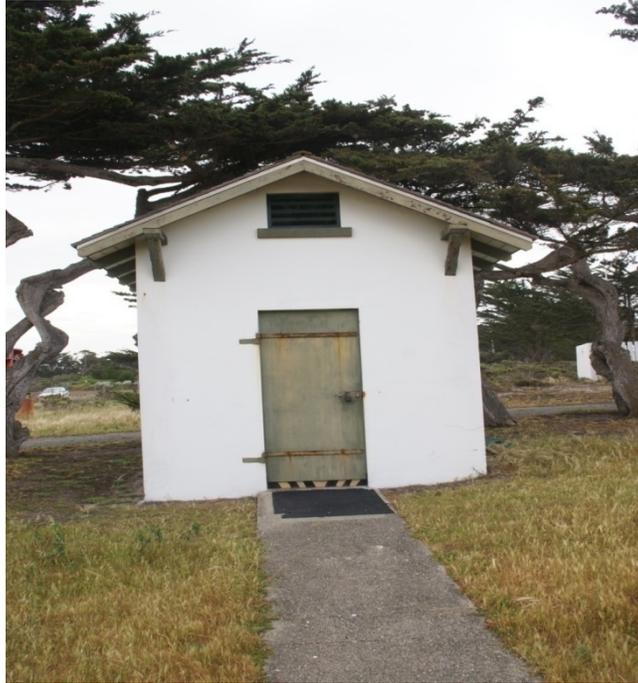
Figure33 : HISTORIC FUEL STORAGE BUILDING

Fuel Storage Building: The overall condition of the Fuel Storage Building is rated as **GOOD** to **FAIR**. The building is of brick construction with a protective stucco exterior coating. The roof system is a wood truss with wide plank roof decking covered by. Fuel Storage Buildings under the care of the U.S. Lighthouse Service and well into the management of the United States Coast Guard, often historically were covered with a metal standing seam roof material usually painted red to indicate the storage of flammable materials. There are several structural cracks along the North and South sides of the building. The iron door is supported by two strap hinges. Both hinges are in a state of advanced metal jacking due to the exfoliation of the metal. There is wood rot on the rafter tails of the roof system and evidence of rot in some of the roof deck planks. Several sections of deck planks have been replaced with newer material.

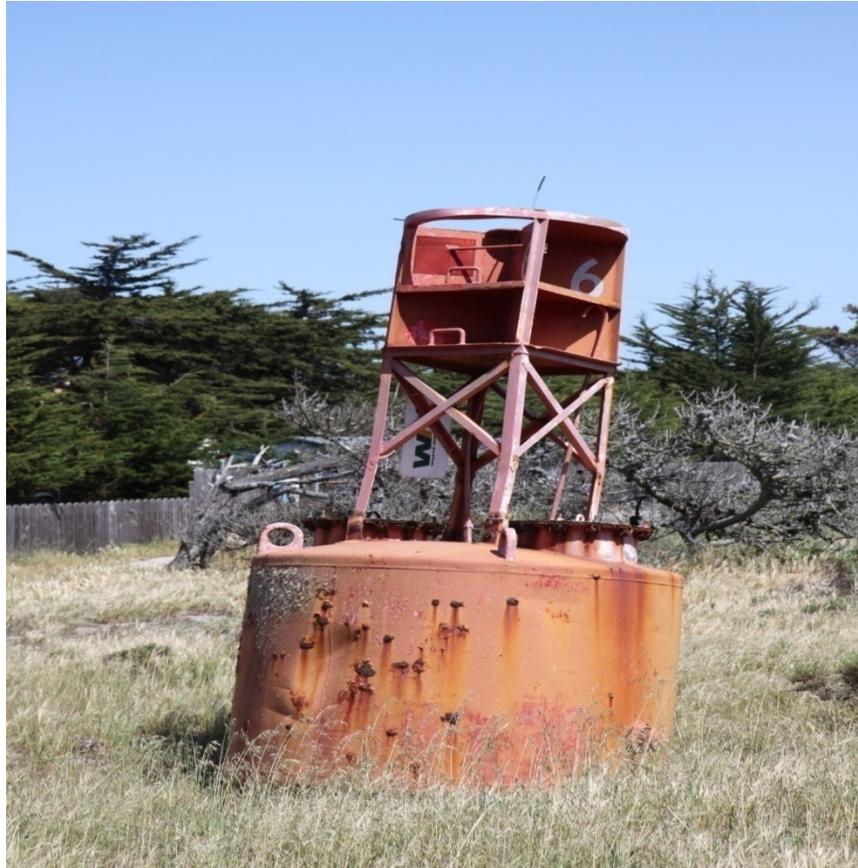
Figure 34: NAVIGATIONAL BUOY

NAVIGATIONAL BUOY: The overall condition of the buoy is ranked as **POOR**. There is widespread loss of protective coatings with resultant oxidation, staining, blistering and exfoliation of the metal surfaces. There are several dents in the Buoy. Repairs can be conducted by volunteers or staff under a controlled environment with protective mask and outer safety wear. Proper encapsulation of Buoy should be installed prior to blasting. All paint debris should be contained, collected, and disposed of according to federal and State of California Law. Buoy should be sand blasted to clean metal of all coatings. Buoy should be repainted based on historic colors and markings.

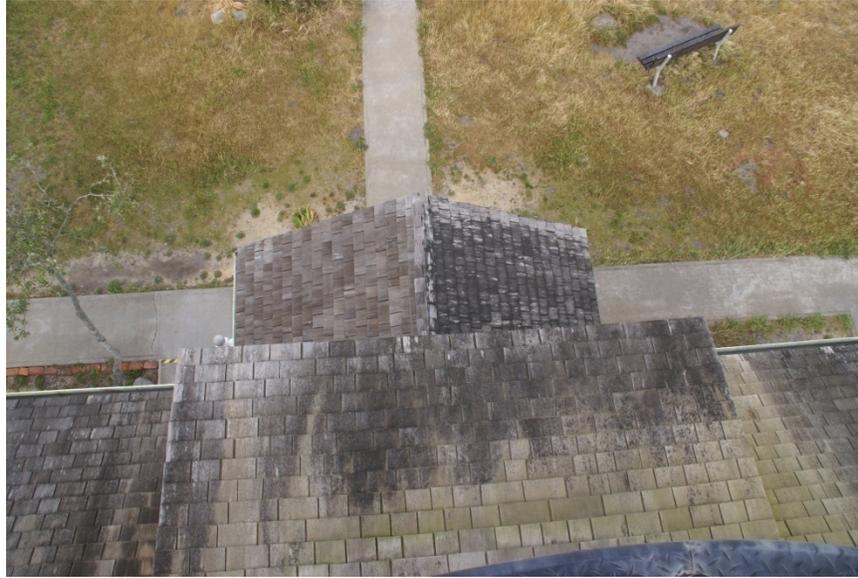
Figure 39: WALKWAYS

CONCRETE WALKWAYS: The overall condition of the concrete walkways is rated as **POOR** to **FAIR**. It is recommended that a new walkway plan be incorporated within the overall Site Design Plan to provide for a more user friendly and ADA complaint walkway system. New walkways should be constructed wide enough to accommodate two way traffic including wheel chair traffic. Visitor traffic patterns should be monitored to help determine the most effective route to guide visitors to the lighthouse, fuel storage building, and grounds. Future construction of missing out buildings should also be factored into the Site Plan Design and Walkway route.

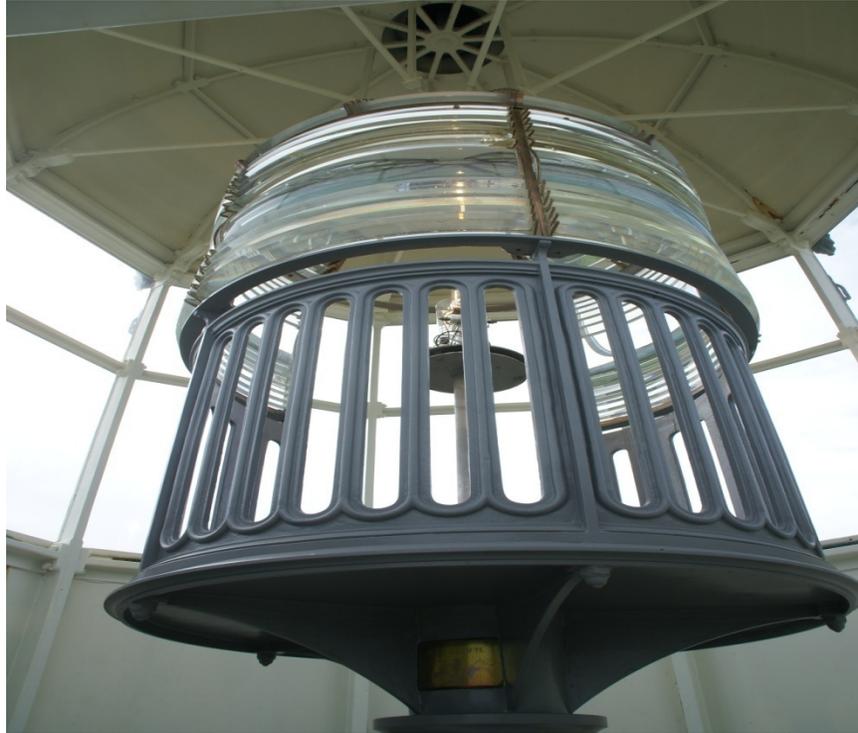
Figure 5: Point Pinos Lantern Room & Historic Optic.

The Point Pinos lantern room houses a historic 3rd Order Henry Le Paute Fresnel Lens which still serves as an active Aid to Navigation operated by the United States Coast Guard. The brass and glass lens system is supported by a historic lens pedestal. The historic optic is surrounded and protected by a copper dome with iron canopy topped by a bronze vent ball. The framing is iron-crossed braced by an iron “spider”. Iron stiles braced by bronze mullions which also serve as condensation collectors, secure the glass storm panes. There are bronze vents at the top of the iron walls. Iron flat plate walls attached to the steel stiles and bronze mullions, a steel deck platform. There is rust staining, rust scale, and metal exfoliation in numerous areas of the lantern room, especially the lantern canopy, walls, and doors. The bronze air vents are also showing signs of advanced deterioration. All damage should be corrected under the IMMEDIATE PHASE of the Preservation Plan. The Overall rating of the Lantern Room interior is **GOOD** to **POOR**.

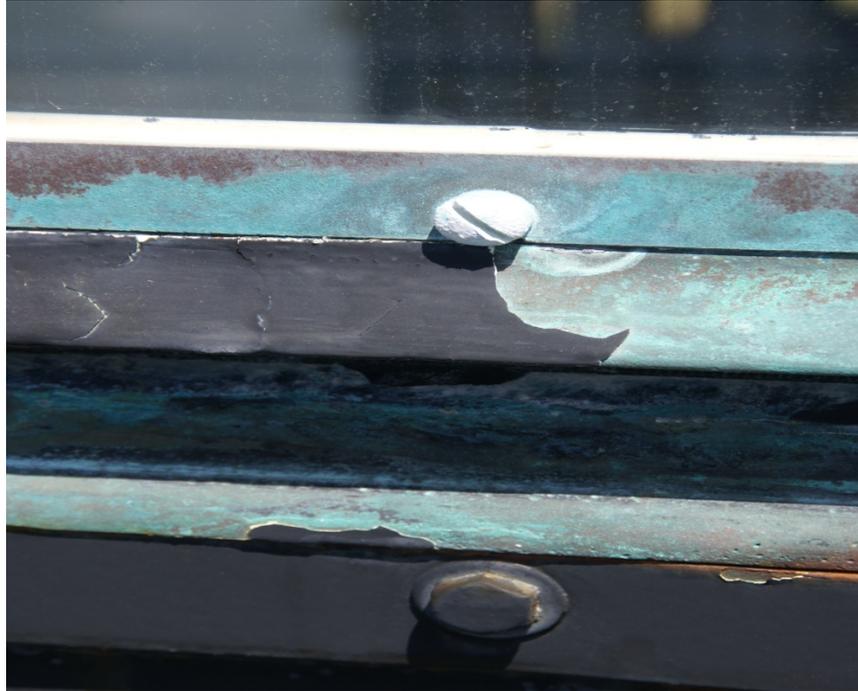
Figure : Bronze astragals securing storm panes.

The Lantern Room storm panes are held in place against the steel stiles and mullions by bronze astragals. There are stamped numbers on each astragal directing proper placement in numerical sequence around the lighthouse lantern and along the storm panes. There is a system of bronze hand safety grips which are bolted to the outer edge of the bronze storm pane astragals (batten strips). All fasteners are bronze and historically were metric. Due to metal fatigue they often break when being removed and once snapped off the remaining bolt will need to be tapped out. Replacement bolts must match originals in size, shape, and material. It appears that the fasteners used to attach the wall astragals are newer and were possibly installed during the period that the aluminum flashing was also installed.

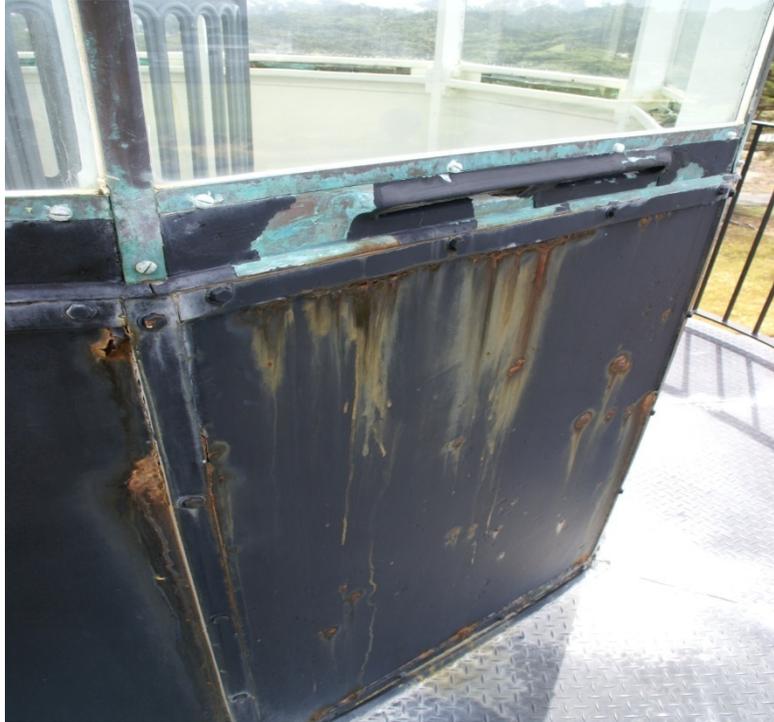
Figure: Iron Lantern Room Wall & bronze astragals.

The Lantern Room is made up of a series of iron plates which enclose the bottom of the Lantern Room and which are connected to the Lantern Room frame by bronze astragals bolted through the plates and threaded into the receiving holes in the inner frame. The black exterior coating system which is part of the Point Pinos “Day Mark” is in widespread failure. There is pervasive damage to both the iron wall panels and more importantly to the softer bronze astragals due to “metal jacking” created by the exfoliation of the iron plates. It appears that there is a process of galvanic corrosion or “catalytic reaction” of the two dissimilar metals taking place which when combined with salt air/water creates the catalyst to produce the corrosive effect. The condition is most pronounced on the western (seaward) sides of the exterior of the lantern. The degree of damage to the metal plates range from surface oxidation, to rust scale, to rust blisters, to exfoliation and “jacking” to loss of significant surface metal.

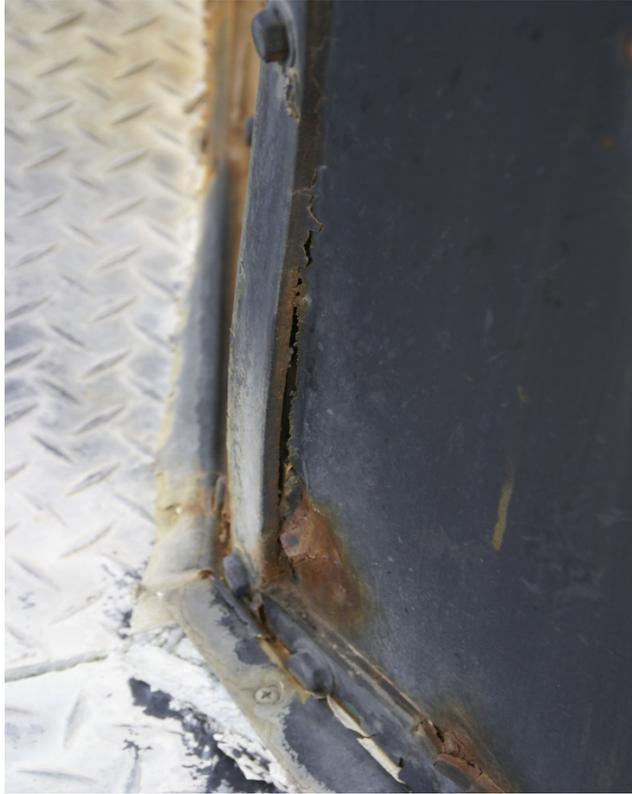
Figure : Stress effect on bronze astragals.

The “Jacking” process has produced enormous stress on the softer bronze astragals resulting in bending of the astragal bar, a wider gap between the astragal bar and the iron wall plate and a greater avenue for moisture to penetrate behind and between metal surfaces. This increased volume of moisture entry accelerates the galvanic corrosion process and will add greatly to the overall repair and replacement of historic fabric if left unchecked.

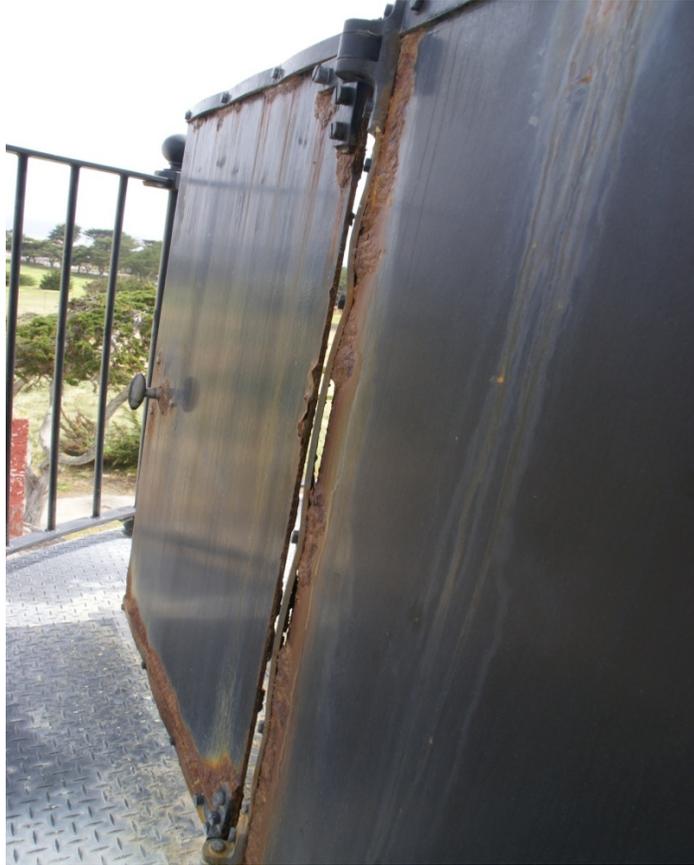
Figure : Iron Lantern Room Door.

The door enclosing the exit/egress to and from the Lantern Room Gallery deck is flat iron plate with attached re-enforcement bars. The hinges which support the door and the hardware which secure the door are original and historic to the Point Pinos Lighthouse. There is widespread coating failure with resultant metal oxidation, scaling, blistering and exfoliation. “Rust jacking” is creating enormous stress on the hinges, and doorframe which currently causes the door to bind when in use. Bronze astragals which secure the doorframe are in advance state of movement due to the stress. This condition poses great risk to the historic fabric and ultimate future loss of the historic door and related framework. Immediate steps should be taken to stabilize the door and adjoining metal fabric.

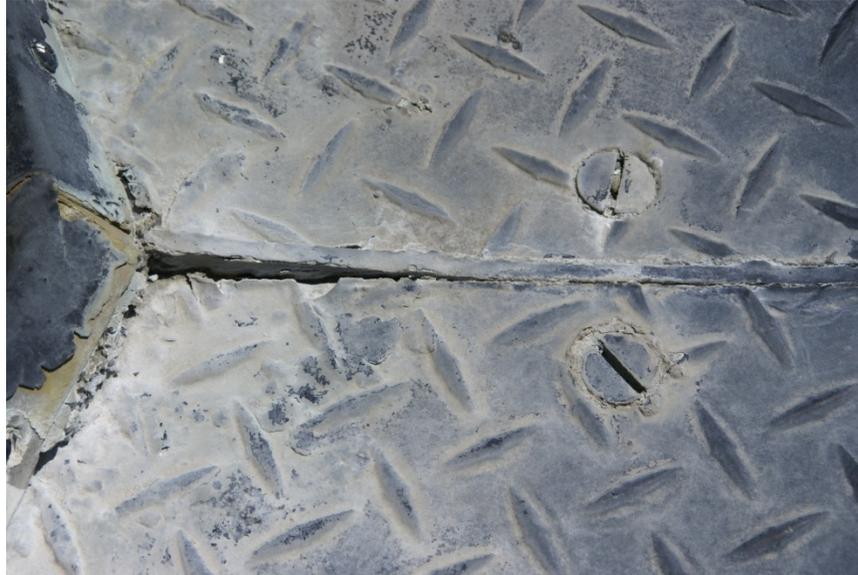
Figure Gallery deck plate-adjointing plate seams.

The gallery deck plates are supported by the bracket system underneath. The brackets are installed under each of the sections of deck plates that meet the adjoining plate. Historically, gaps were filled with soft lead seals to prevent water entry between deck plates. Currently the material used to fill those gaps is in an advance state of deterioration and failure. Thick oxidation staining has contaminated deck plates surfaces and undersides, including metal collar and bracket support systems under the deck plate. Counter-sunk bolts should be sealed as well. These areas should be thoroughly cleaned and re-caulked prior to re-painting.

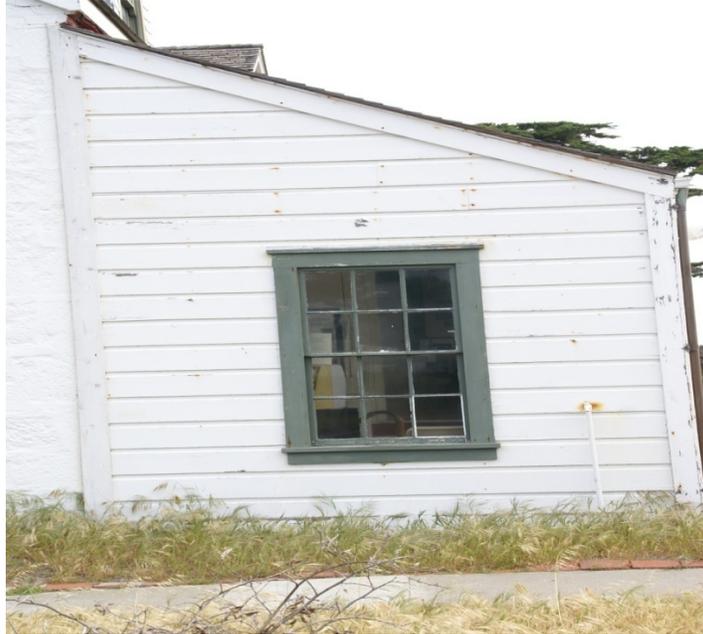
Figure : Build up of earth and vegetation against wood fabric.

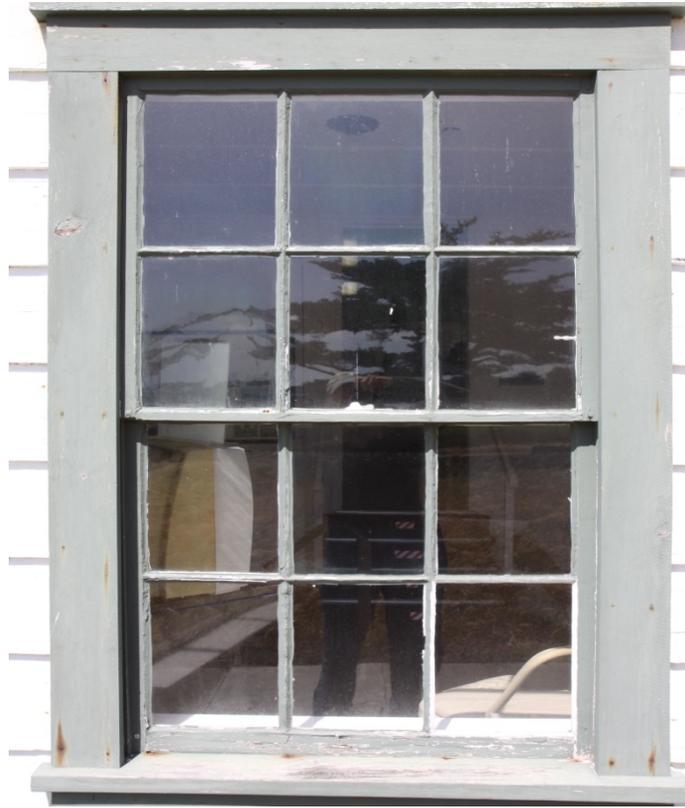
Figure#28 : TYPICAL WINDOW CONDITION-POOR

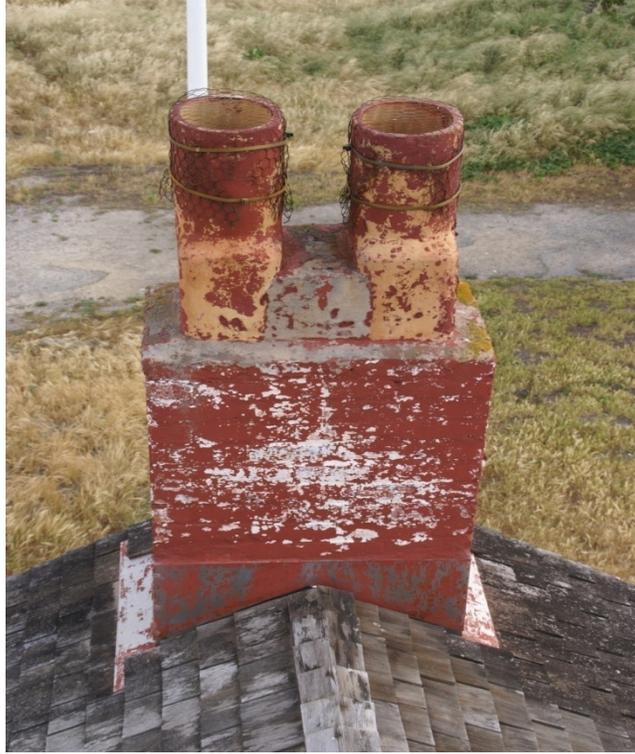
Figure #39: TYPICAL EXISTING CONDITION OF HISTORIC CHIMNEY SYSTEM.

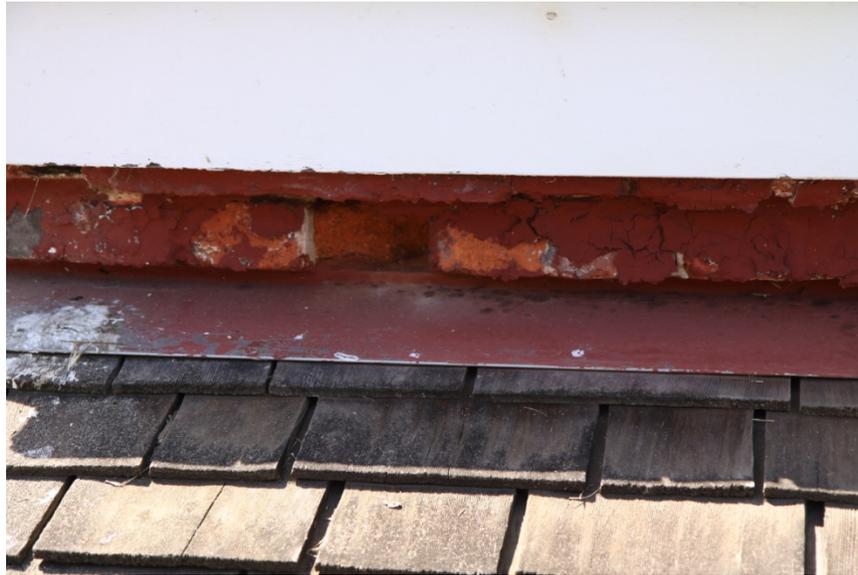
Figure #40: TYPICAL CONDITION OF BRICK CORBEL-**POOR**.

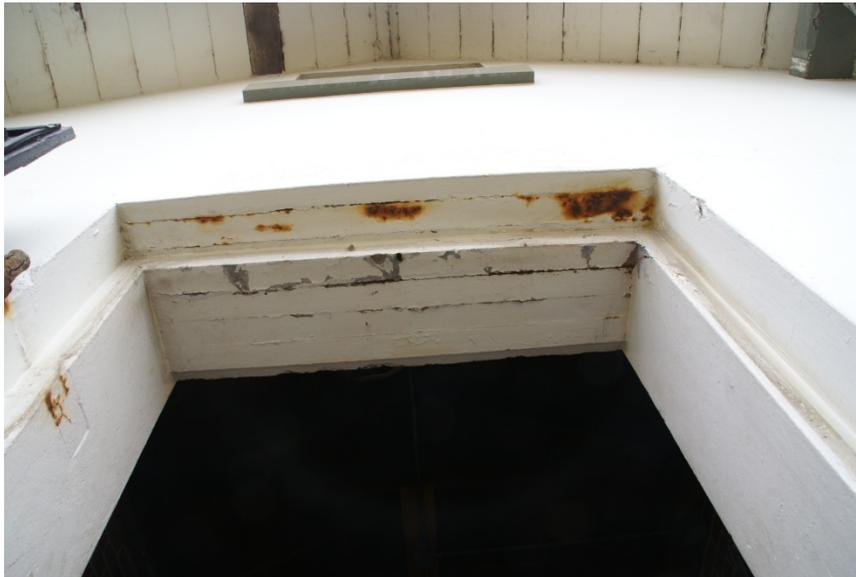
Figure #58 & #59: Typical conditions of iron door frame.

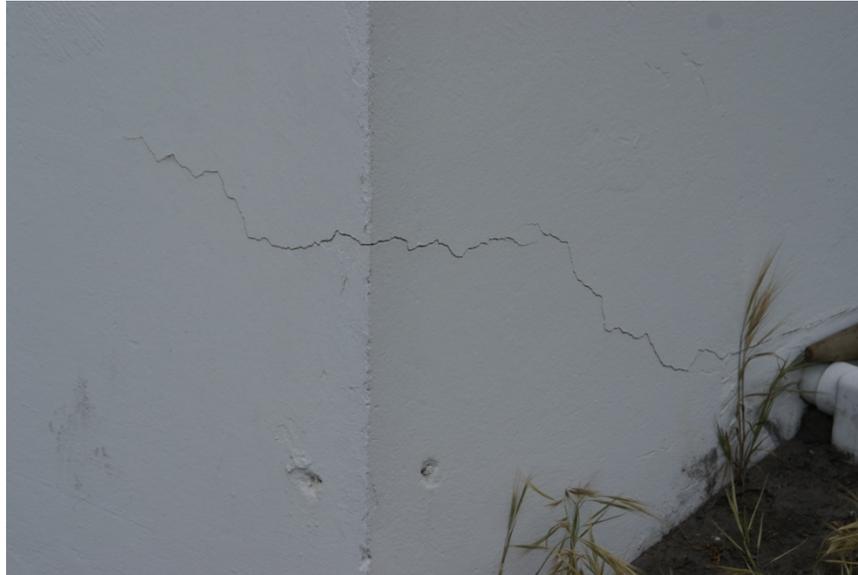
Figure # 60 & #61 : Showing cracks in the exterior stucco walls.

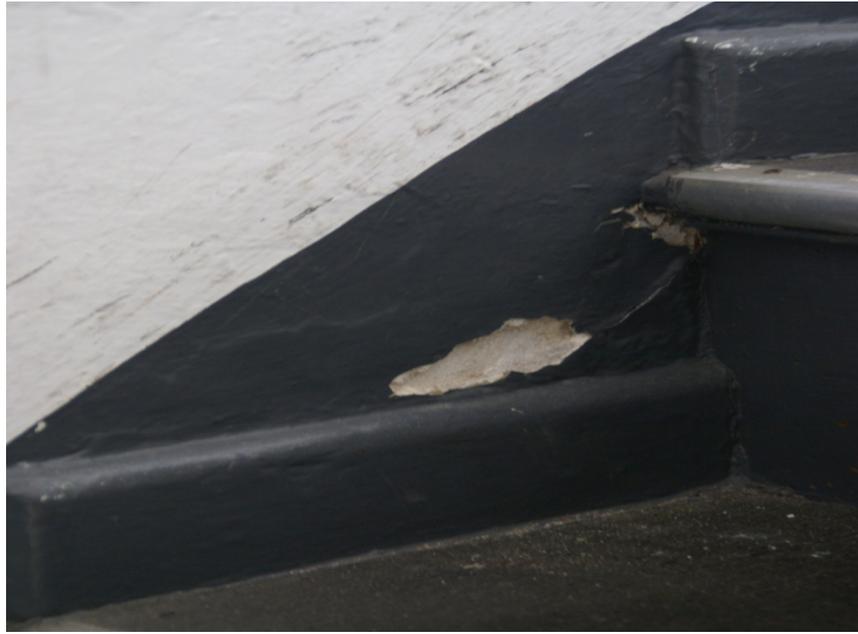
Figure # 18 : DAMAGE TO WALL PLASTER ALONG STAIR TREAD.

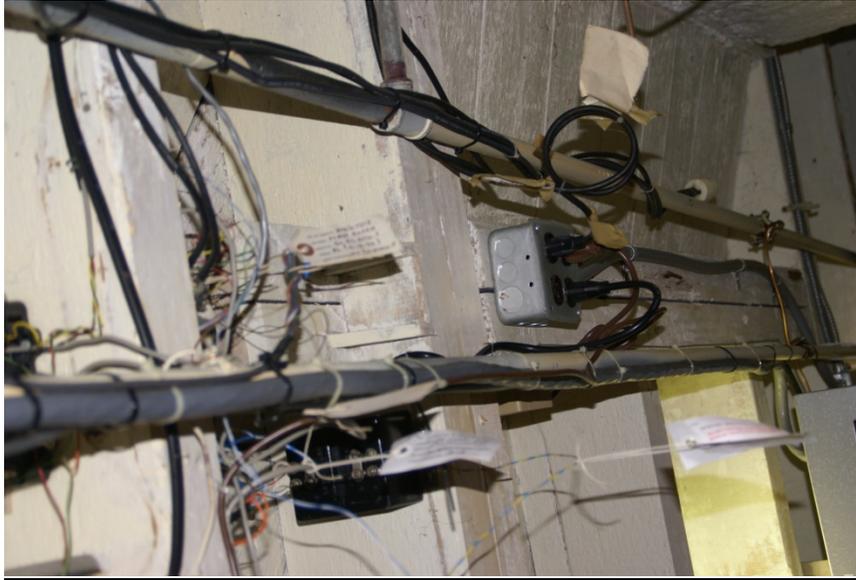
Figure #26 : Maze of electrical lines and conduit in ceiling of basement.

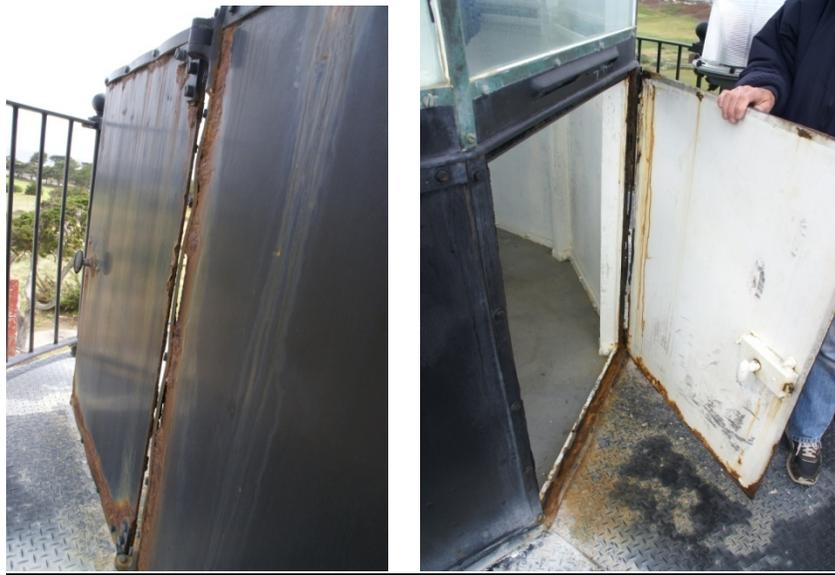
LANERN ROOM DOOR

QCR-POOR / MDPR -CRITICAL to CATASTROPHIC.

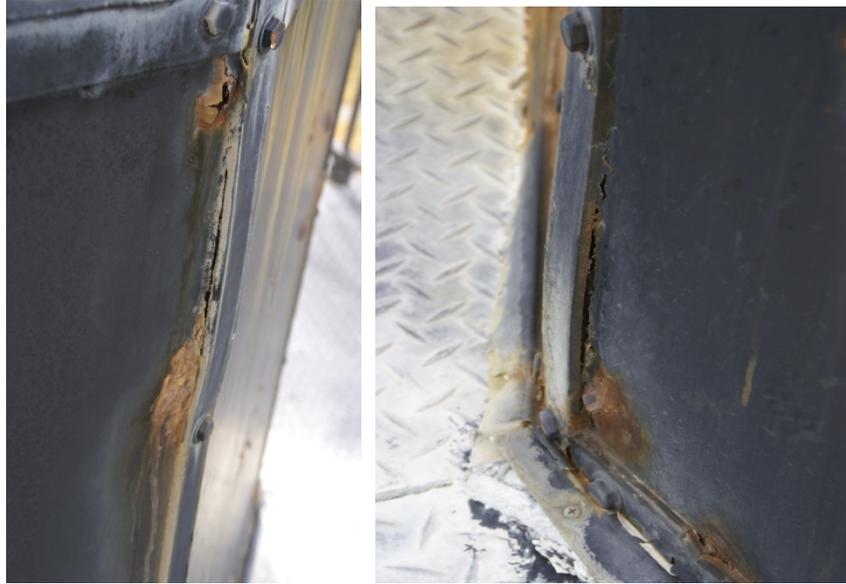
Photo: LR#2 and#3: **Loss of integrity of astragals which secure wall panels to lantern room frame.**

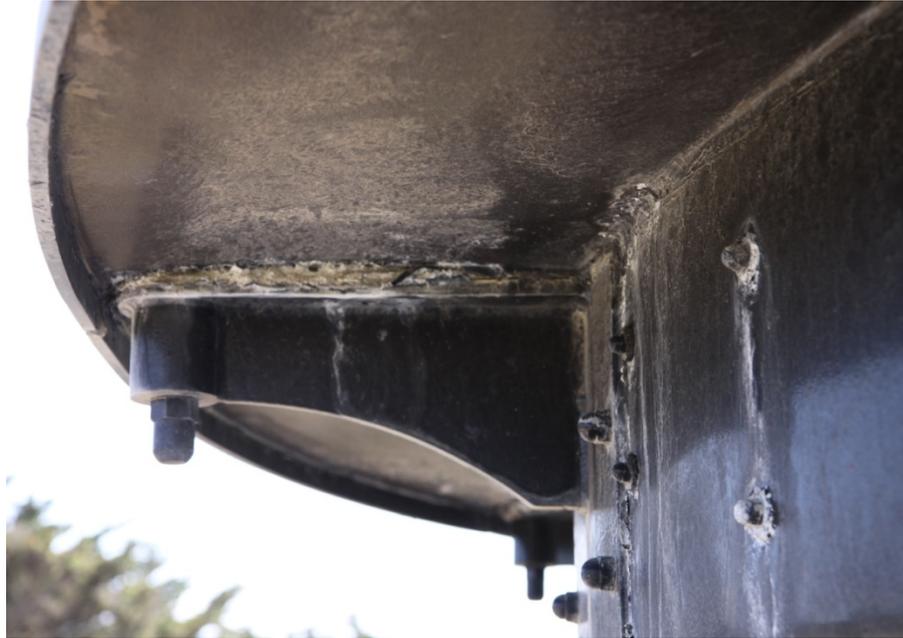
Note missing nut on far right support bracket. Note build up of aluminum oxide along top edge of bracket along seams and connector bolt heads.

- * Inspect all support brackets and connections to determine structural integrity.
- * Inspect all metal surfaces and welds for any scratches, breaks, or damage to finish coatings. Clean all surfaces and connectors of aluminum oxidation. Hand- brush all surfaces to remove surface rust, scale and debris. Apply MK350 or Ospho to neutralize surface oxidation. Prime with zinc base primer ASAP. Use approved metal coating and historic colors to finish coat all damaged paint surfaces. Any & all replaced metal must match the replaced system in scale, design, and materials and should be etched with year of casting replacement to identify new fabric.
- * Staff should conduct periodic inspections of all metal- work for signs of oxidation and repair ASAP to prevent expensive damage to finish coats from occurring.

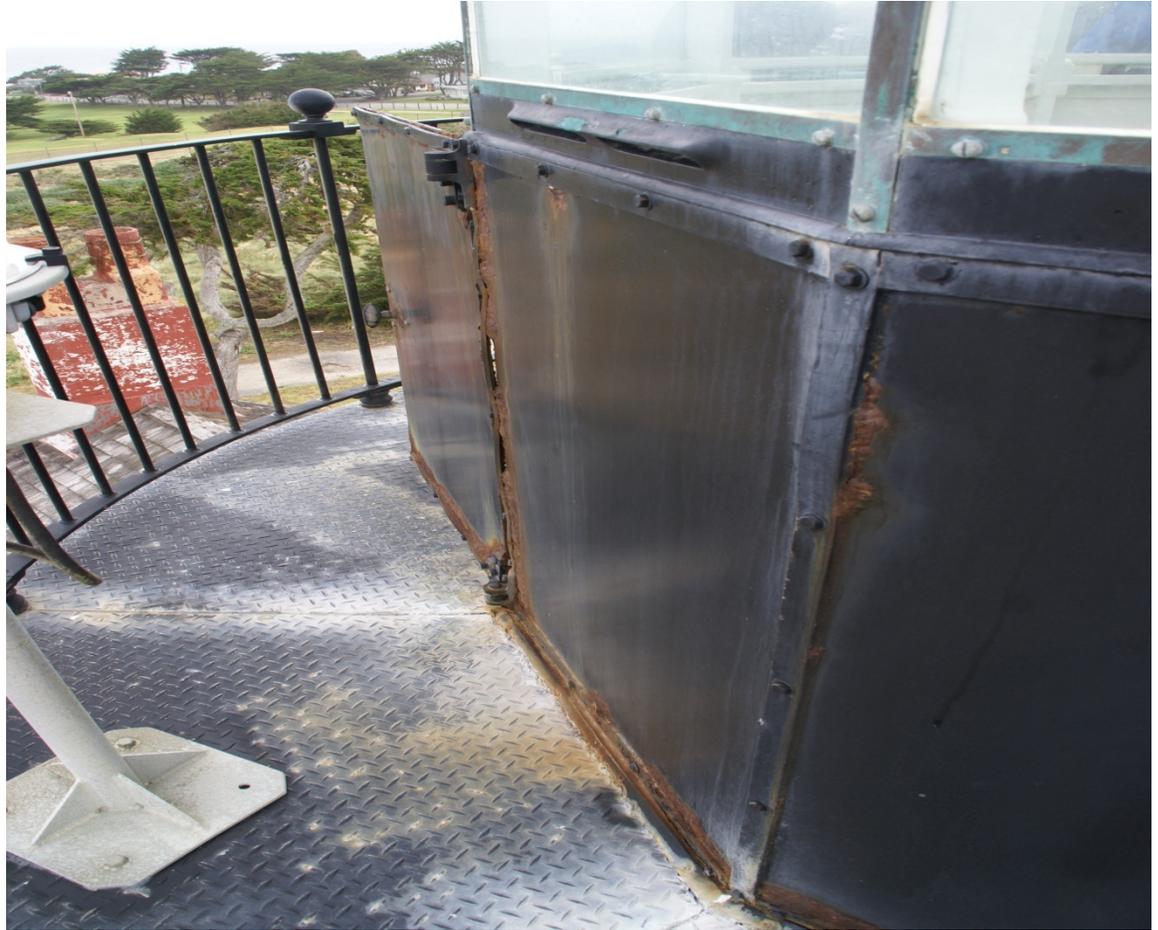
Photo: WRSGD&SRS#1: **Note: Under no circumstances should visitors be permitted or provided a means of unauthorized access to this area even when repaired.**

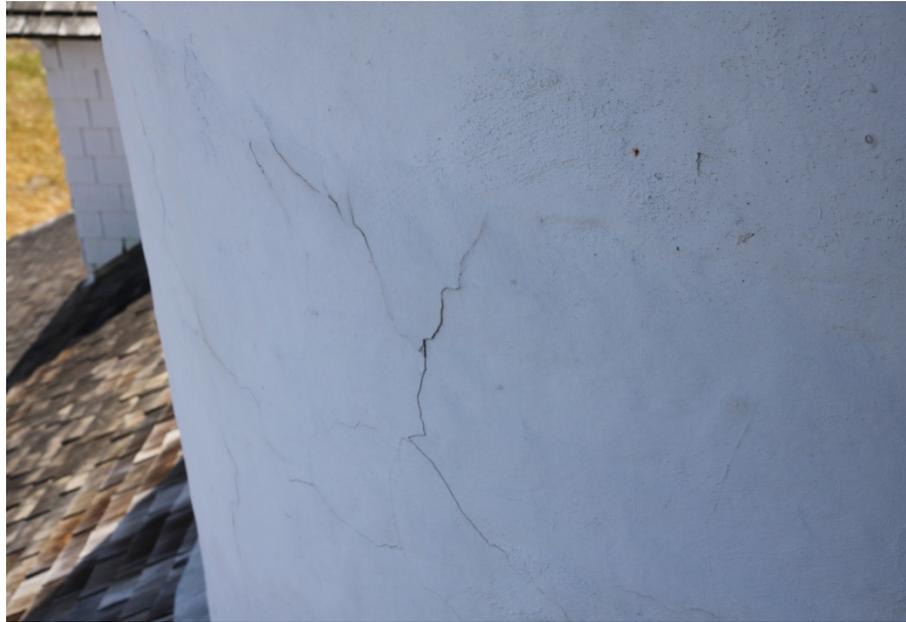
EXTERIOR STUCCO/CONCRETE WALLS

QCR-POOR - MDPR -SERIOUS TO CRITICAL

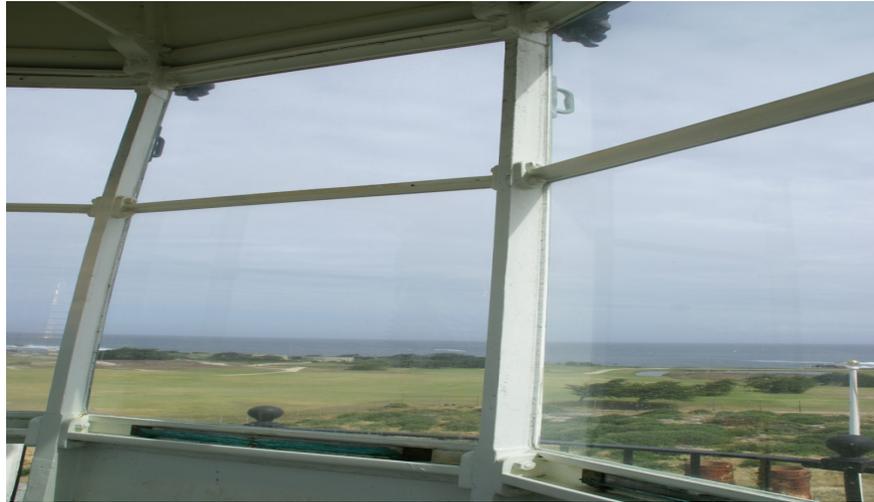
LANTERN ROOM STORM PANES AND FRAMING PANELS

QCR- FAIR to POOR - MDPR - MINOR to SERIOUS.

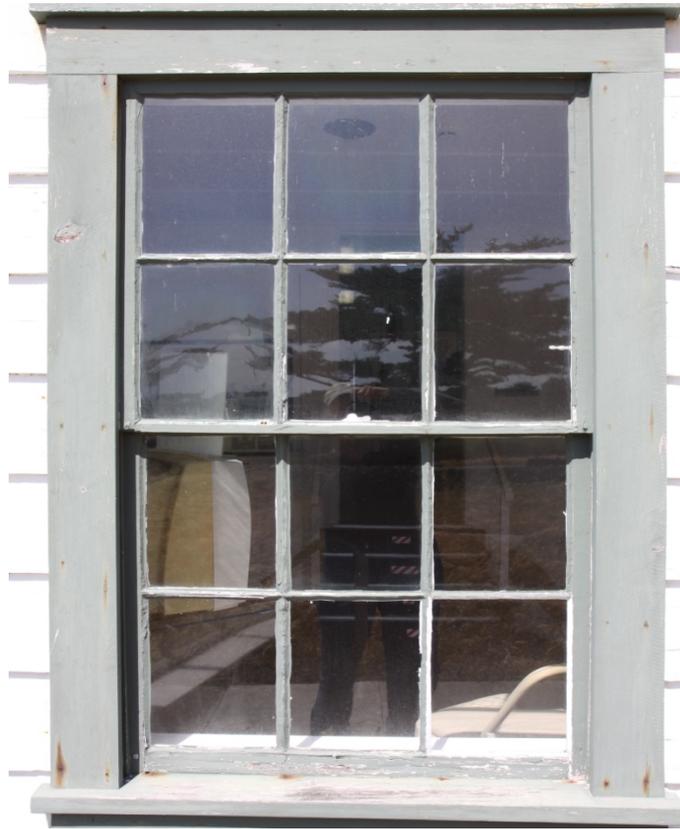
WOOD WINDOW FABRIC

QCR-MINOR/MDPR- SERIOUS:

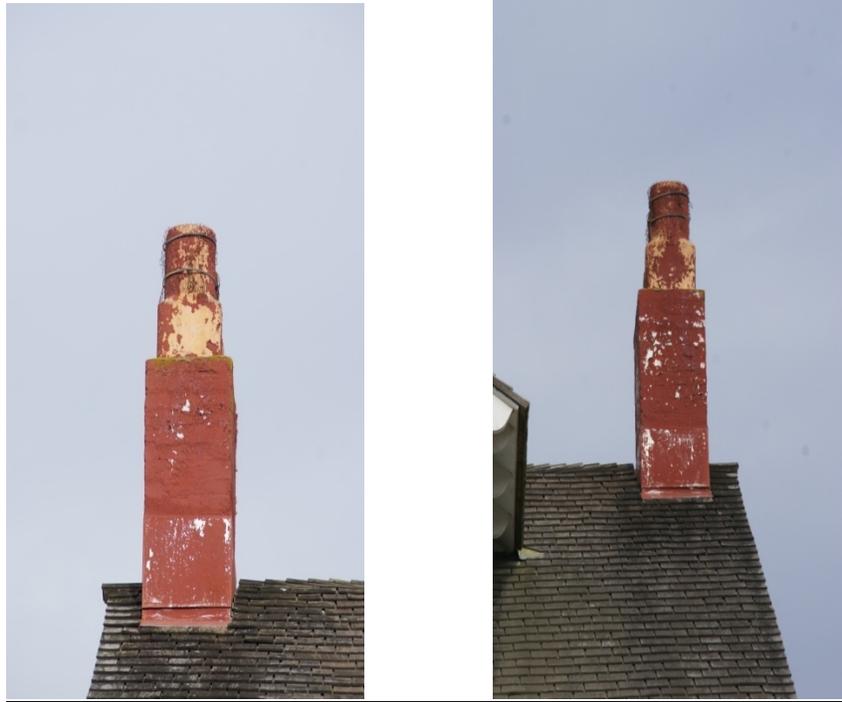
BRICK CHIMNEYS

QCR- FAIR to POOR/ MDPR -SERIOUS to CRITICAL.

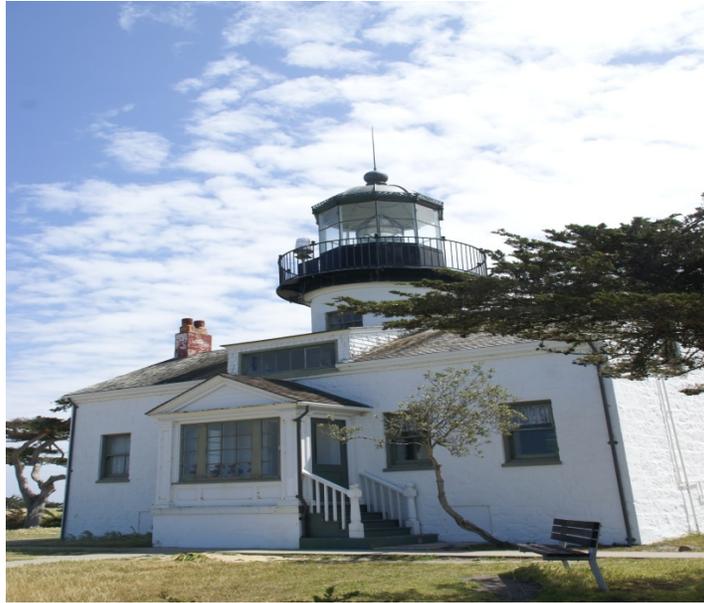
Photo: LBPC # 4.

FAILED COATING ON BRICK AND OTHER HISTORIC FABRIC

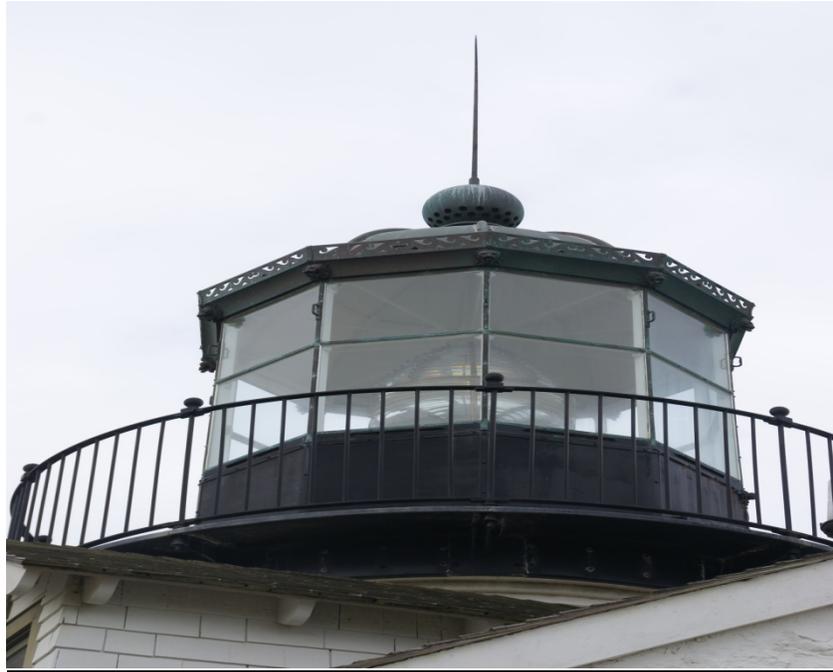
BRONZE LIGHTNING SUPPRESSION CABLE

QCR-POOR/MDPR-SERIOUS.
