POINT PINOS LIGHTHOUSE

PACIFIC GROVE CALIFORNIA

PRESERVATION PLAN

August 2009

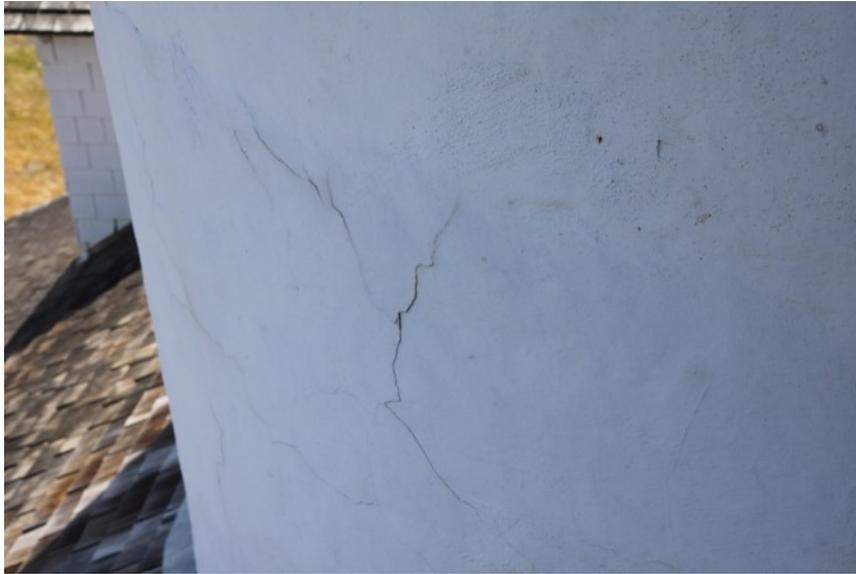
Figure 3: Cracks in stucco.

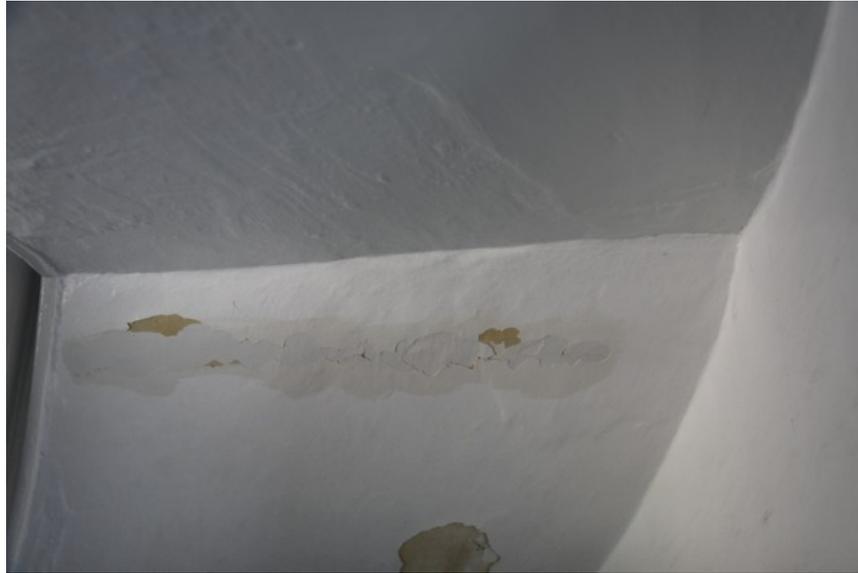
Figure3: Evidence of moisture damage from exterior cracks in stucco.

There has been a resultant moisture entry into the porous stucco coat which has permeated into the interior of the lighthouse with resultant damage to the historic fabric, including plaster. Whether due to improper application or moisture damage, there is widespread failure of the adhesion of the stucco coat to the exterior concrete which produces a hollow sound when we tested the circumference of the exterior lighthouse cylinder. There are also numerous hairline cracks or separations throughout the exterior surfaces of the stucco coat which has provided additional moisture entry into the hollows between the stucco coat and the exterior concrete surface. The extent of the damage ranges from hairline cracks to actual failure of sections of stucco coats with resultant large openings into the stucco coat and higher levels of moisture entrapment and damage.

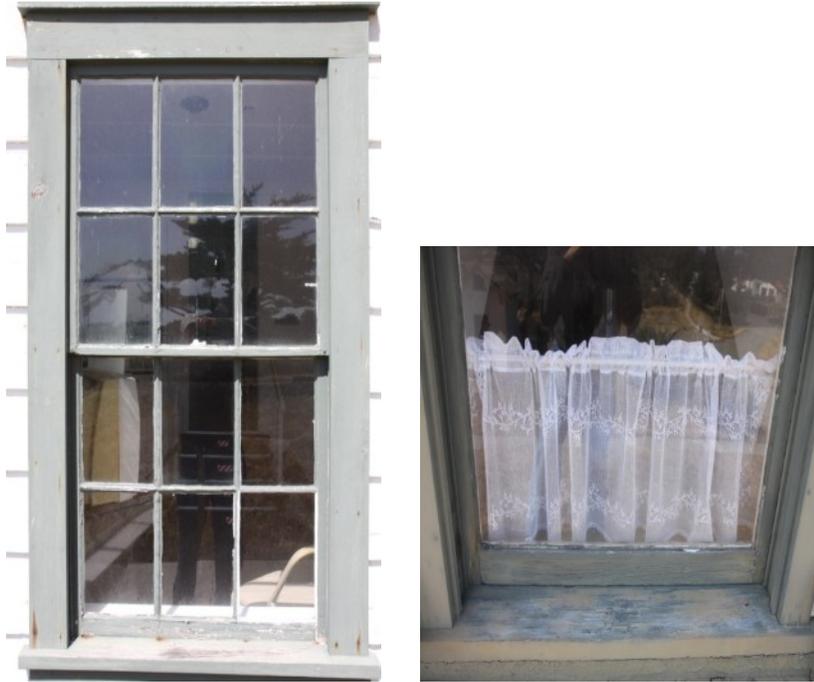
Figure 14 & 15: Example of damage to window trim and window - sill.

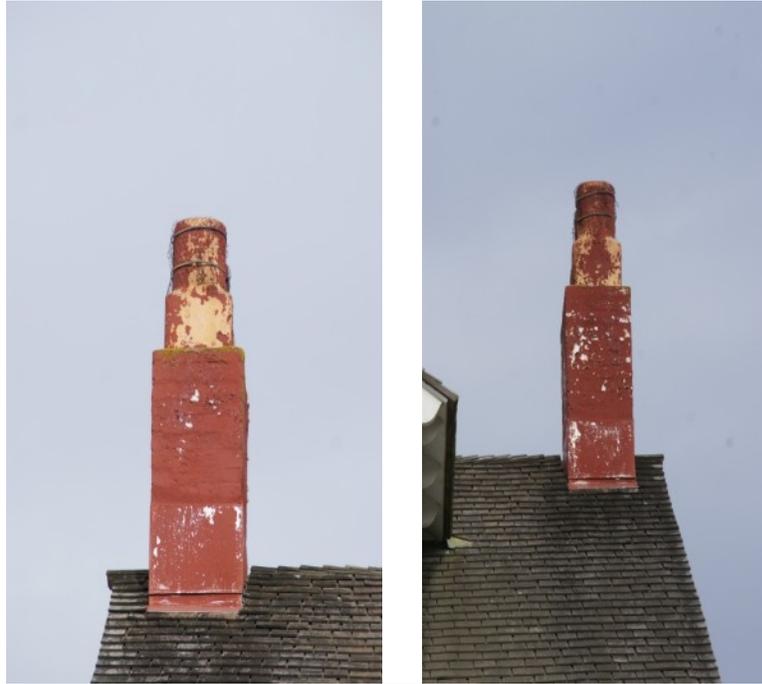
Figure 26 & 27: North and South chimney systems

CHIMNEYS: The end gable chimneys are constructed of fired red brick with a protective stucco coating. They are topped by clay pipe flues which have wire screening to prevent bird entry. There is a metal flashing at the base of the chimneys as they meet the cedar shake shingle roof. (Flashing material appears to be metal other than copper which would have been used historically and which has a longer life span in hostile coastal environments.) The overall condition of both brick chimney systems is rated **POOR**. Most of the protective paint coating has failed and there is widespread loss of the protective stucco as well. We noted extensive loss of mortar joints on both chimney systems which could result in loss of structural integrity, especially during a high wind event. The repair to the chimney systems should be performed by qualified contractors.

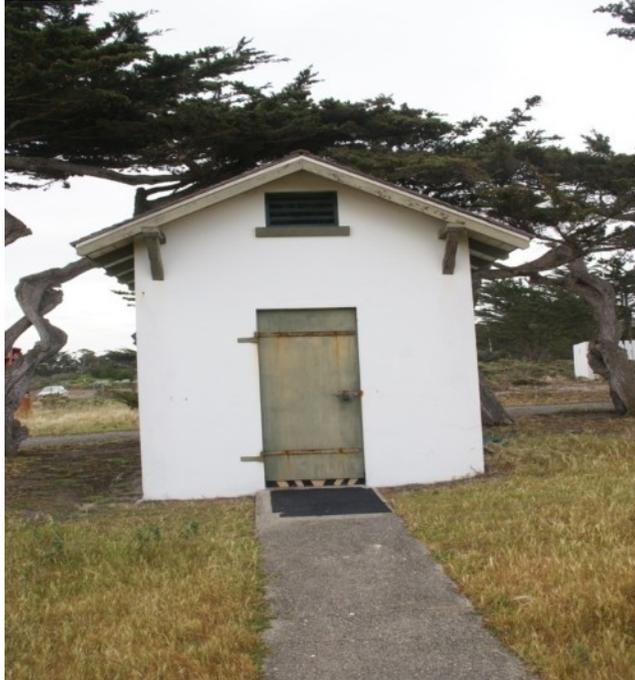
Figure33 : HISTORIC FUEL STORAGE BUILDING

Fuel Storage Building: The overall condition of the Fuel Storage Building is rated as **GOOD** to **FAIR**. The building is of brick construction with a protective stucco exterior coating. The roof system is a wood truss with wide plank roof decking covered by. Fuel Storage Buildings under the care of the U.S. Lighthouse Service and well into the management of the United States Coast Guard, often historically were covered with a metal standing seam roof material usually painted red to indicate the storage of flammable materials. There are several structural cracks along the North and South sides of the building. The iron door is supported by two strap hinges. Both hinges are in a state of advanced metal jacking due to the exfoliation of the metal. There is wood rot on the rafter tails of the roof system and evidence of rot in some of the roof deck planks. Several sections of deck planks have been replaced with newer material.

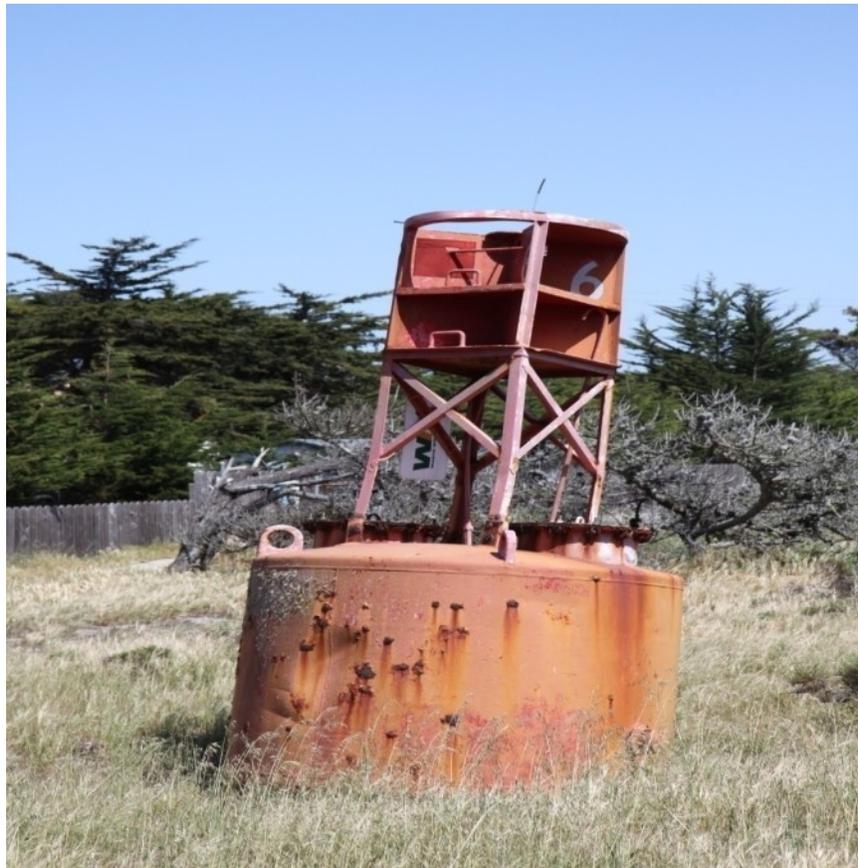
Figure 34: NAVIGATIONAL BUOY

NAVIGATIONAL BUOY: The overall condition of the buoy is ranked as **POOR**. There is widespread loss of protective coatings with resultant oxidation, staining, blistering and exfoliation of the metal surfaces. There are several dents in the Buoy. Repairs can be conducted by volunteers or staff under a controlled environment with protective mask and outer safety wear. Proper encapsulation of Buoy should be installed prior to blasting. All paint debris should be contained, collected, and disposed of according to federal and State of California Law. Buoy should be sand blasted to clean metal of all coatings. Buoy should be repainted based on historic colors and markings.

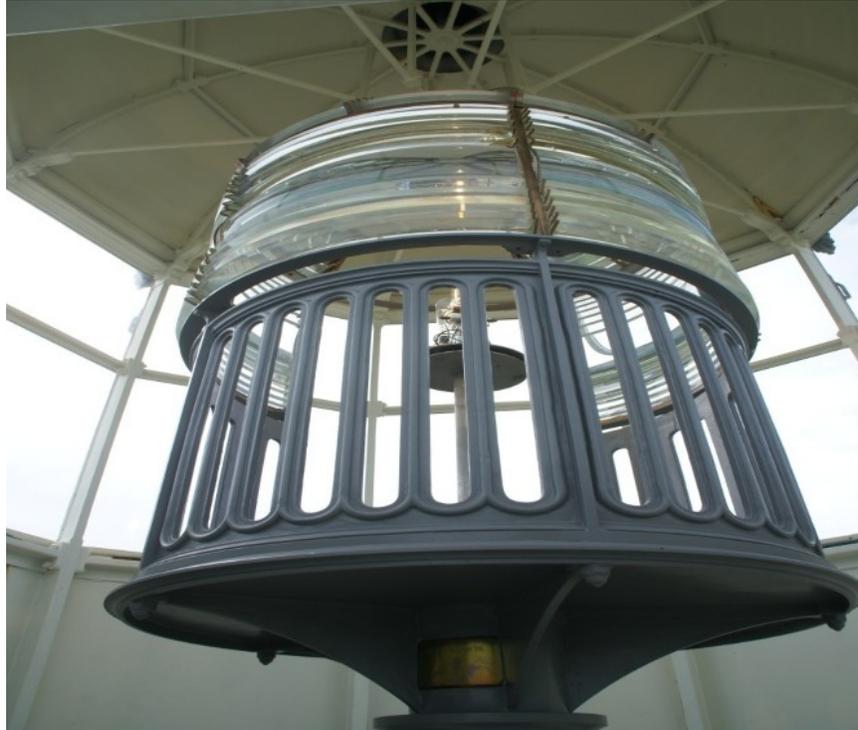
Figure 5: Point Pinos Lantern Room & Historic Optic.

The Point Pinos lantern room houses a historic 3rd Order Henry Le Paute Fresnel Lens which still serves as an active Aid to Navigation operated by the United States Coast Guard. The brass and glass lens system is supported by a historic lens pedestal. The historic optic is surrounded and protected by a copper dome with iron canopy topped by a bronze vent ball. The framing is iron-crossed braced by an iron “spider”. Iron stiles braced by bronze mullions which also serve as condensation collectors, secure the glass storm panes. There are bronze vents at the top of the iron walls. Iron flat plate walls attached to the steel stiles and bronze mullions, a steel deck platform. There is rust staining, rust scale, and metal exfoliation in numerous areas of the lantern room, especially the lantern canopy, walls, and doors. The bronze air vents are also showing signs of advanced deterioration. All damage should be corrected under the IMMEDIATE PHASE of the Preservation Plan. The Overall rating of the Lantern Room interior is **GOOD** to **POOR**.

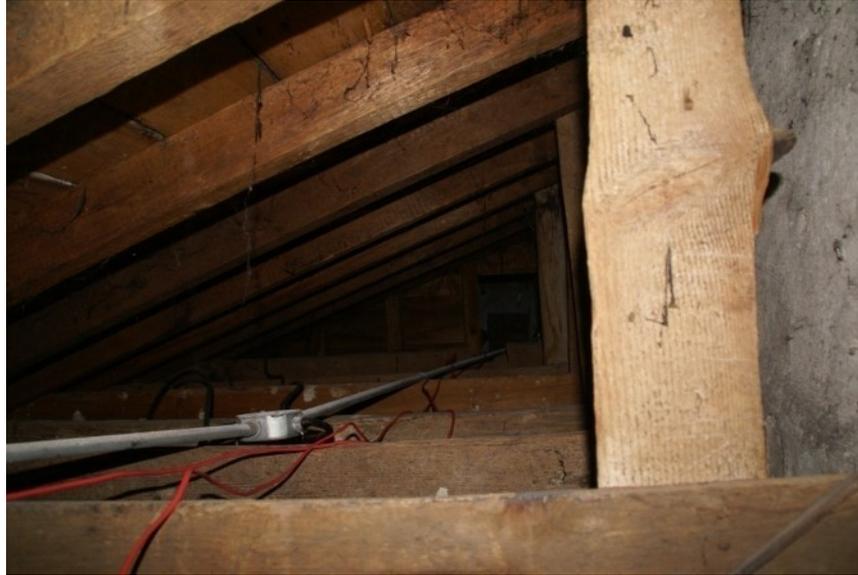
The small crawl space above the kitchen and bathroom area was inspected for indications of roof failure and leaks. Structural integrity and possible wood rot and insect damage were also concerns. No significant damage or any evidence of recent water entry was observed. The wiring system was noted to be in need of inspection and updating to provide adequate and safe electrical service to the lighthouse.

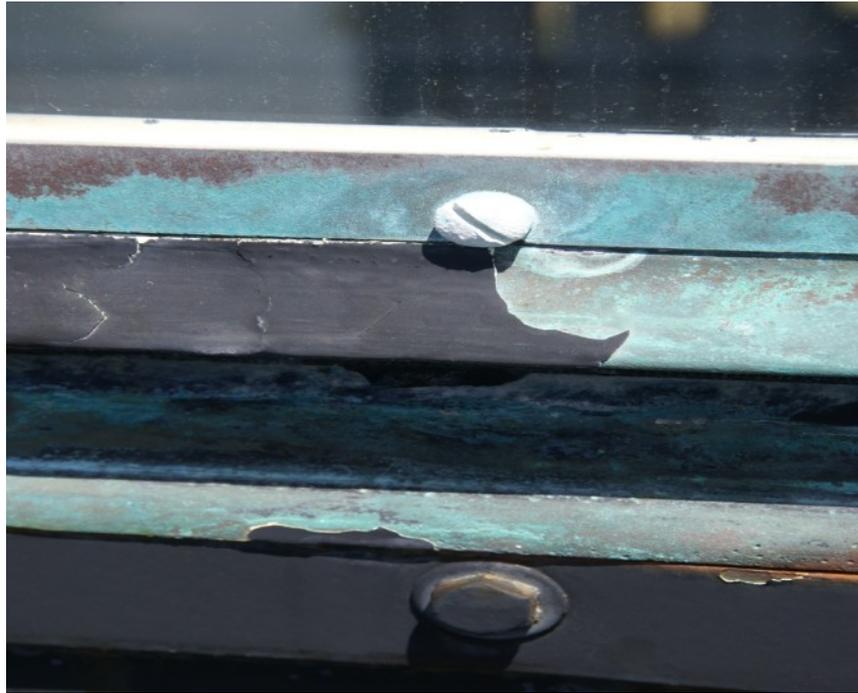
Figure : Bronze astragals securing storm panes.

The Lantern Room storm panes are held in place against the steel stiles and mullions by bronze astragals. There are stamped numbers on each astragal directing proper placement in numerical sequence around the lighthouse lantern and along the storm panes. There is a system of bronze hand safety grips which are bolted to the outer edge of the bronze storm pane astragals (batten strips). All fasteners are bronze and historically were metric. Due to metal fatigue they often break when being removed and once snapped off the remaining bolt will need to be tapped out. Replacement bolts must match originals in size, shape, and material. It appears that the fasteners used to attach the wall astragals are newer and were possibly installed during the period that the aluminum flashing was also installed.

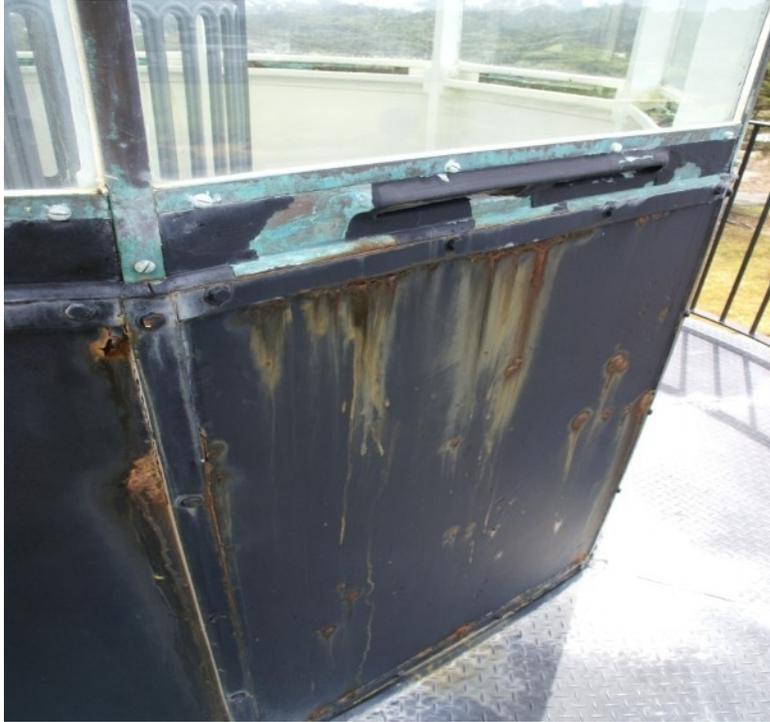
Figure: Iron Lantern Room Wall & bronze astragals.

The Lantern Room is made up of a series of iron plates which enclose the bottom of the Lantern Room and which are connected to the Lantern Room frame by bronze astragals bolted through the plates and threaded into the receiving holes in the inner frame. The black exterior coating system which is part of the Point Pinos “Day Mark” is in widespread failure. There is pervasive damage to both the iron wall panels and more importantly to the softer bronze astragals due to “metal jacking” created by the exfoliation of the iron plates. It appears that there is a process of galvanic corrosion or “catalytic reaction” of the two dissimilar metals taking place which when combined with salt air/water creates the catalyst to produce the corrosive effect. The condition is most pronounced on the western (seaward) sides of the exterior of the lantern. The degree of damage to the metal plates range from surface oxidation, to rust scale, to rust blisters, to exfoliation and “jacking” to loss of significant surface metal.

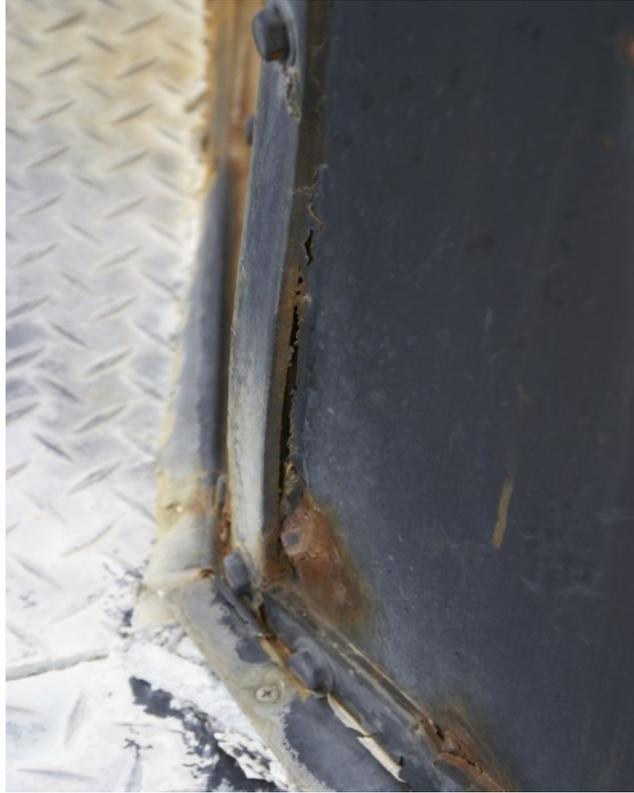
Figure : Stress effect on bronze astragals.

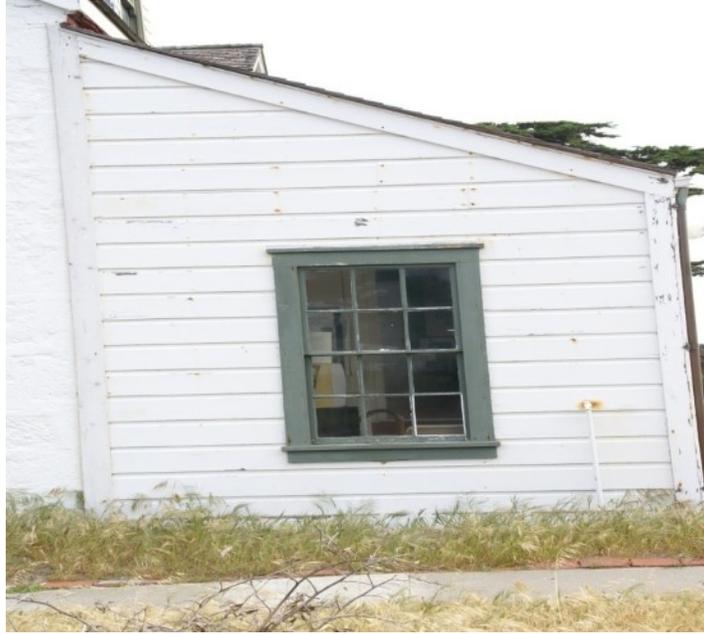
Figure : Build up of earth and vegetation against wood fabric.

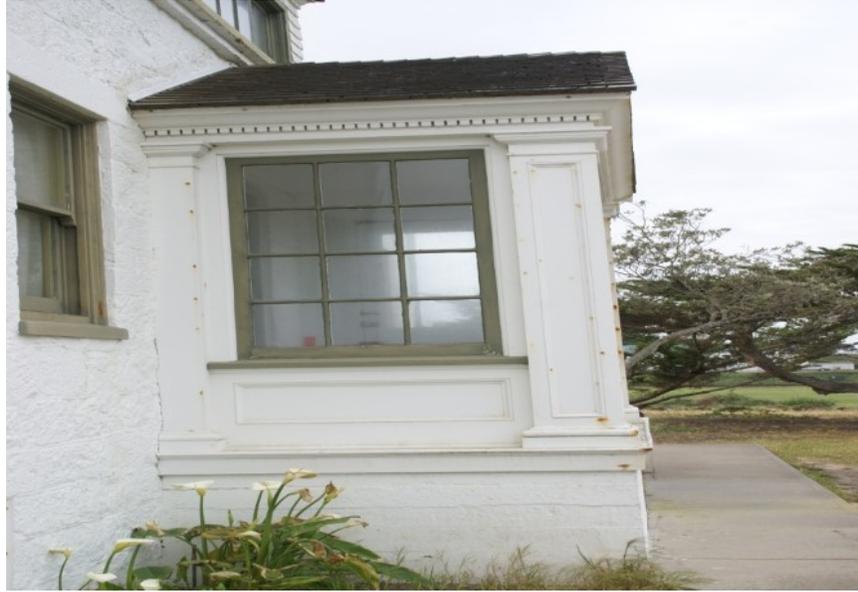
Figure#7 : FRONT PORCH-NORTH SIDE WINDOW-FAIR.

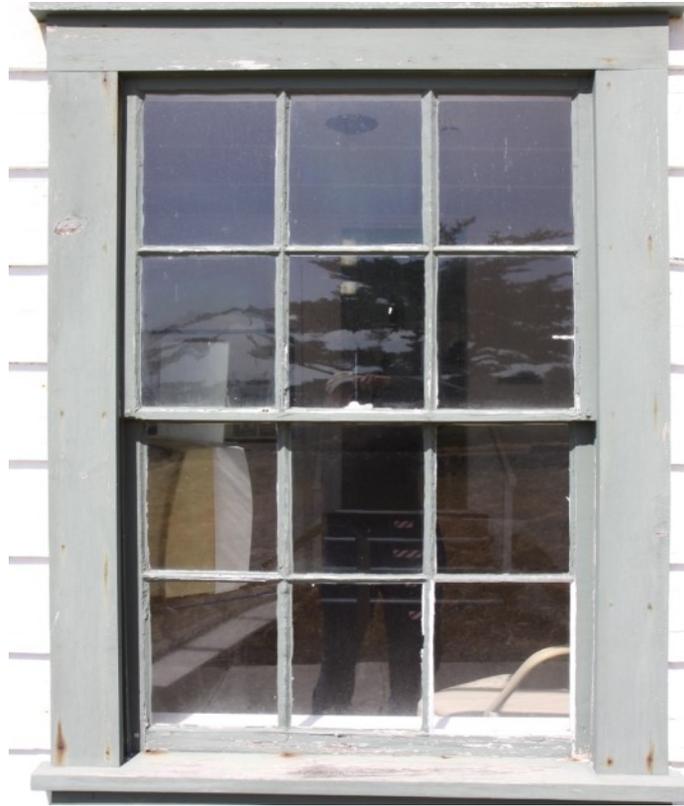
Figure#28 : TYPICAL WINDOW CONDITION-**POOR**

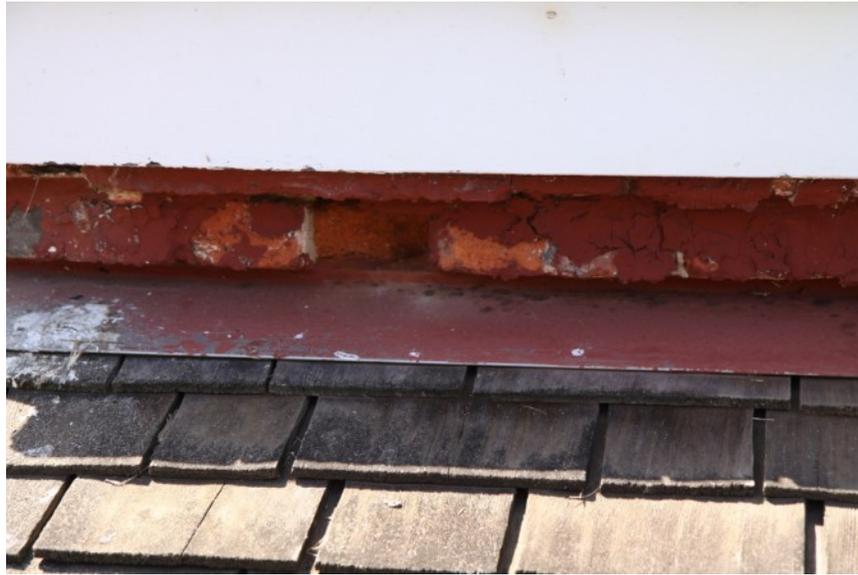
Figure #40: TYPICAL CONDITION OF BRICK CORBEL-**POOR**.

The brick corbels supporting the roof system on the rear-east elevation is rated **POOR**. A majority of the brickwork requires extensive repair and significant replacement. Replacement material must match original in size, character, and craftsmanship of installation.

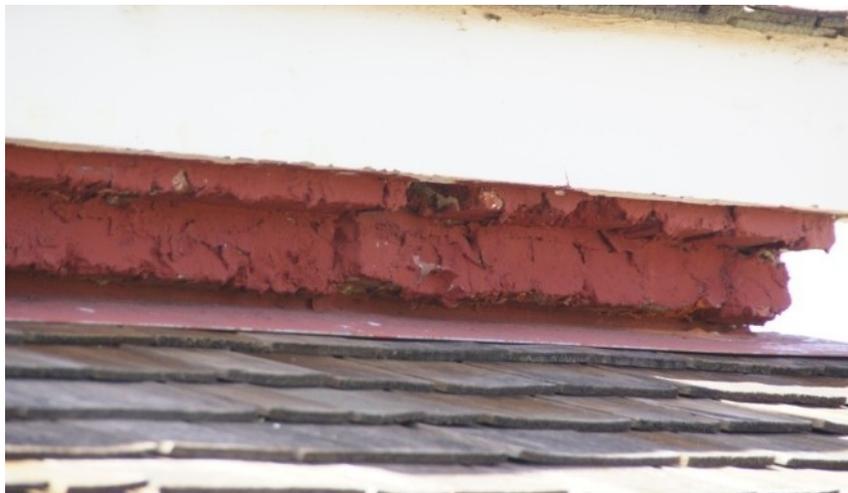
Figure #41: TYPICAL CONDITION OF BRICK CORBEL-**POOR**

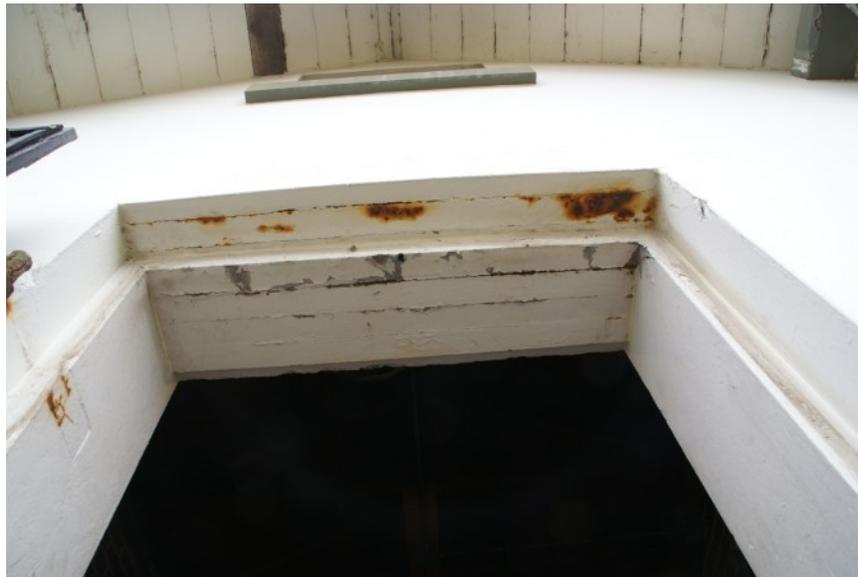
Figure #58 & #59: Typical conditions of iron door frame.

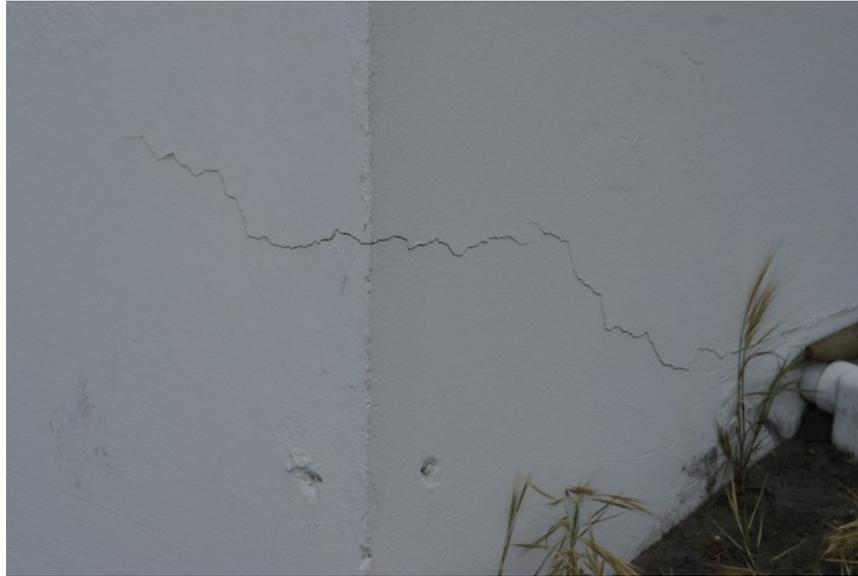
Figure # 60 & #61 : Showing cracks in the exterior stucco walls.

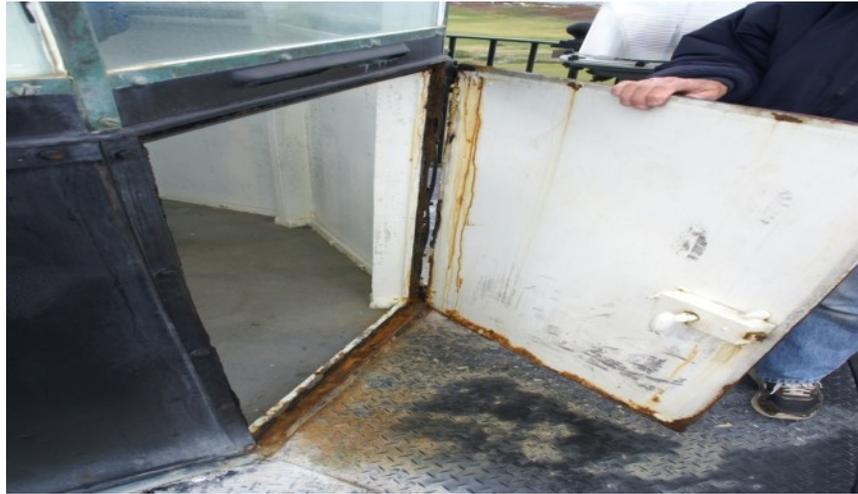
Figure#10: Inside surface of Lantern Room door requires immediate and extensive repair.

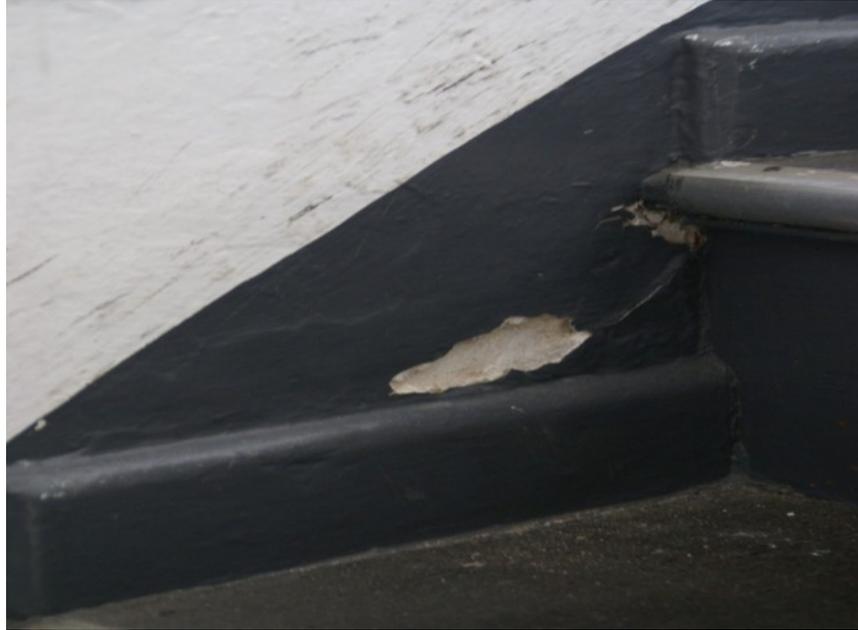
Figure # 18 : DAMAGE TO WALL PLASTER ALONG STAIR TREAD.

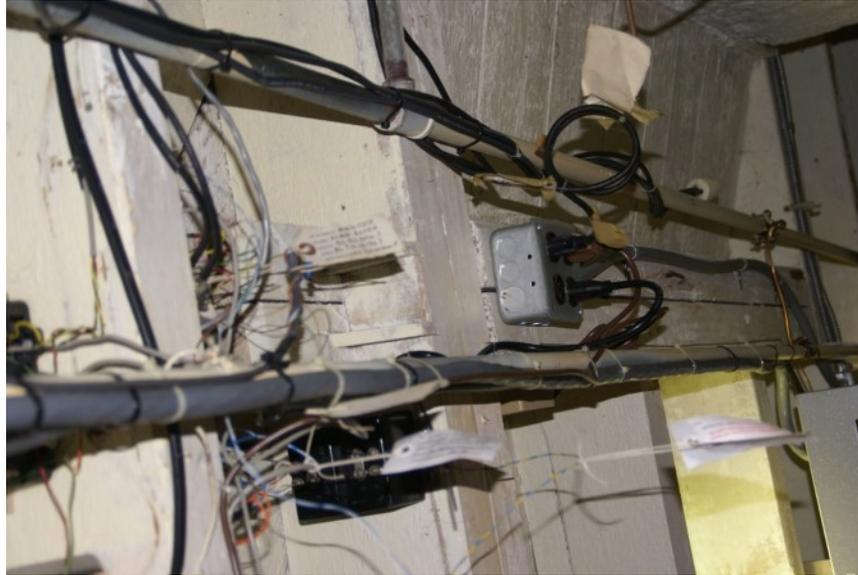
Figure #26 : Maze of electrical lines and conduit in ceiling of basement.

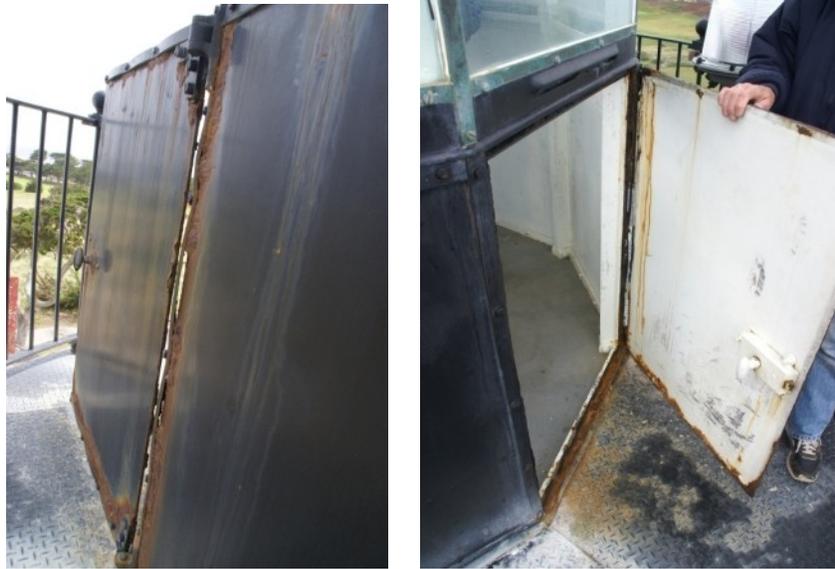
LANTERN ROOM DOOR

QCR-POOR / MDPR -CRITICAL to CATASTROPHIC.

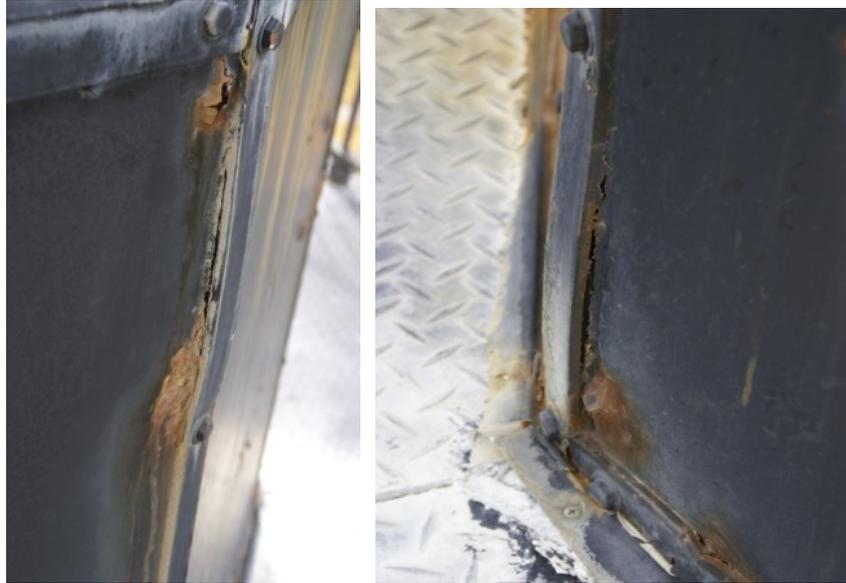
Photo: LR#2 and#3: **Loss of integrity of astragals which secure wall panels to lantern room frame.**

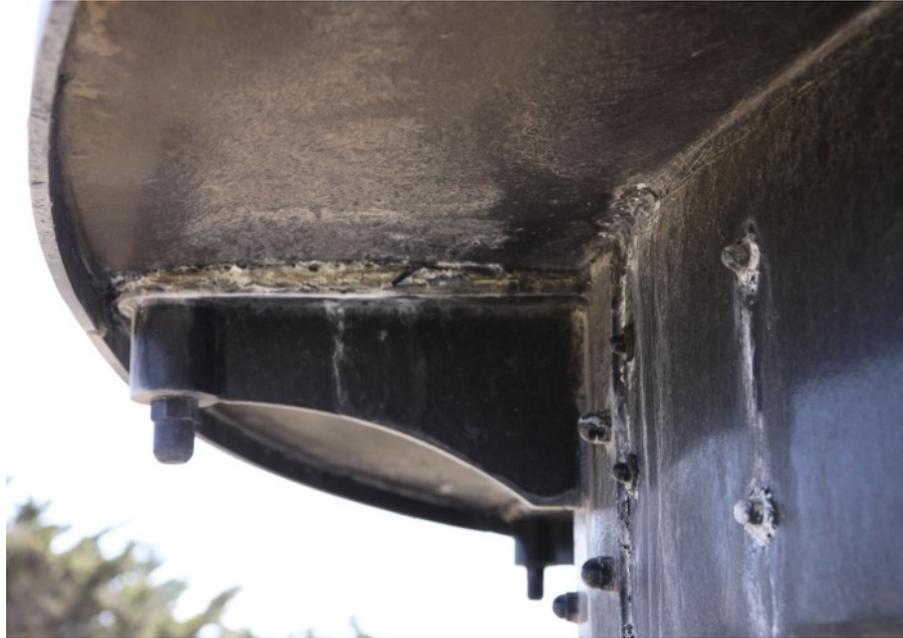
Note missing nut on far right support bracket. Note build up of aluminum oxide along top edge of bracket along seams and connector bolt heads.

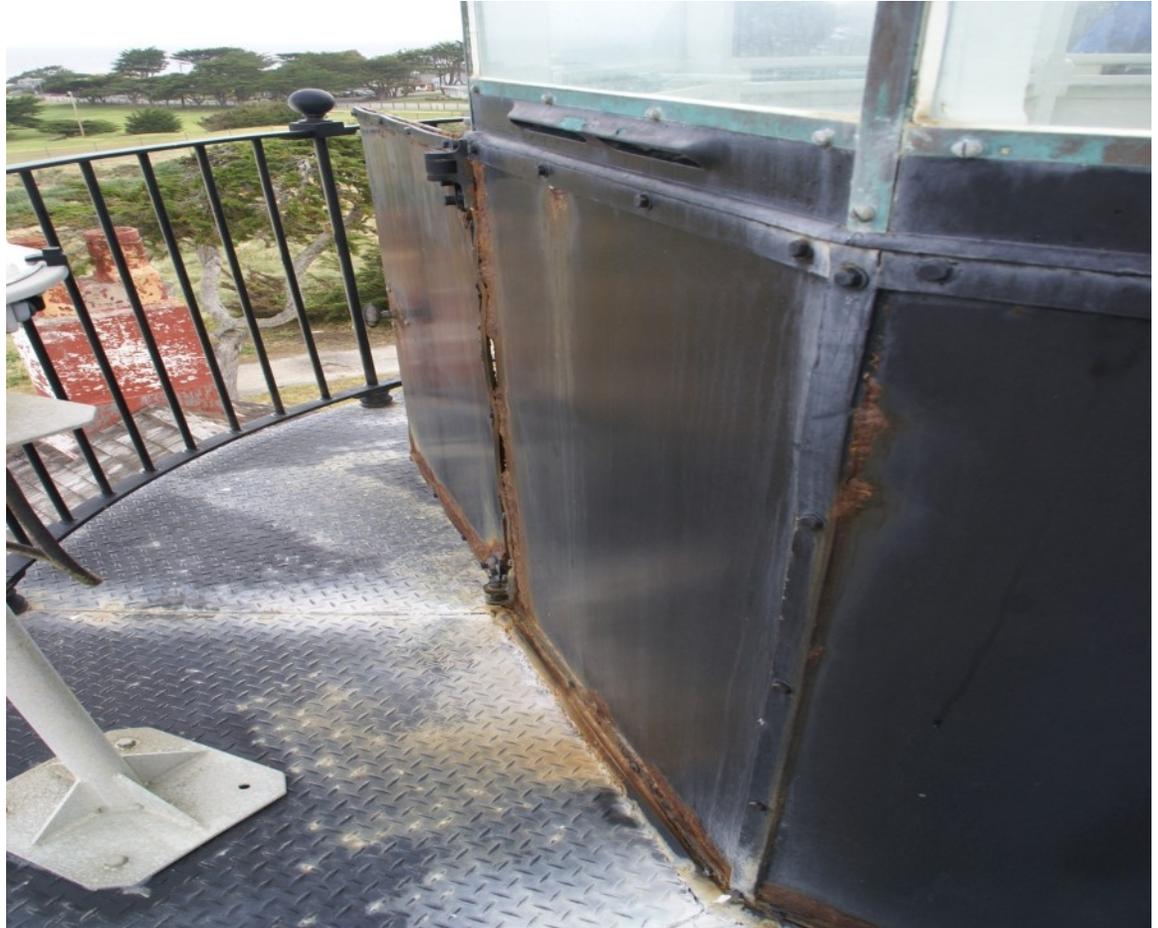
Photo: WRS&SRS#1: **Note: Under no circumstances should visitors be permitted or provided a means of unauthorized access to this area even when repaired.**

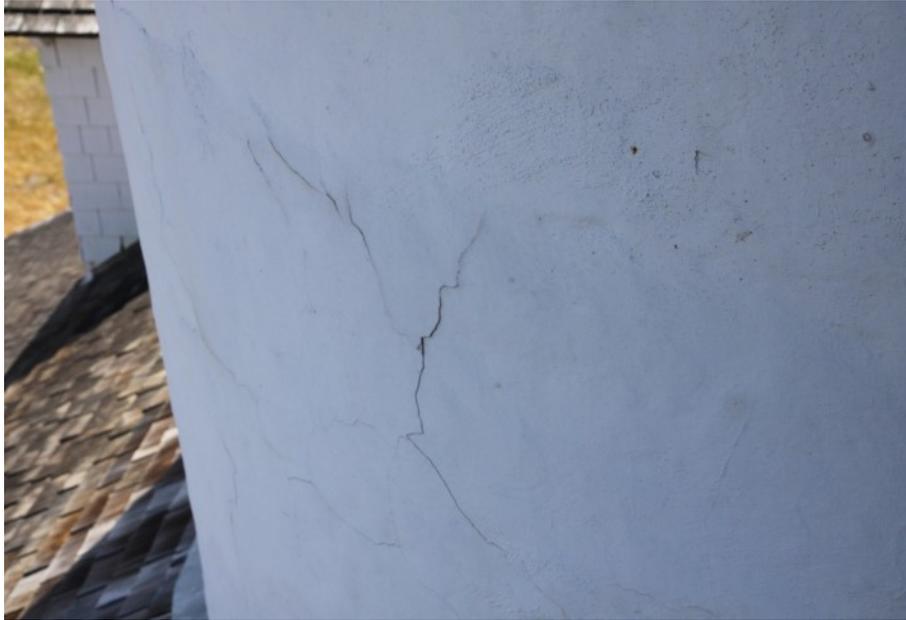
EXTERIOR STUCCO/CONCRETE WALLS

QCR-POOR - MDPR -SERIOUS TO CRITICAL

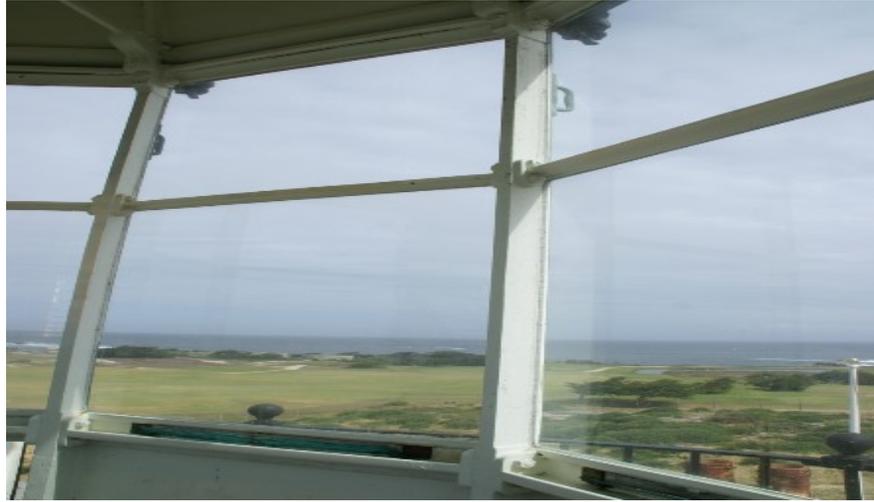
LANTERN ROOM STORM PANES AND FRAMING PANELS

QCR- FAIR to POOR - MDPR -MINOR to SERIOUS.

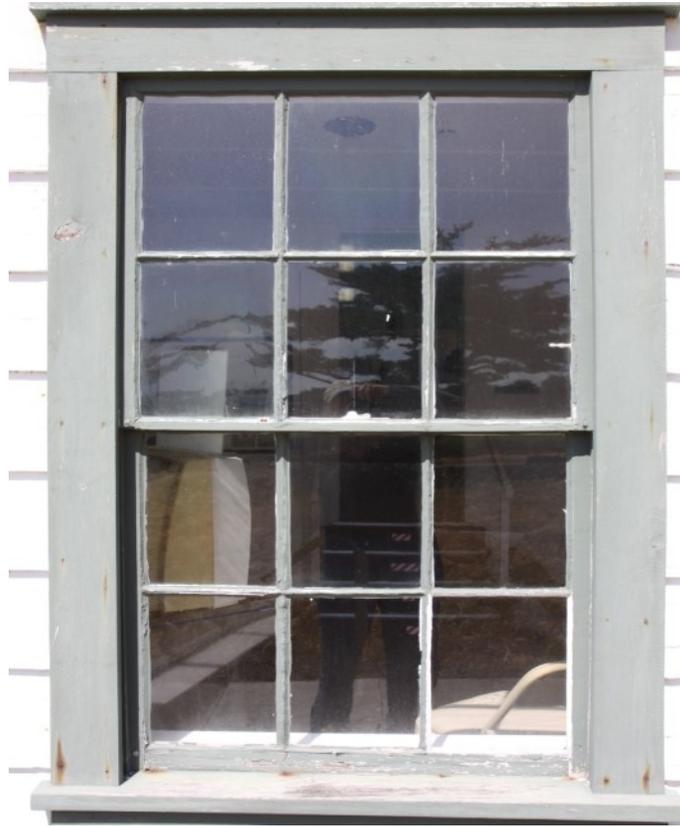
WOOD WINDOW FABRIC

QCR-MINOR/MDPR- SERIOUS:

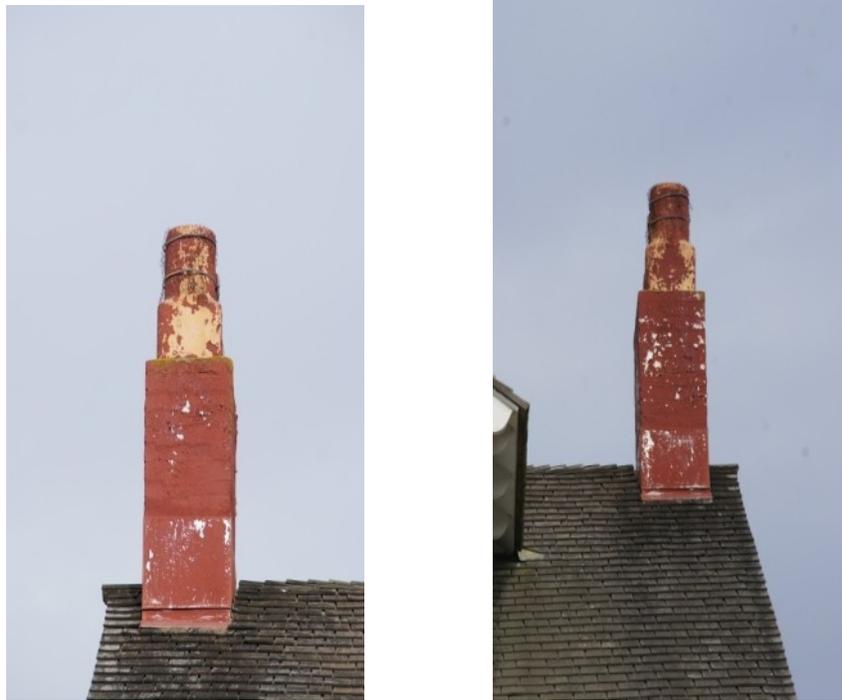
BRICK CHIMNEYS

QCR- FAIR to POOR/ MDPR -SERIOUS to CRITICAL.

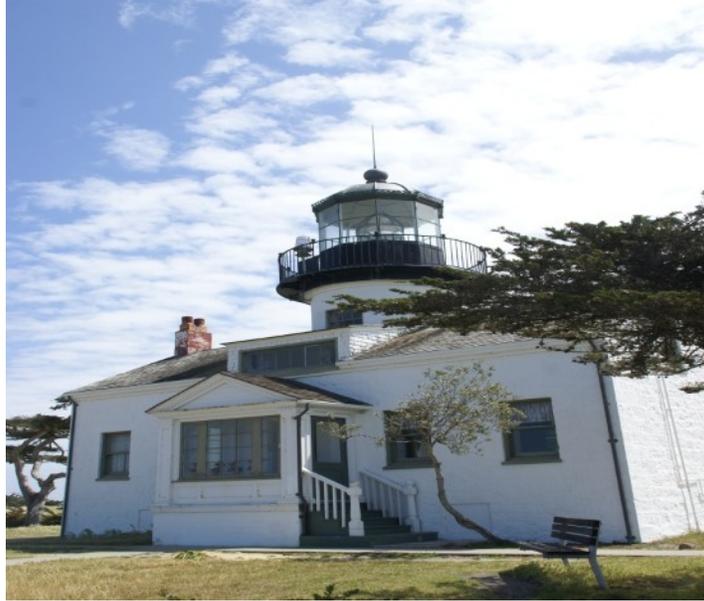
Photo: LBPC # 4.

FAILED COATING ON BRICK AND OTHER HISTORIC FABRIC

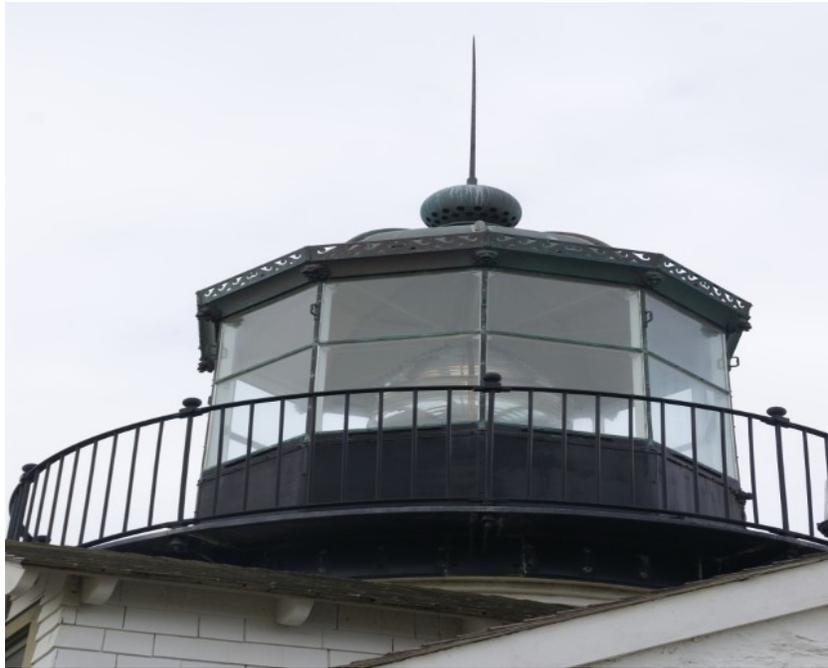
BRONZE LIGHTNING SUPPRESSION CABLE

QCR-POOR/MDPR-SERIOUS.
