To: Ken Hinshaw
From: Bill Peake
Subject: Lighthouse Doors
August 26, 2012

POINT PINOS LIGHT HOUSE

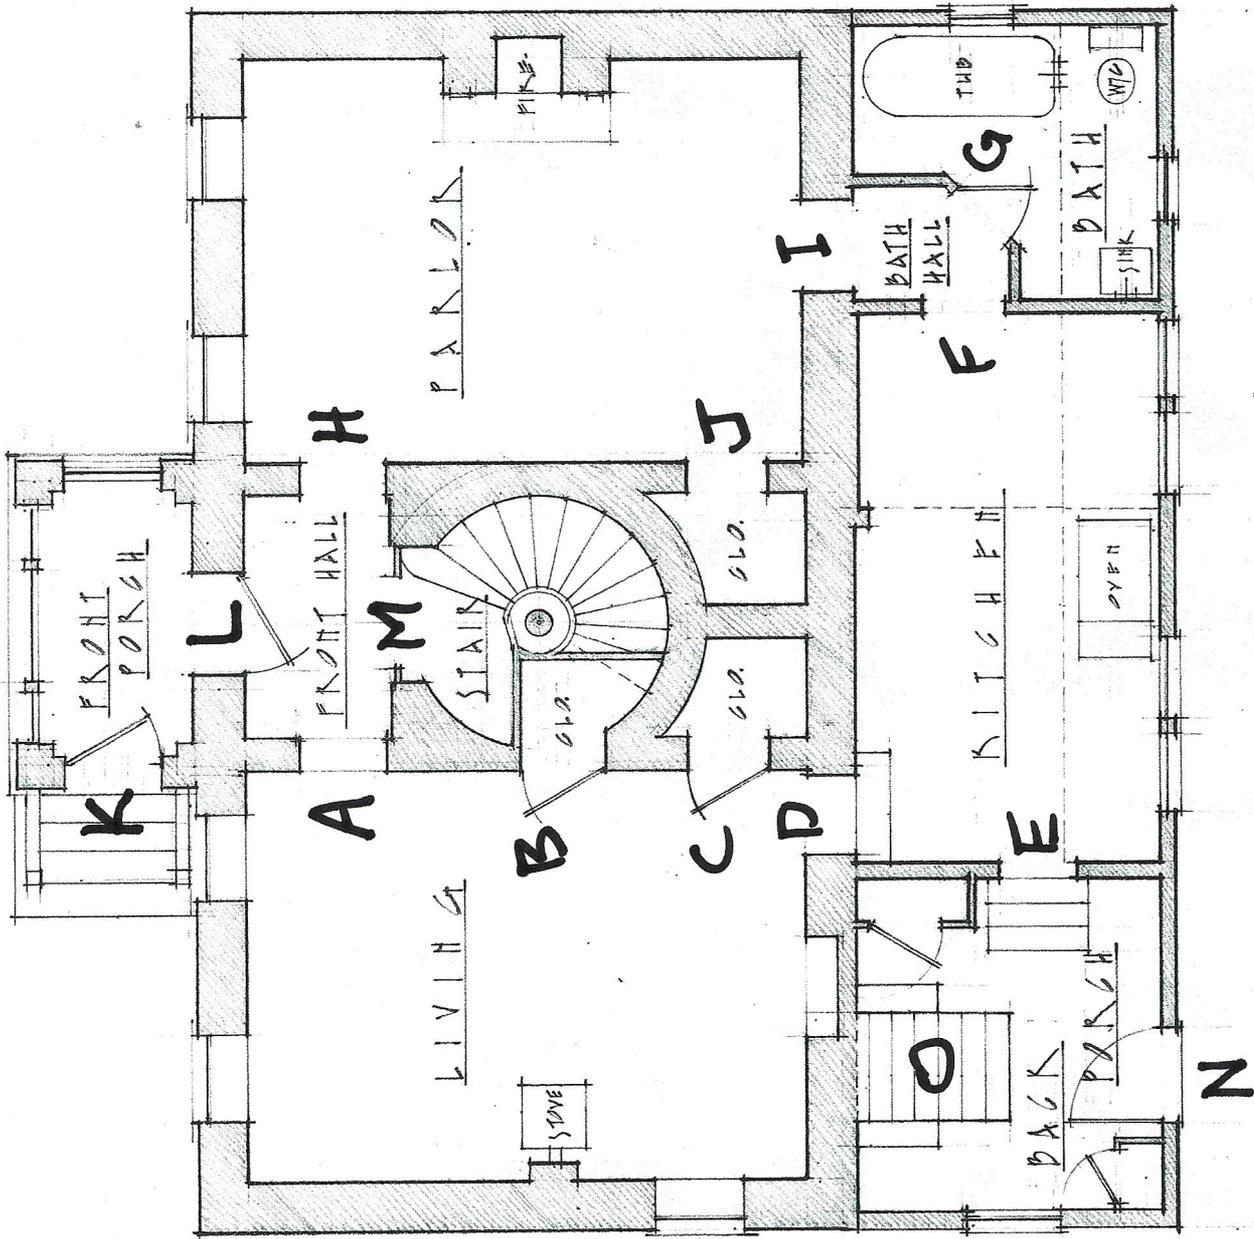
There are 20 locations that have or may have had doors. This includes walk-in closets. These 20 locations are listed in Table 1 and are shown as letters A-T on floor plans. Only the trap door to the lantern is omitted. Room names in Table 1 are from the floor plans.

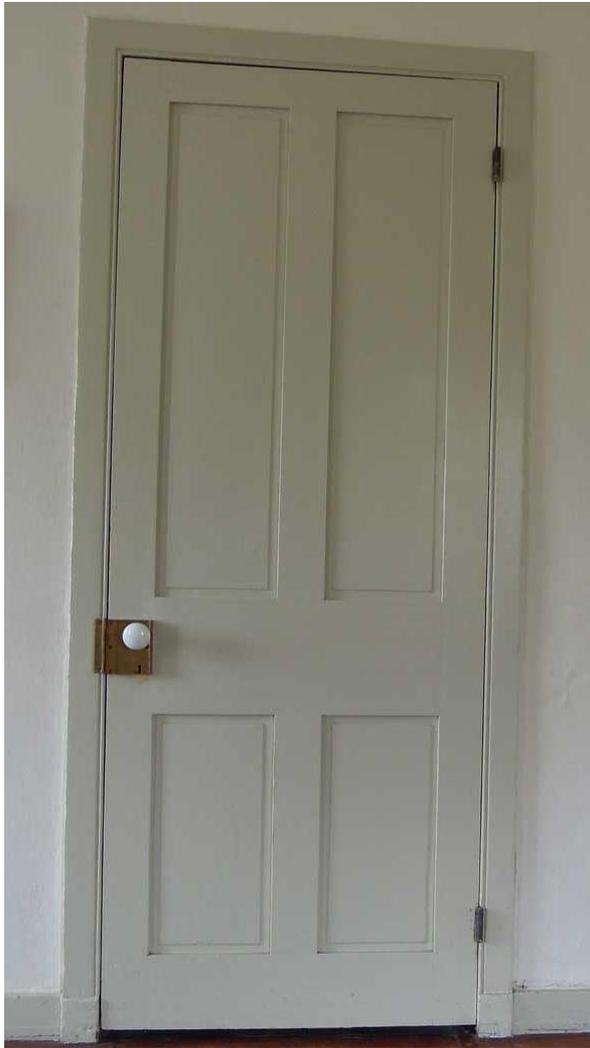
Typical Interior Door

Door style is apparently Greek Revival as described in References 1 and 2. Greek Revival is indicated by (1) the date of lighthouse construction (1853-1854), (2) door heights generally near 7 ft and (3) door style which is typically 4 panels with the top panels taller than bottom. The exception to Greek Revival are the 2 upstairs closet doors which are plank style. Perhaps this is due to their non-uniform height.

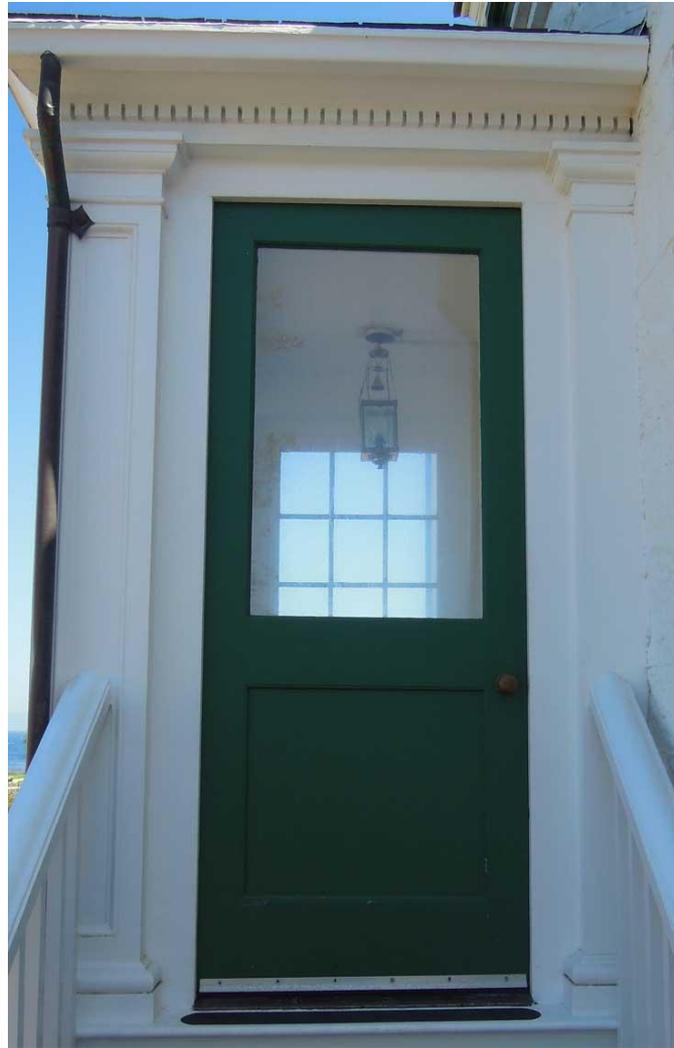
Front Exterior Door

Greek Revival style of architecture is also evident in the construction of the front porch which has a pediment, pilasters and lintel with dentil moulding. Pilaster design is similar to a Greek Revival house photo found on the internet (<http://historicbuildingsct.com>). Untypically, the front porch exterior door is not located in the front of the porch, but on the right or south side due to prevailing northwest winds.

- 3.2. Remove one of the two latches on the front exterior door, as two are not needed. Better yet, replace both latches with an antique.
 - 3.3. Install matching door knobs and rosettes on the front porch exterior door, as the exterior styles don't match with the interior door knob and rosette. The exterior knob and rosette may be newer.

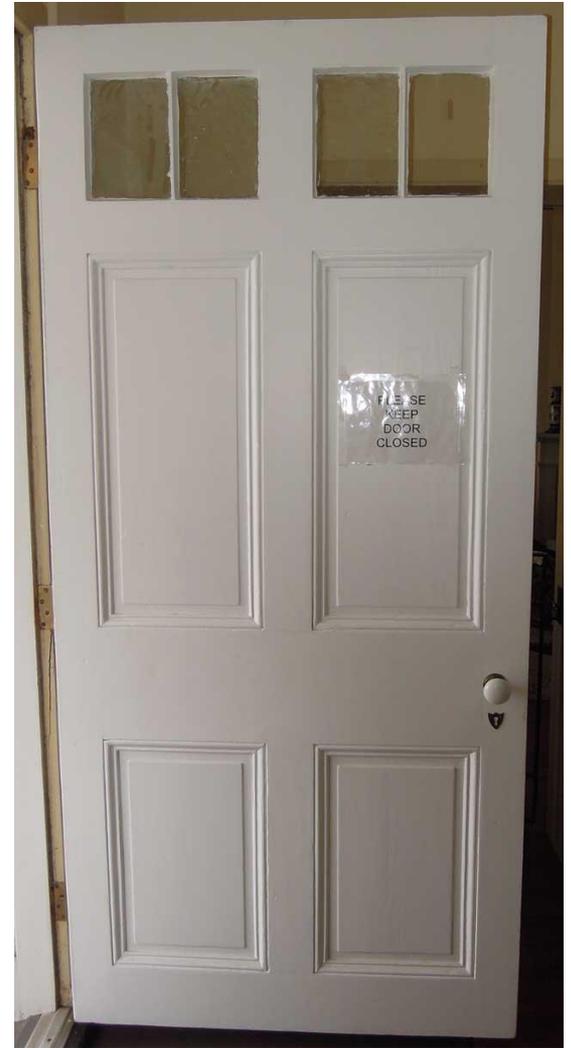
Front Porch Interior Door

When the lighthouse was originally built there was no front porch. Because the front porch was added later the door from the front porch to the front hallway was originally an exterior door. This door has glass panels not typical of an interior door.

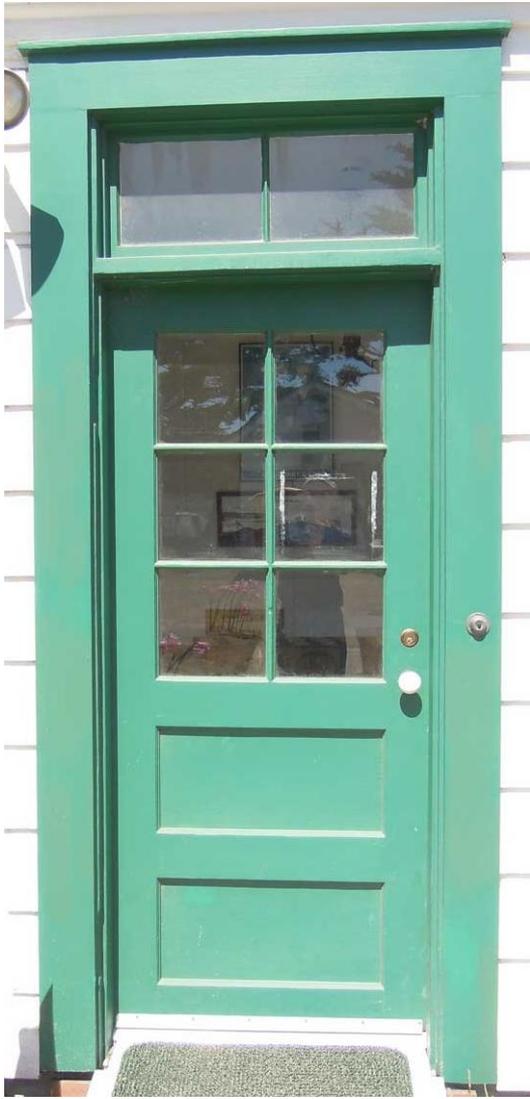
Rear Exterior Door

The rear door has glass panels and a glass lite and mutin. The rear door style is plain compared to the front porch entry.

- 3.4. Adjacent to the rear exterior door is a floodlight, motion detector and alarm. Remove the floodlight and motion detector from the building. If they are necessary consider installing on the ground. Consider new location for alarm, perhaps in the closet so it's not visible to visitors. Rethink the need for exterior lighting – doesn't the lighthouse close before dusk?

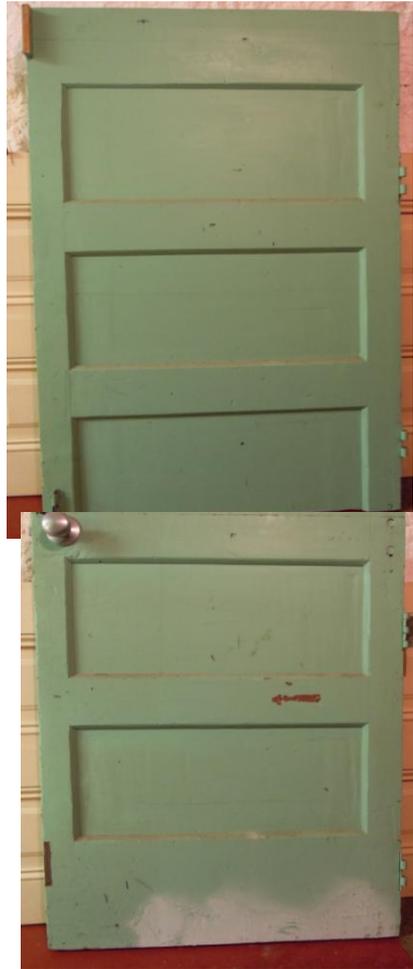
Dutch Door

A Dutch door is stored in the cellar and has the same paint color as the Kitchen. [The Dutch door style came to America from Holland when the Dutch were settling New York and New Jersey in the late 1700's.] Panels on the door are very plain and all 5 panels are the same size, unlike the Greek Revival door style. Reference 1 indicates that 5 equal sized paneled doors were used 1900-1930. This is confirmed by the Pt. Sur Headkeeper's house constructed in 1902. Upstairs doors there are also 5 paneled.

The Dutch door hardware is modern, with no obvious marks for a rim lock. Of course, the rear of the lighthouse underwent a number of changes over the years. This door is unusual and worth researching so as to determine if its use coincides with the lighthouse restoration timeframe.

- 5.3. If the timeframe is appropriate: rehang the Dutch door (Y & Z) in the Kitchen (Location E). Replace the modern door knobs to match restoration timeframe if appropriate. This will partially cover the cabinet but adds much character to the house as it is an unusual door style. There is a wall alarm that would also need to be moved.

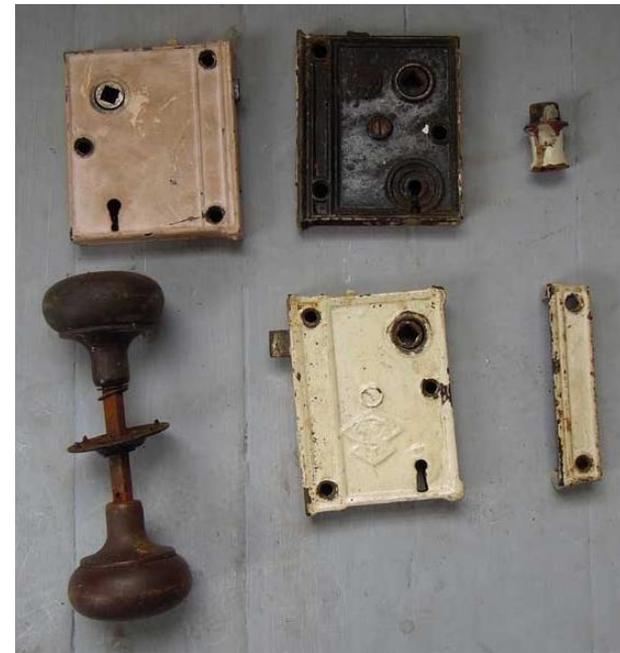
Spare Hardware

Nearly all doors have (or had) rim locks which were popular in early to mid 1800's construction. Door hardware is listed in Table 2. Hardware materials include brass or bronze and cast iron or steel. No attempt was made to distinguish between the metals. All hinges are butt type, with some of earlier construction where the pin is cast within the hinge and not removable. Extra door hardware, including 3 rim locks, is also stored in the cellar.

2. Continue to restore all door hardware including spares in the cellar. Continue to leave door hardware unpainted or with a clear coat to show the metal used.
