Investigation – Rear Porch Closet

Restoration Target Dates

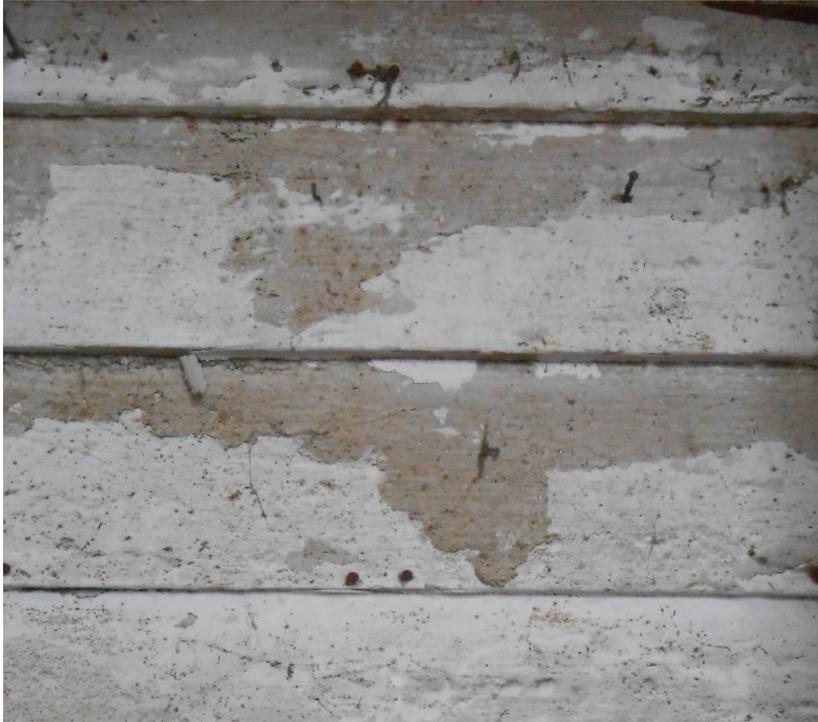
**Original
Wood Siding**

Beaver Board Walls

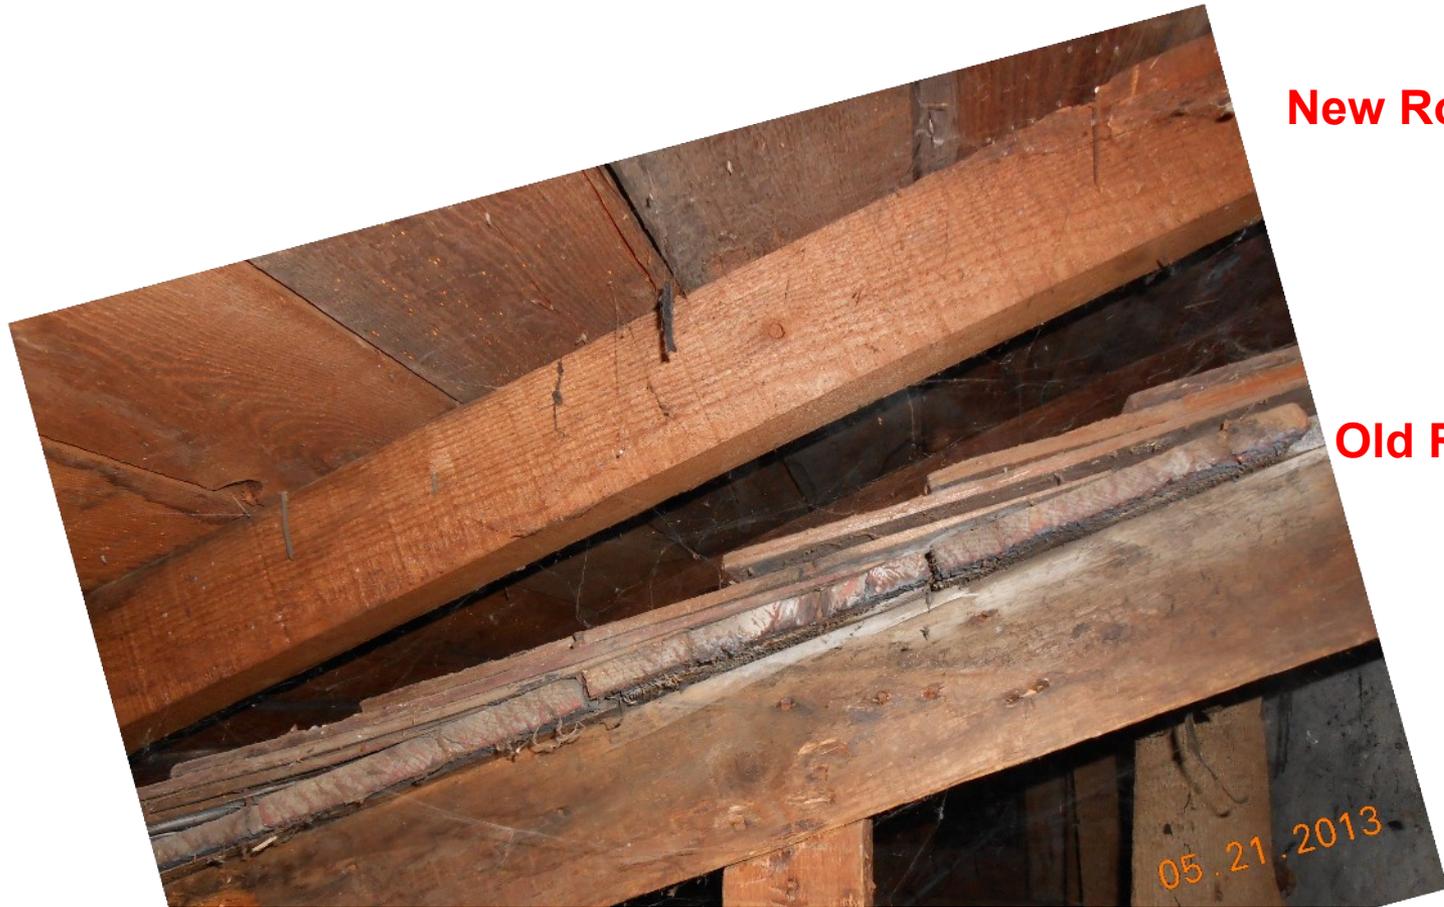
Investigation – Kitchen Attic

New Roof

Old Roof

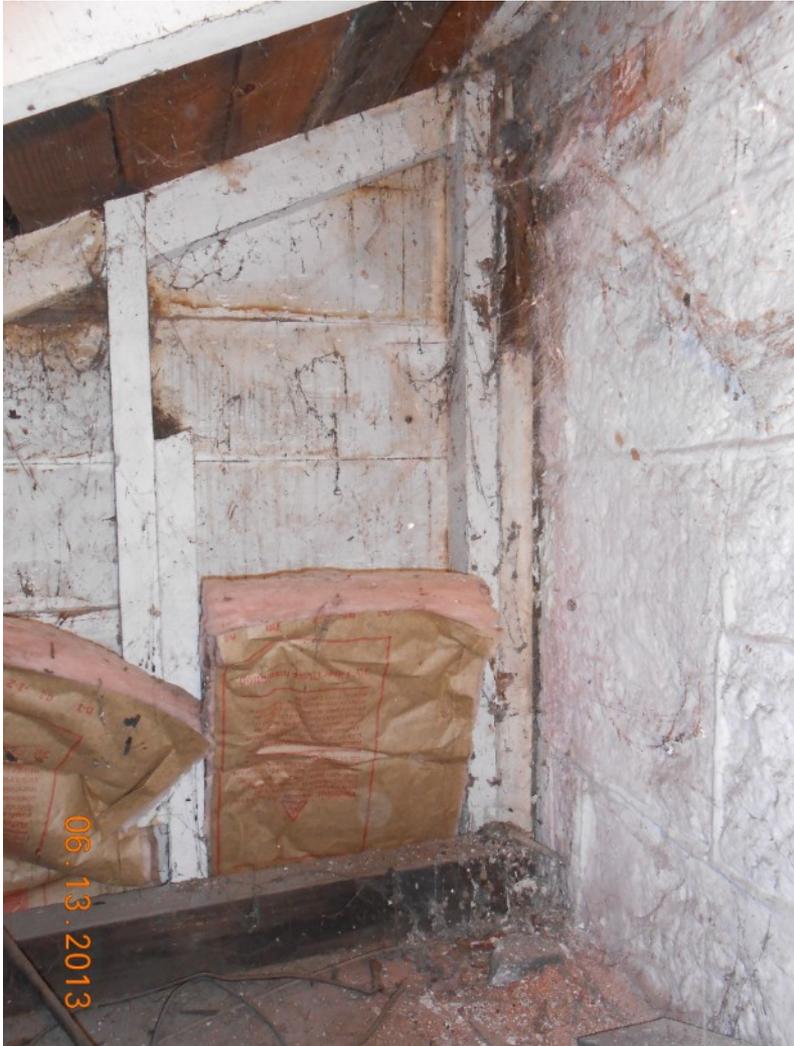
Investigation – Rear Porch Attic

- **Confirmed rear porch roof raised**
- **Confirmed original east window**
- **Rear porch painted prior to finishing with Beaver Board**

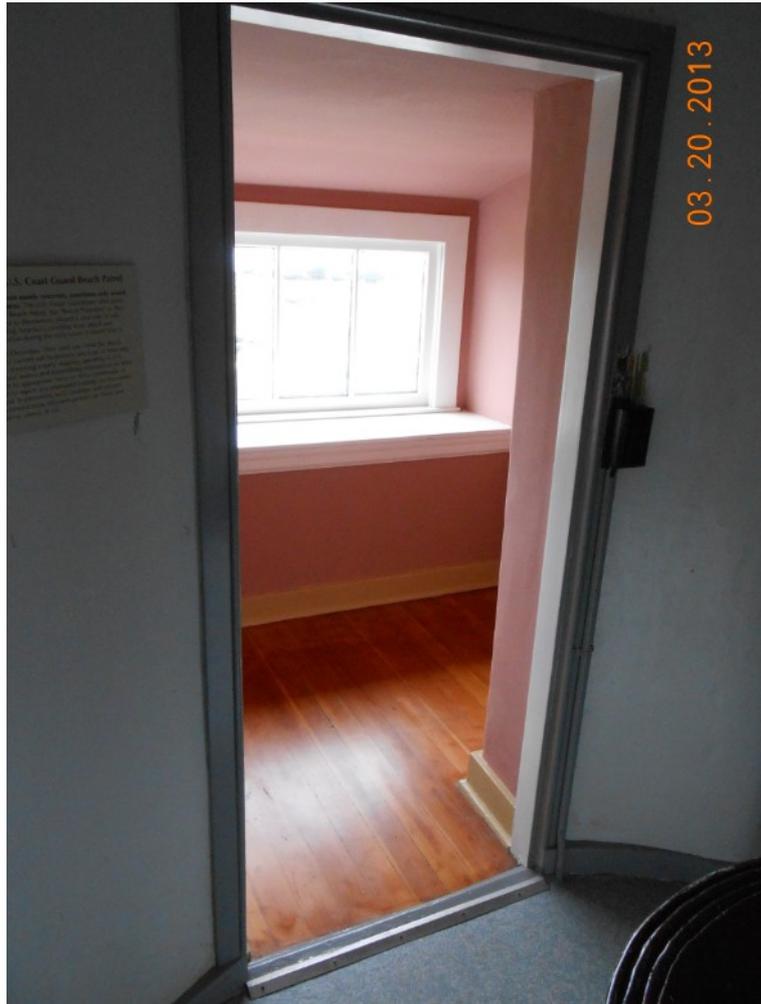
Restoration Watch Room

Sample 5	Munsell
White	N 9.5/
Off-white	2.5Y 8.5/1
White	N 9.5/
Blue-gray	10BG 6/1
Off-white	2.5Y 8.5/1
Rose	7.5R 6/4
White	N 9.5/

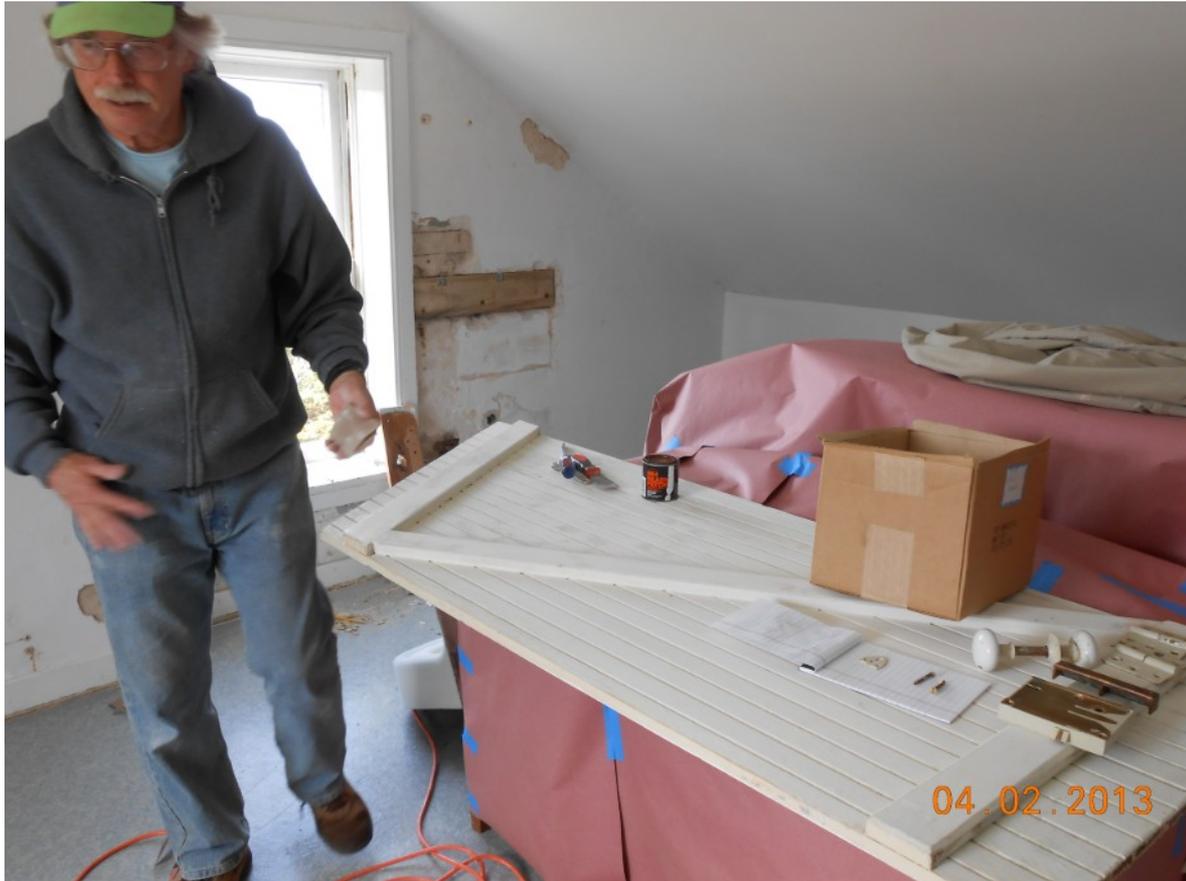
Remodeling – Restoration Beach Patrol Room

Sample 16	Munsell
White	N 9.5/
Cream	2.5Y 8.5/3
Cream	2.5Y 8/4
White	N 9.5/
Pink	10YR 8/3
Light green	2.5G 8/2
Green	2.5G 5/2
Light green	2.5G 8/2
Light green	2.5GY 7/2
Light green	2.5G 7/2
White	5Y 9/1
Off-white	10YR 8/1
Golden varnish	-----
Cream	2.5Y 8.5/3
