POINT PINOS LIGHTHOUSE

PACIFIC GROVE CALIFORNIA

PRESERVATION PLAN

SUBMITTED BY: LIGHTHOUSE
PRESERVATIONIST, LLC.

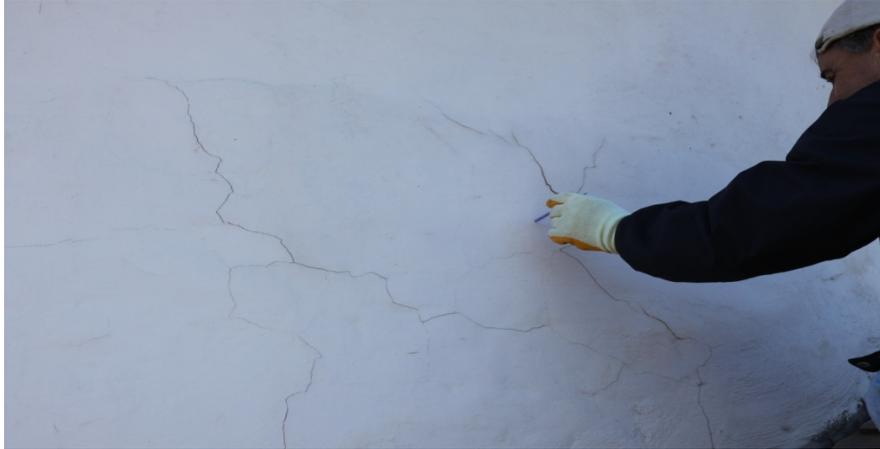
Figure 4: Example of failed stucco coat with resultant loss of protection and additional moisture entry behind stucco coat.

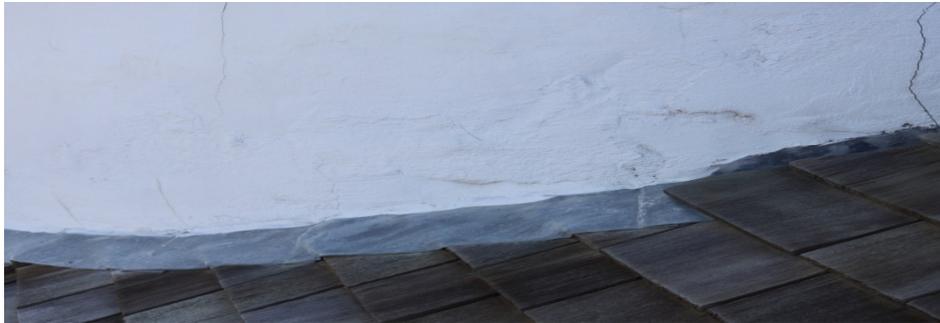
Figure 5: Example of failed stucco coat with resultant loss of protection and additional moisture entry behind stucco coat. Crack allows avenue for water behind metal flashing and into interior walls.

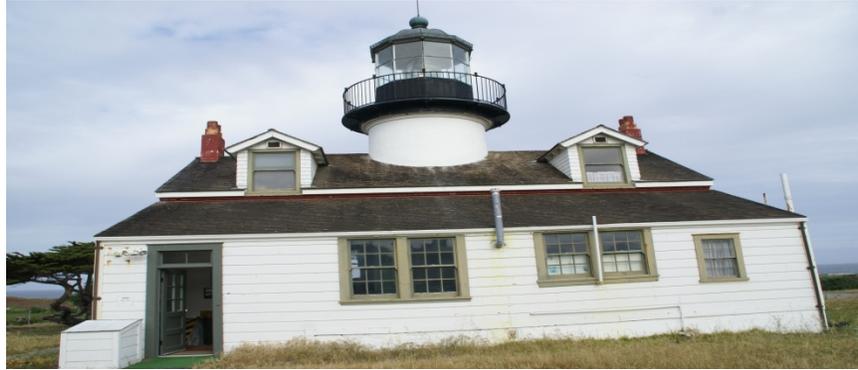
Figure 6: Window system east -rear.

WINDOWS- LIVING QUARTERS: The overall condition of the wood window systems have been rated **GOOD** to **POOR**. Loss of protective paint coatings and window pane glazing has resulted in extensive damage to many window sashes, aprons, sills and trim. Documentation of historic time periods should be established to determine which style /design of windows will be used in interpreting the Point Pinos Lighthouse living quarters. It is our recommendation that no change in window design take place as existing windows represent a significant period of interpretation and contributes to a diversity of window design which adds interest to the historic character of the living quarters. **Window repair has been ranked as one of the Immediate phases of the scope of work. Qualified volunteers could conduct the repair of windows to reduce the budget cost to the City of Pacific Grove as long as they wear proper protective mask and garments and contain, collect and dispose of paint debris according to Federal and State of California law.**

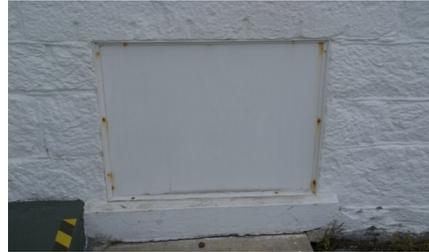
Figure 8: Example Dormer window Figure 9: Enclosed basement window.

Both enclosed basement windows located on the west elevation should be restored to improve historic character and provide light in basement areas.

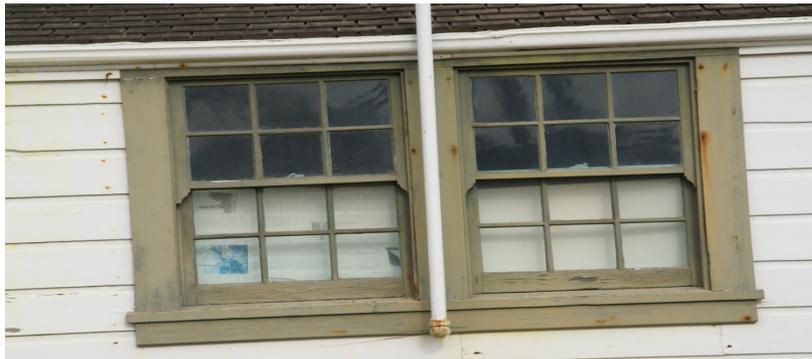
Figure 10: Example of 6/6 double hung sash windows- rear attachment.

The condition or existence of window weights, ropes/chains/ or pulley wheels was not determined during this inspection. Restoration of window systems to a functional condition should be determined based on budget constraints as well as security consideration.

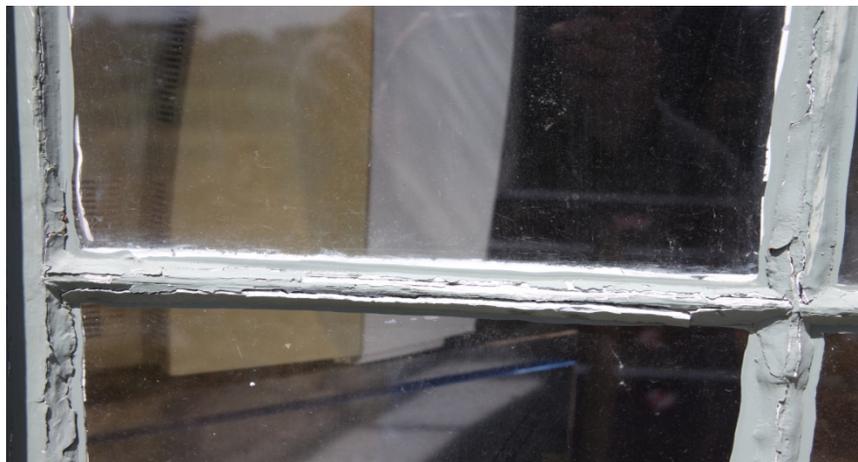
Figure 16: Example of damaged window- pane glazing has loss its integrity and has separated from wooden muntins. Gaps allow moisture between glass and wood fabric.

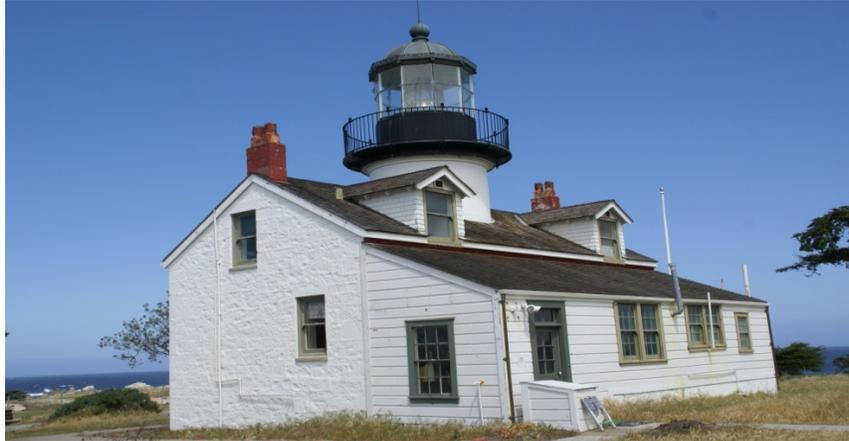
Figure 17: SOUTH-SIDE ELEVATION

LAPSIDING: The overall condition of the wood lap siding is **GOOD** to **FAIR**. The condition of the wood siding is still sound though there is a thinning and loss of protective coatings. Steel nail fasteners have failed in numerous areas and there is rust staining associated with loss of protective coatings. Previous use of metal connectors to attach other equipment has also produced holes for water entry behind lap siding as well as additional rust stains. All obsolete connectors should be removed. All holes should be filled with appropriate wood filler. Siding should be hand sanded, primed, and re-painted in order to prolong life span of siding. **Accumulated earth should be immediately raked away from contact with building and lap siding. This area would be excellent use of qualified volunteers to make repairs to offset budget cost to City of Pacific Grove.**

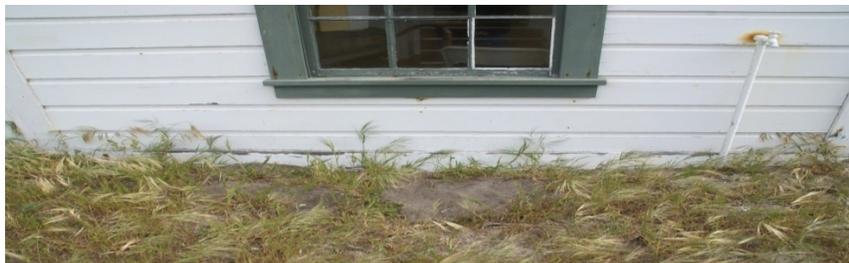
Figure 18: Accumulated dirt and vegetation should be raked away from contact with wood ASAP.

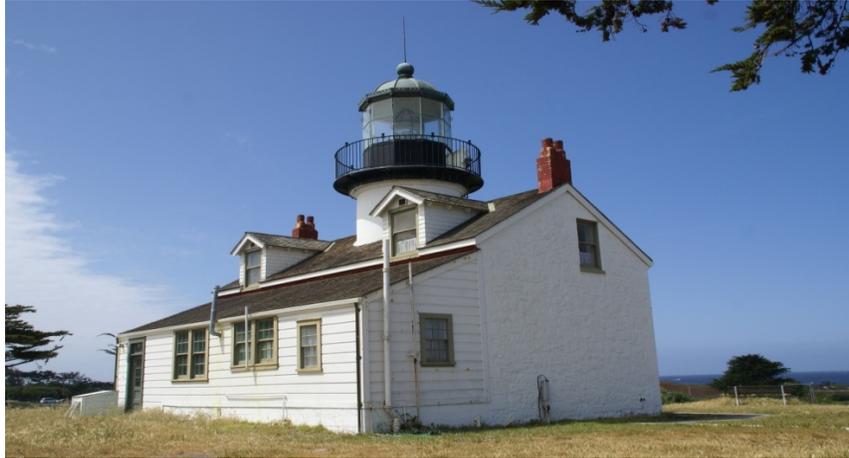
Figure 19: NORTH-SIDE ELEVATION

EXTRANOIUS ATTACHMENTS/FASTENERS.

There are numerous metal attachments/fasteners on the exterior of the living quarters of the lighthouse. All obsolete equipment, water piping, stovepipes etc should be removed and holes filled with appropriate material. Surfaces should be sanded and re-painted ASAP. **This activity could be conducted by qualified volunteers to offset budget cost to the City of Pacific Grove.**

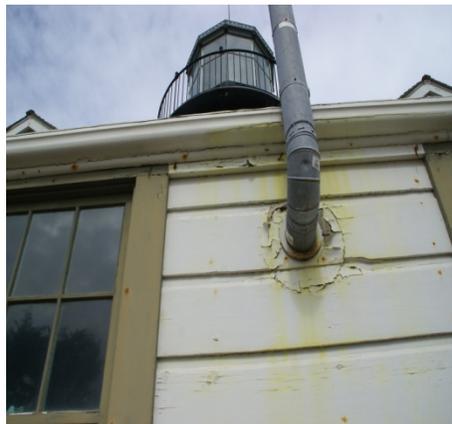
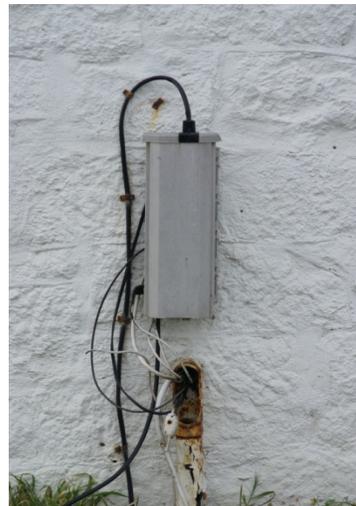
Figure 20 & 21: Obsolete equipment and attachments should be removed and historic fabric repaired.

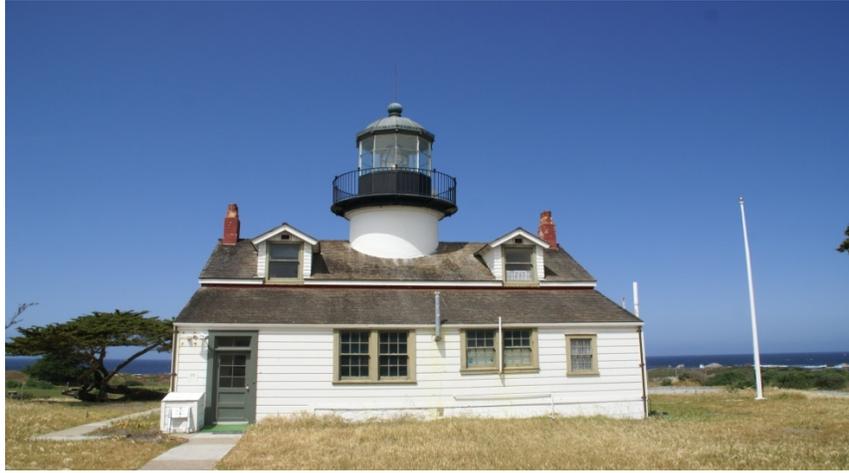
Figure 22: EAST-REAR ENTRANCE

ROOF SYSTEM: The roof material used on the living quarters of the lighthouse is wooden cedar shake shingles. The overall condition of the cedar shake shingle roof system is rated **FAIR** to **POOR**. The shakes are in the later period of their life span and have resultant cupping, cracking, separation, fungus contamination, and loss of nail fasteners. There are several areas with ridge caps missing entirely-potentially allowing moisture under the shakes and into the attic area of the lighthouse. There will be a need to replace the cedar shakes in the near future but repairs to damaged areas, including ridge caps should provide at least two more years of service. Staff/volunteers should inspect attic area on a regular basis following a rain event to monitor potential shake failure and leaks.

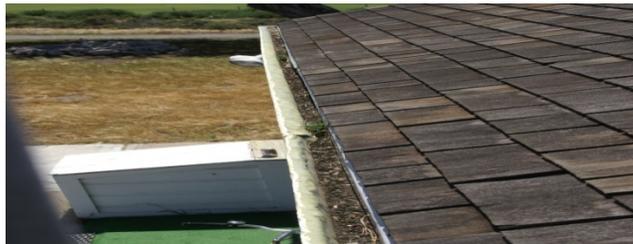
Figure 23: Roof gutters and downspouts should be cleaned ASAP.

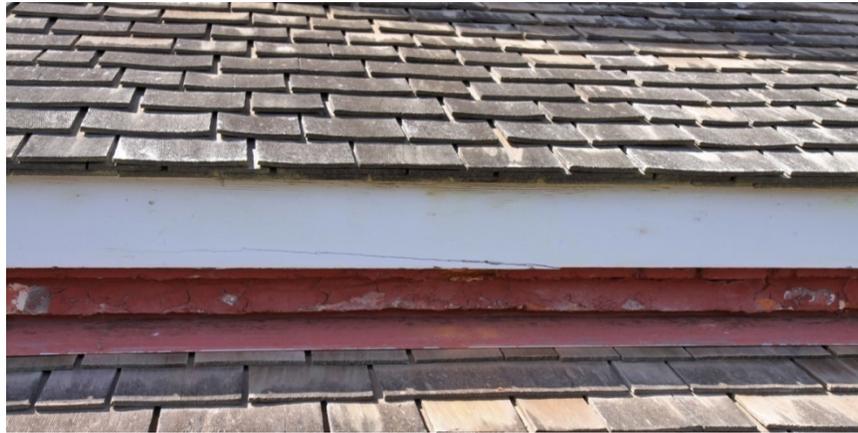
Figure 28: Condition of corbel bricks.

BRICK WORK ON ROOF SUPPORT CORBEL – REAR ELEVATION OF LIVING QUARTERS.

There is extensive damage to the brick corbel which helps support the roof system on the rear elevation of the living quarters. The overall condition of the brickwork on the corbel is rated **POOR**.

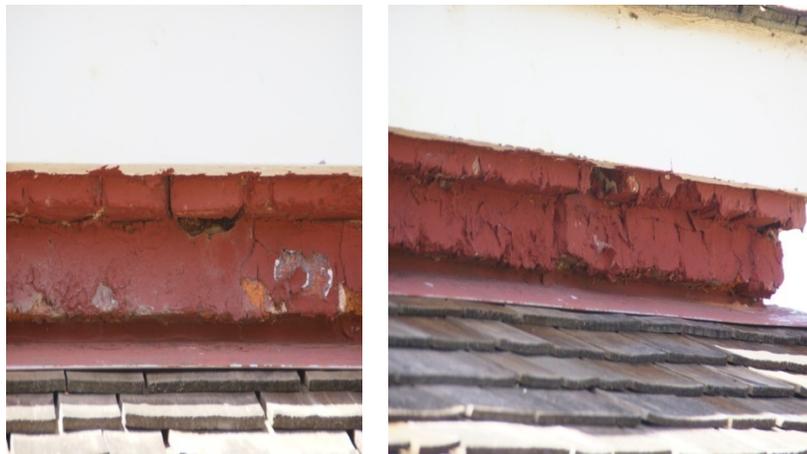
Figure 29 & 30: Examples of type of damage to roof brick corbel.

The repair of the brick corbels should be performed by qualified contractors.

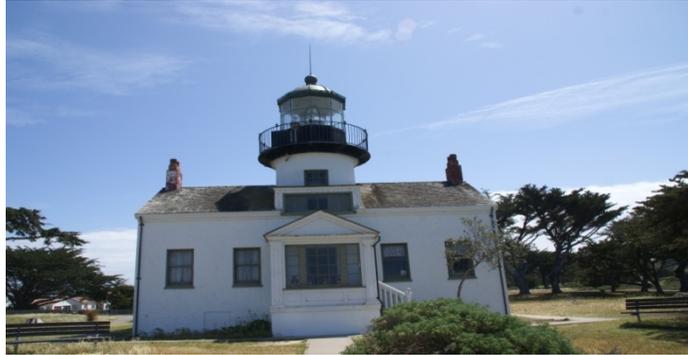
Figure 31: WEST-FRONT –ENTRANCE

STONE WORK: Overall condition of the stone- work of the Point Pinos Lighthouse is **GOOD** with no apparent structural damage or serious surface deficiencies. Numerous layers of coating systems prevent more extensive investigation. There are rust stains and limited damage related to the use of steel fasteners which attached conduit or other apparatus to the exterior of the lighthouse. These metal fasteners should be carefully removed to prevent additional damage or staining. It was noted that in basement area of lighthouse there were signs of moisture penetration evidenced by yellow staining and damage to the paint coating ranging from peeling to absence of coating.

It is believed that in the near future some additional investigation into the source of moisture entry should be conducted by selected digging along the base of the stonework corresponding to the damage on the interior.

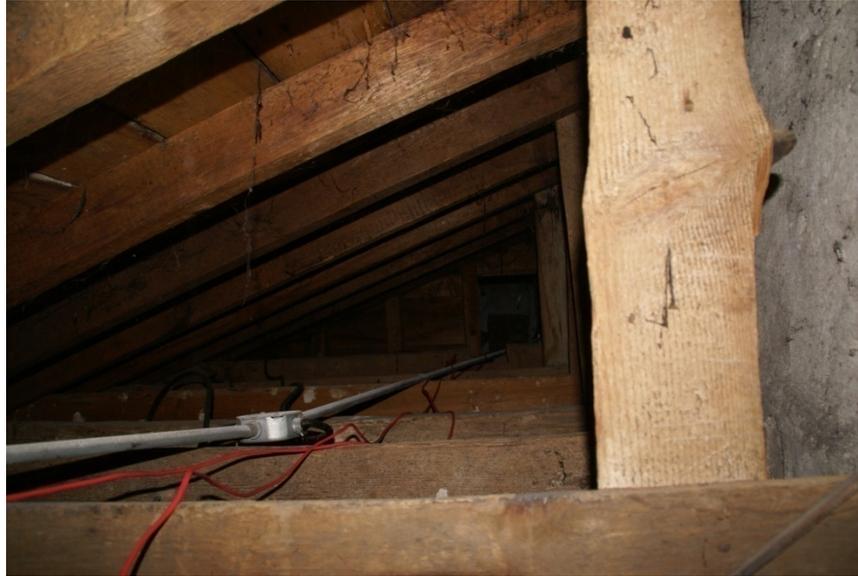
The small crawl space above the kitchen and bathroom area was inspected for indications of roof failure and leaks. Structural integrity and possible wood rot and insect damage were also concerns. No significant damage or any evidence of recent water entry was observed. The wiring system was noted to be in need of inspection and updating to provide adequate and safe electrical service to the lighthouse.

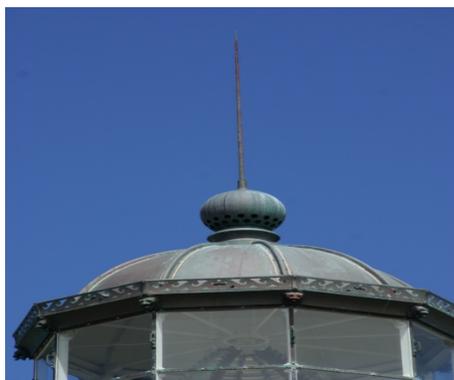
The Lantern Room of the Point Pinos Lighthouse is composed of a mixture of metals which include cast iron , wrought iron, bronze, brass, steel and recent (within ten years) use of aluminum flashing along the exterior base of the wall of the Lantern Room and deck plates. The Lantern Room is enclosed by a bronze dome or cupola which is topped by a bronze vent ball designed to vent heat, soot, smoke, and humidity from the interior of the Lantern Room. This device was especially important during the period fossil fuels were used as a means of lighting the lamps which illuminated the historic beacon. There is a bronze lightning rod atop the vent ball. It is not known at the time of this report as to whether the lightning rod is properly grounded and functions as designed.

Figure 7 : Lightning rod and vent ball.

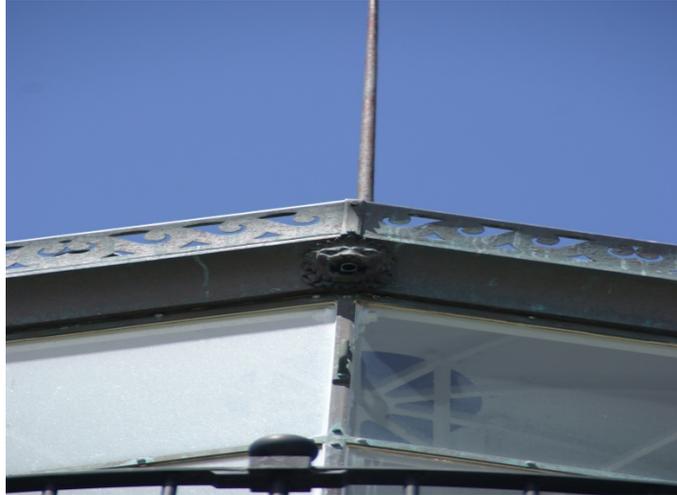
Figure: Gutter and downspout system.

The canopy is outlined with a highly decorative and unique scroll and lion's head gutter and downspout system to direct rainwater runoff away from the dome of the lighthouse. The drain system should be checked for proper function.

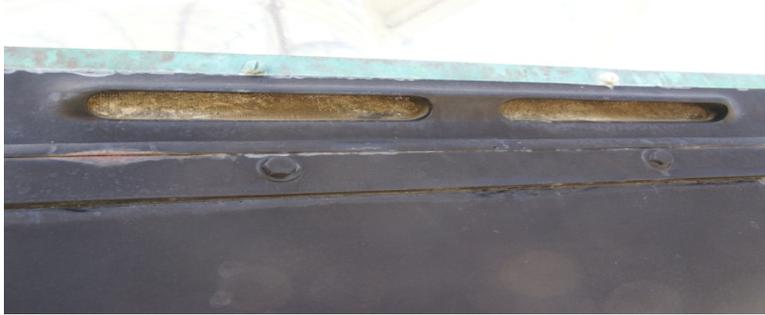
Figure: Bronze vent system.

There is a system of bronze air vents which are located along the bottom of the storm panes and atop the iron Lantern Room parapet walls. This vent system worked in conjunction with the vent ball to provide air exchange within the Lantern Room. There are bronze screens in the vents to prevent insect entry into the Lantern room which would create problems during the nighttime use of the lamps or lights provided to illuminate the lens/optic.

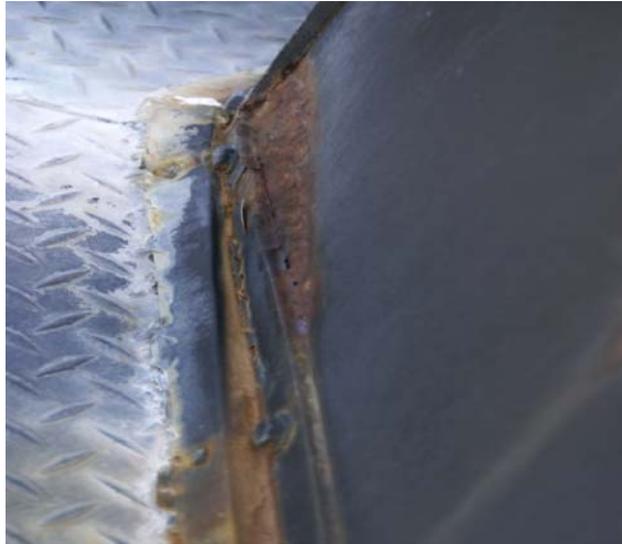
Figure: Base of Lantern Room wall as it connects to deck plate.

The extreme degree of adverse effect of the catalytic reaction of the use of dissimilar metals is pronounced separation of metal connections and waterproofing as well as extensive damage to both historic and new materials. It was noted during our site visit that recent repairs to the lantern and lantern deck area included the use of modern materials (aluminum) as flashing to waterproof the gaps between the iron lantern wall and the iron gallery deck. There is pronounced “jacking” of the softer aluminum flashing as well as an extensive “bled off” of what appears to be aluminum oxide. The volume of white powder is so great it has produced extensive and widespread staining of all areas adjoining or near the placement of the aluminum and caulking material. Budget permitting it might be advisable to remove the aluminum flashing and replace it with an appropriate fabric.

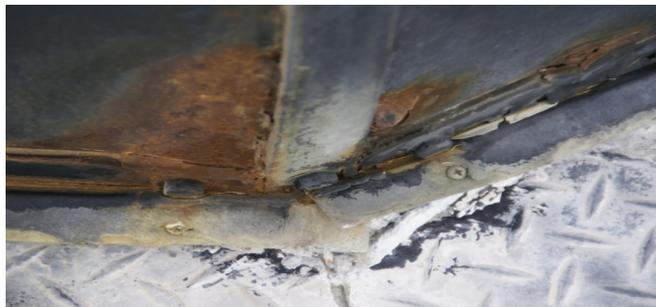
Figure: Damage to deck plate and aluminum flashing.

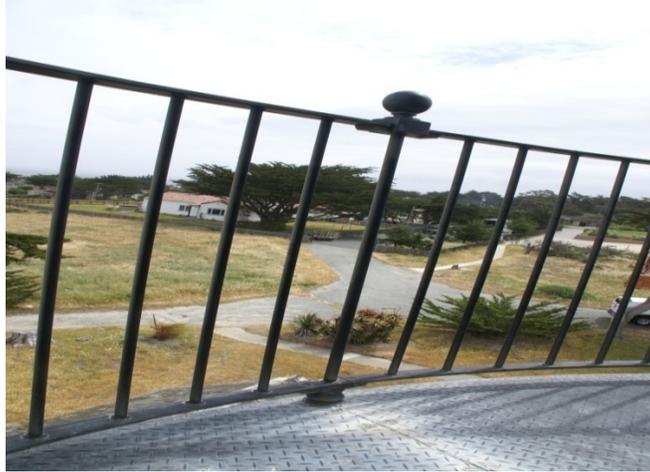
Figure: Gallery Deck safety rail and post system.

The Lantern is surrounded by an iron plate gallery deck which is enclosed by safety rail system made up of an iron rod and flat bar top and bottom rail which secures the round rail rods. The railing system is connected to the deck and gallery bracket support system by wrought iron posts which are threaded on each end to receive the ball cap on top and to thread through the deck plate and into the support bracket on the underside of the gallery deck.

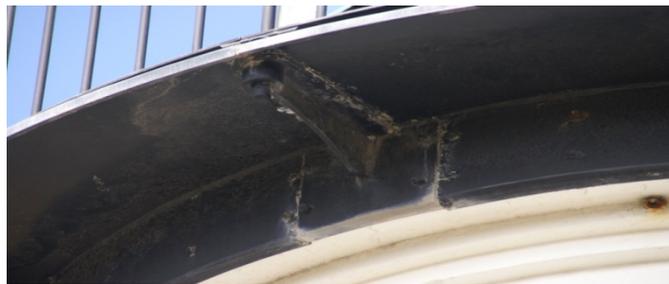
The gallery deck is supported by iron brackets arms which extend under the gallery plates at the ends of the iron deck plate which provide strength and connection to both edges of the adjoining deck plates. The bracket arms are bolted through the cast iron collar which encircles the top of the brick/stucco support cylinder. There are numerous support brackets which have bolt nuts missing from heads. These nuts help secure the railing post above.

Figure: Gallery deck support brackets.

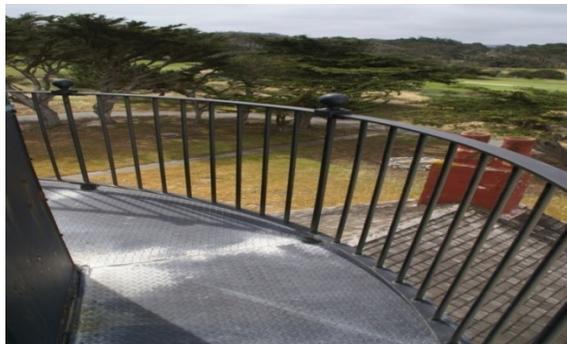
Figure 8: Textured deck plates. Note oxidation of surface.

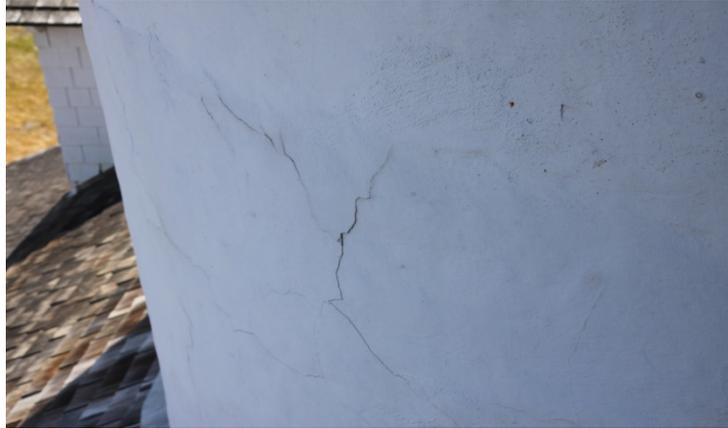
Figure : LANTERN ROOM SUPPORT CYLINDER

There are extensive surface cracks on the support cylinder which are most evident on the north –east elevation. The source and cause or extent of these cracks in the stucco is not known at the time of this report. The width of the cracks range from hairline to ¼” with significant separation of stucco from the wall. This separation indicates the cracks may in fact be structural in degree. Further selective investigation by qualified architect/structural engineer is highly recommended. Until full- scale repair work can take place it is recommended that careful application of an approved elastomeric caulking material be used to seal cracks from water entry. The application must be performed in a manner which can be easily reversed. There is a corresponding adverse effect of the exterior cracks and related moisture entry on the interior plaster wall of the support cylinder.

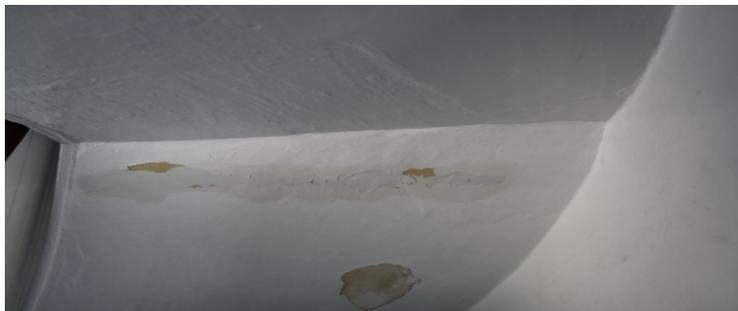
Figure :Moisture stains on inside of lantern support cylinder/stairwell.

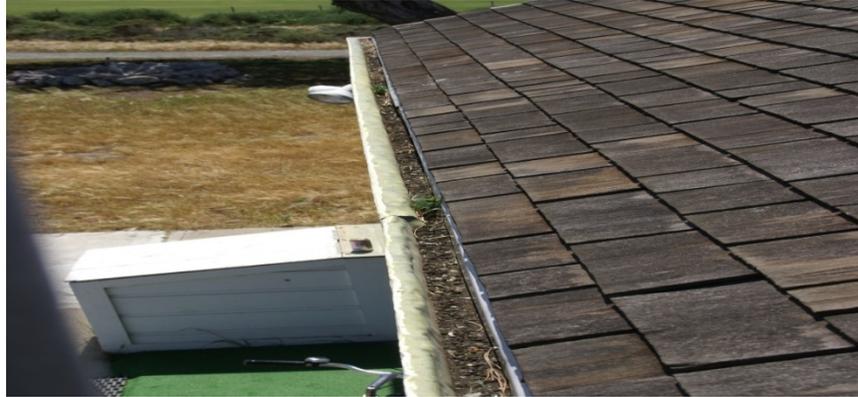
Figure: Gutters filled with debris.

The gutter system along the roofline on the living quarters is metal lined with bronze. There are lead soldered seams. There are several sections of the gutter and downspout system which are poorly connected. Some attachments to the roof have failed. The gutters are shallow and do not carry a large volume of water. Even the same amount of accumulated debris greatly restricts the effectiveness of the gutter system. Volunteers should be used to clean the gutter system and be recruited to check their function on a monthly basis as part of a preventive maintenance plan. **Note: Extensive repair of all gutter and downspouts should be conducted as part of scope of work during replacement of cedar shake shingles.**

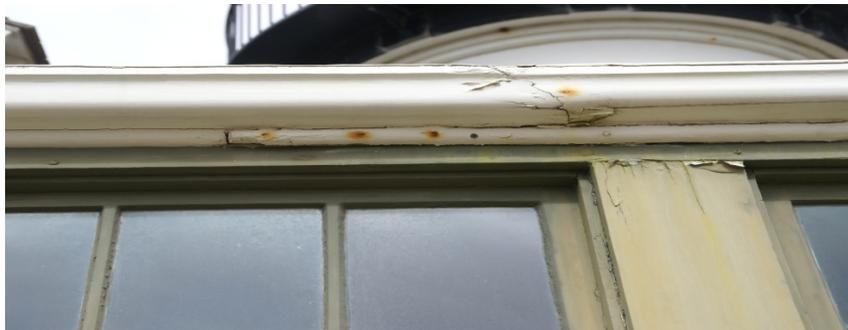
Figure: Gutter system has numerous areas of damage related to failed fasteners.

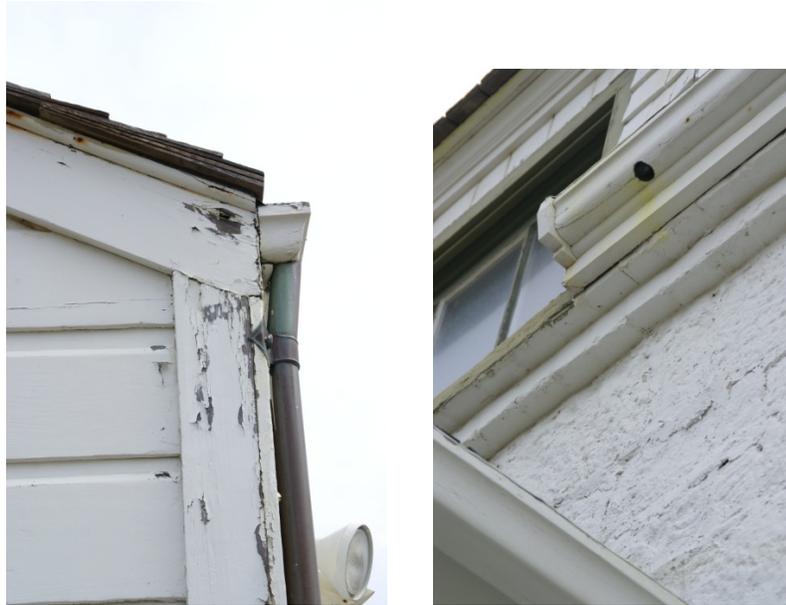
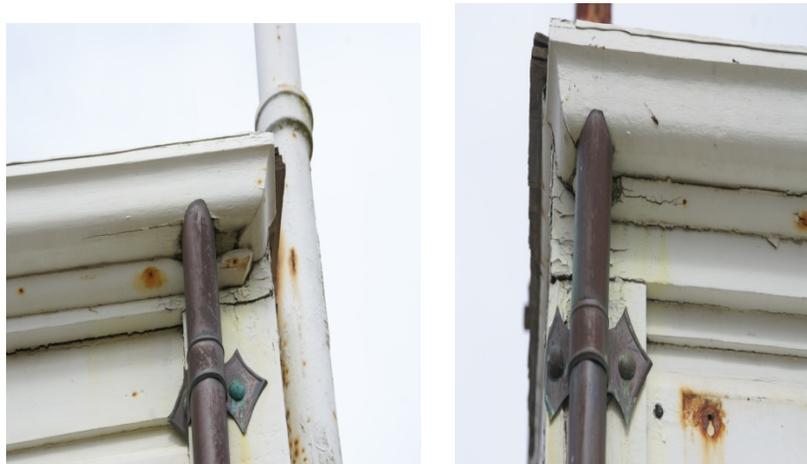
Figures : downspout system.

The entire downspout system is rated as **POOR** and requires comprehensive repairs. Work should be performed a qualified contractors as this downspout design is historic to the building, is constructed of metal and wood and has delicate wood trim. Where possible the copper downspouts should be repaired rather than replaced. There is a section of downspout entirely missing on the front elevation of the lighthouse. Replacement downspouts should be of same material as existing and of equal quality of materials.

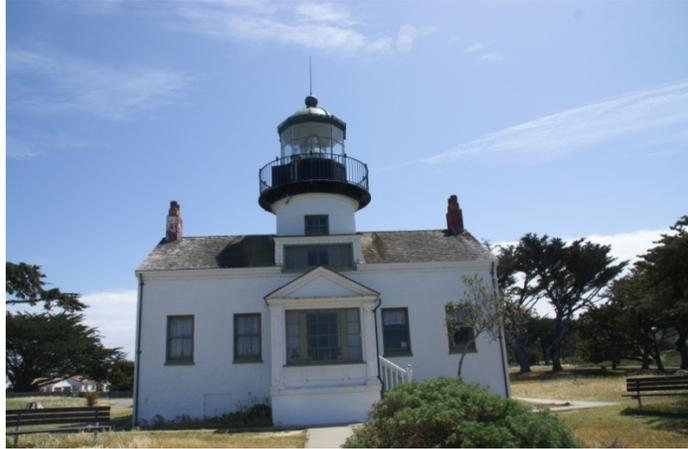
Figure 10: Window system front elevation.

There have been several modifications to the window system on the Point Pinos Lighthouse over its history. The existing windows reflect those numerous changes, including the large window incorporated into the front enclosed porch which was a later but nevertheless historic modification to the west elevation of the lighthouse. Currently 1/1 wood window sashes are in place on the front ground floor of the lighthouse living quarters. Photo documentation clearly indicated that in an earlier period 6/6 double sash windows were in use. It is our recommendation to continue to use all existing windows on the front elevation and to proceed with repairs **immediately**.

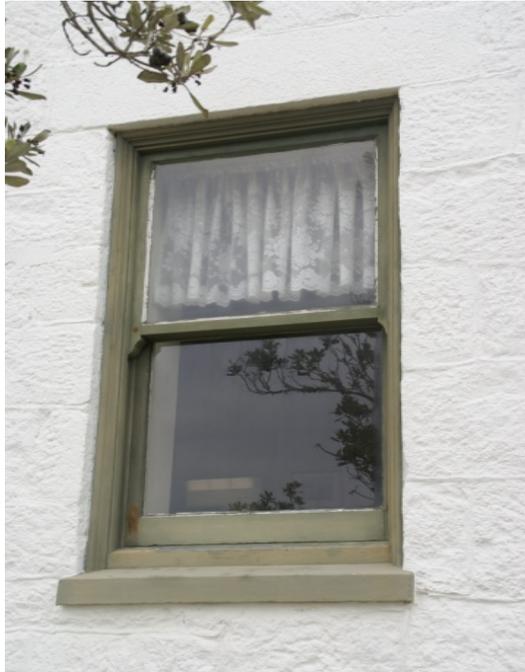
Figure #1.1/1 DOUBLE HUNG SASH WINDOW WEST ELEVATION **GOOD** to **FAIR**.

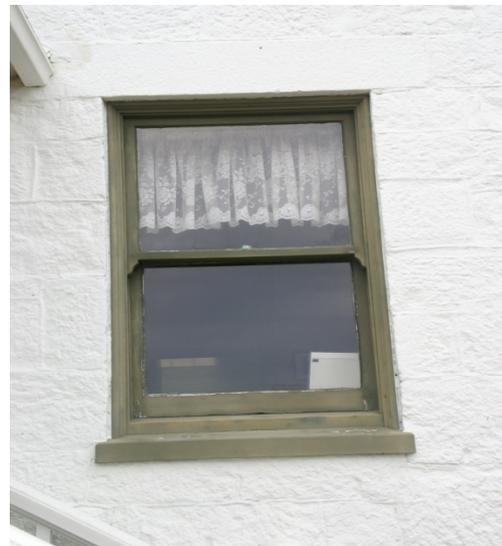
Figure #2.WINDOW SYSTEM WEST
ELEVATION **GOOD** to
FAIR.

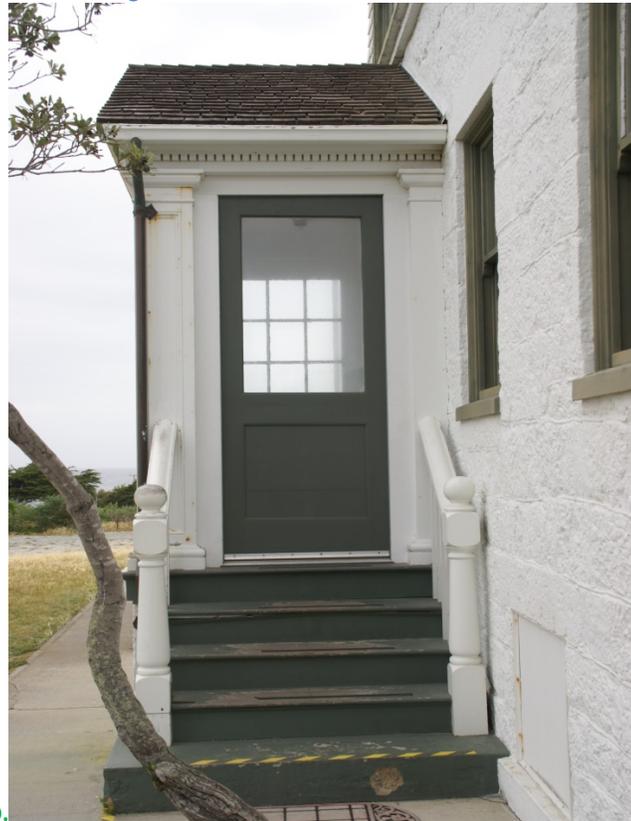
Figure#3 : FRONT ENTRANCE DOOR-

GOOD.

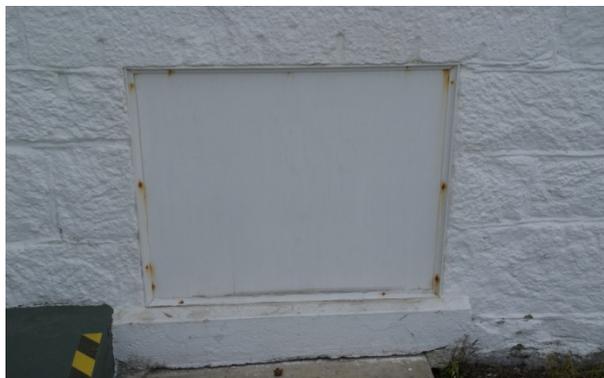
Figure#4 : ENCLOSED BASEMENT WINDOW WEST ELEVATION-**POOR.**

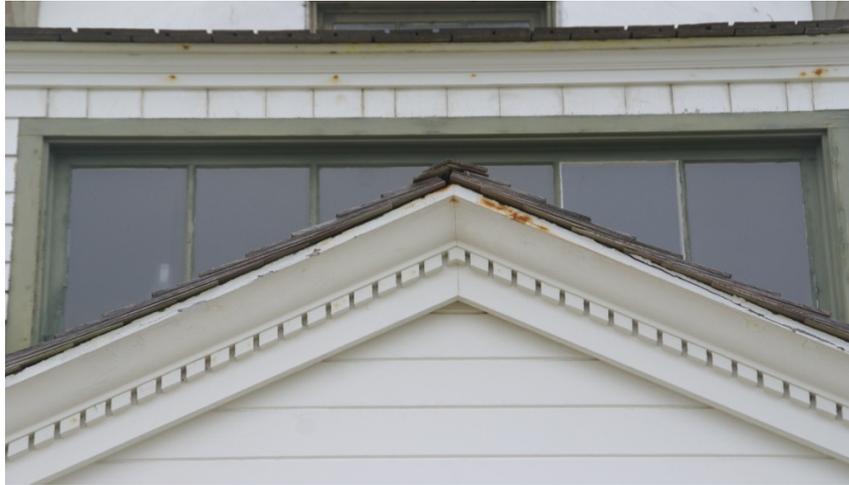
Figure#5 : WATCH ROOM WINDOW-GOOD to FAIR.

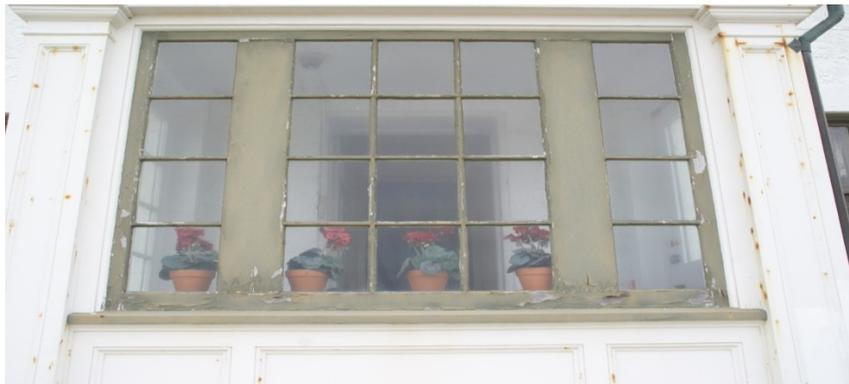
Figure#6 : FRONT PORCH/ENTRANCE WINDOW-GOOD to FAIR.

The 1907 modification of the original design of the Point Pinos lighthouse front porch window system should be treated and preserved as historic. Very careful treatment of failed coating system, glazing and wood repair should be conducted by qualified staff or volunteers. Oxidation stains should be treated to reduce their damaging effect.

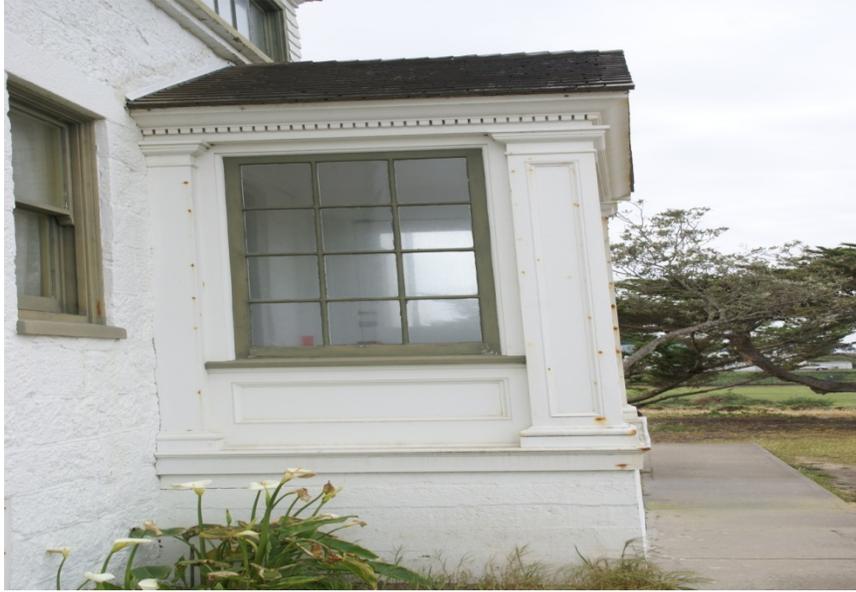
Figure#7 : FRONT PORCH-NORTH SIDE WINDOW-FAIR.

Fenestration around historic windows should be repaired rather than replaced where possible. Enclosed basement windows should be restored based on documentation.

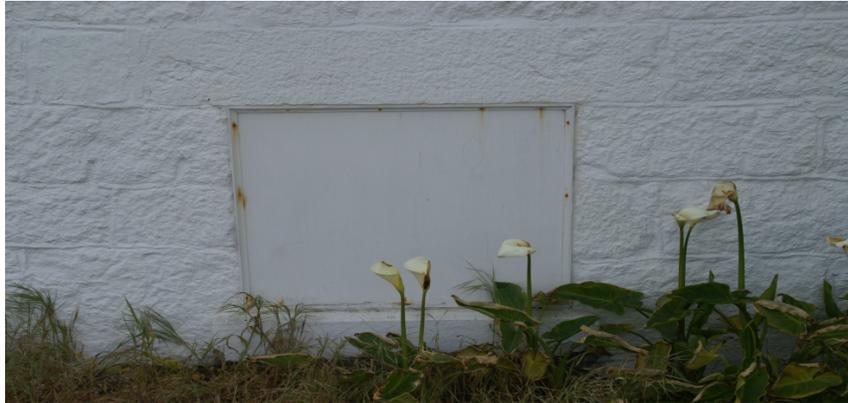
Figure #8: ENCLOSED BASEMENT WINDOW-NORTH-POOR.

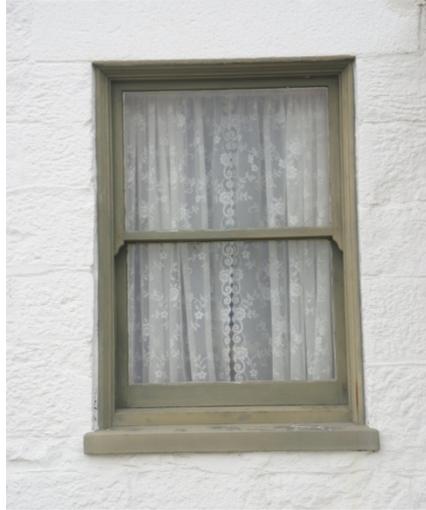
Figure #9-WEST ELEVATION WINDOW-GOOD to FAIR.

Existing windows should be retained, repaired, and restored.

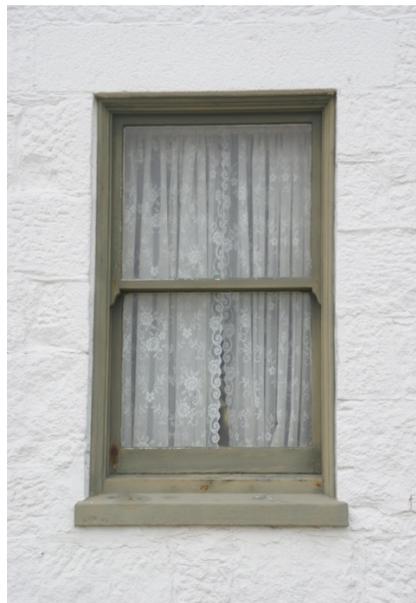
Figure #10: WEST ELEVATION-WINDOW- FAIR to **POOR**.

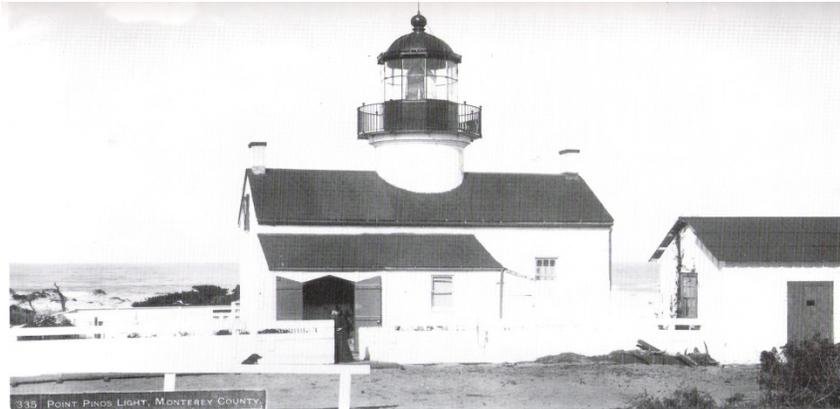
Figure #12: The window system on the rear -east elevation has also been modified over the years.

One of the major changes affecting window design and modifications was the 1907 construction of the attached lean-to addition. The addition also underwent modifications over the years. Existing window systems should be retained and restored as a singular period of interpretation of the lighthouse would require removal of significant historic material and distort the historic changes to the lighthouse. 6/6 windows were also in place during earlier periods of the Point Pinos Lighthouse.

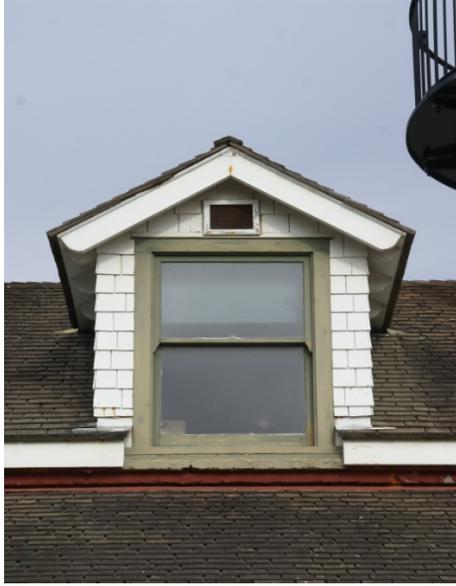
Figure #13: EAST ELEVATION DORMER WINDOWS-FAIR to **POOR**.

Paint analysis should be conducted to determine historic colors prior to removal of existing coating system. Screens in air exchange vents above dormer windows should be repaired as needed.

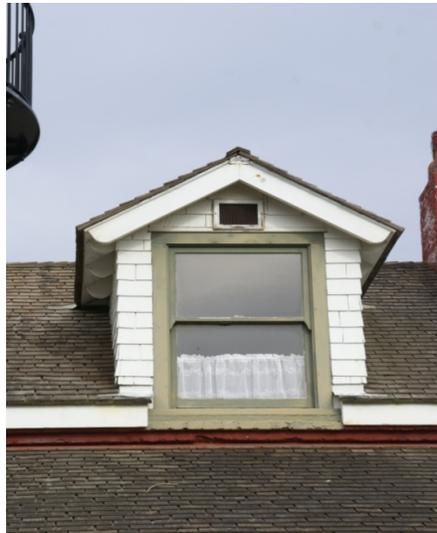
Figure #14: DORMER WINDOW EAST ELEVATION-FAIR to **POOR**.

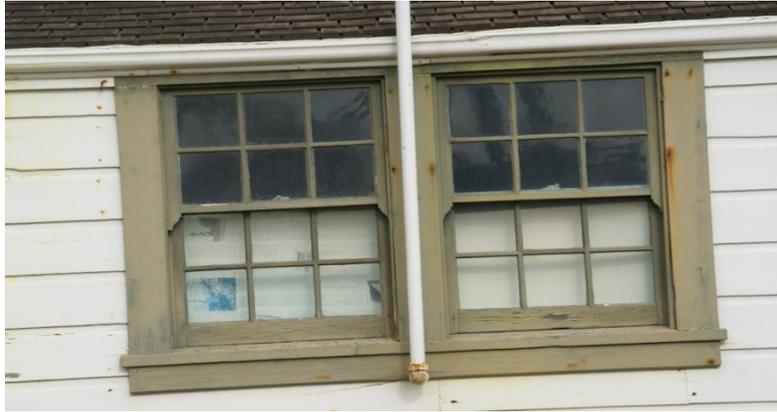
Figure#15 : EAST ELEVATION WINDOWS 6/6 double hung sash windows.-**POOR.**

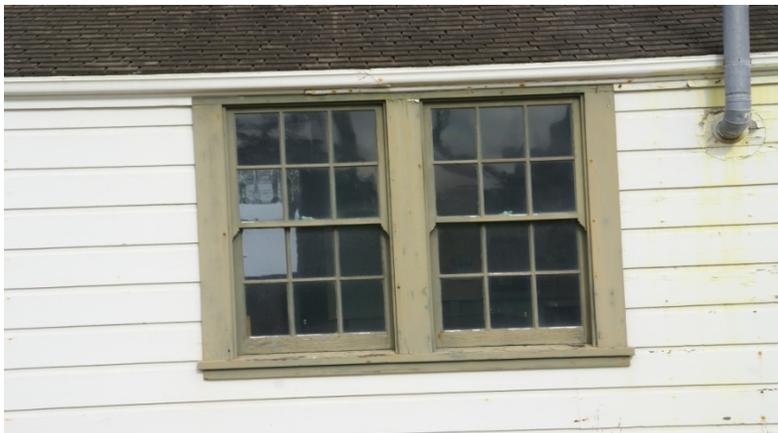
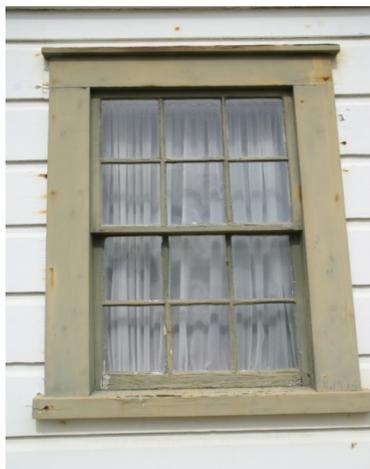
Figure# 16 & 17: 6/6 DOUBLE HUNG SASH
WINDOWS-**POOR.**

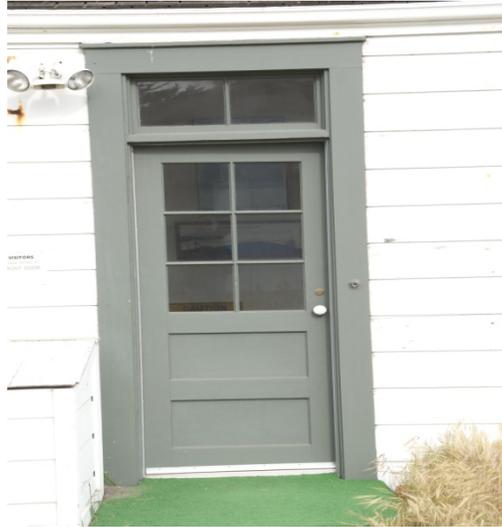
Figure #18: EAST ELEVATION REAR DOOR-GOOD.

The existing rear door is not original to the attached lean-to addition located on the east elevation. The age of the two-panel door is of unknown. The six light door design provides the ability for visitors and staff entering or exiting the door to view opposing traffic. **Note: mass of dry vegetation along side of lap siding and door stoop.**

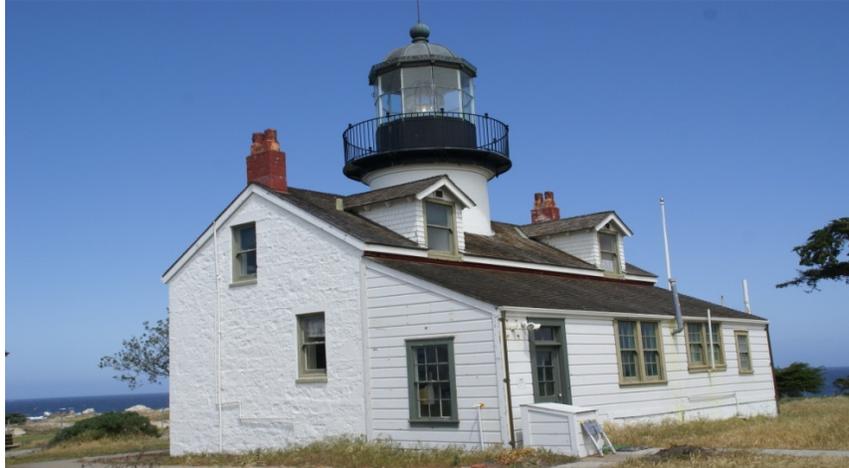
Figure#19: WINDOW SYSTEM-SOUTH ELEVATION

The circa 1900 lower window system on the south elevation reflects the same evolution as the other elevations. Vegetation growth obscures some of the detail of the earlier period captured in the photo below but clearly existing 6/6 windows in place today existed in the earlier photo. One major change is the rear door which was a solid four panel door with transom as opposed to the existing two panel six light door.

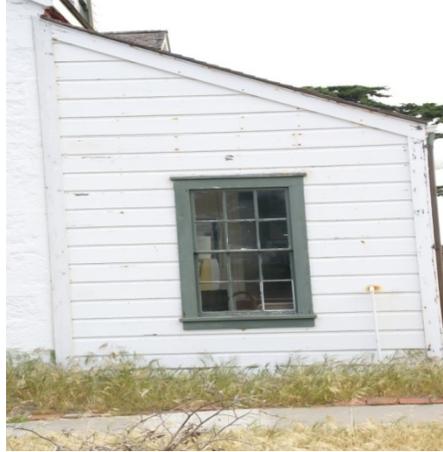
Figure #21: 6/6 DOUBLE HUNG WINDOW -REAR ATTACHMENT-**POOR**.

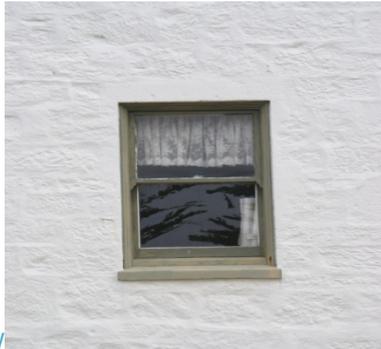
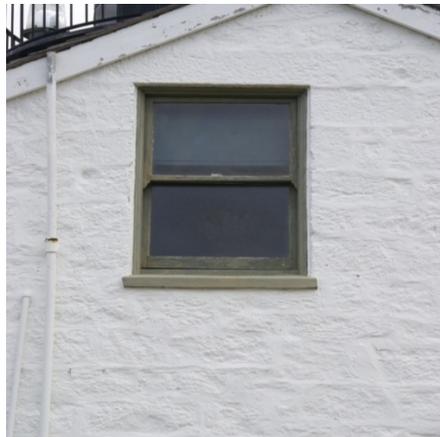
Figure#23 & #24: SOUTH ELEVATION-2nd FLOOR WINDOW-FAIR to **POOR**

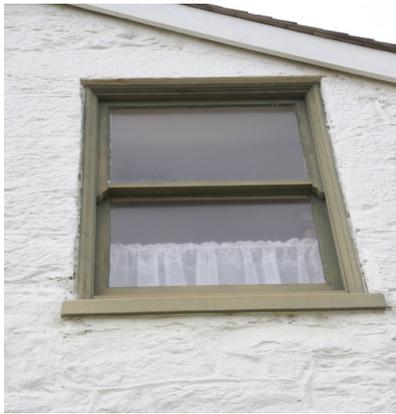
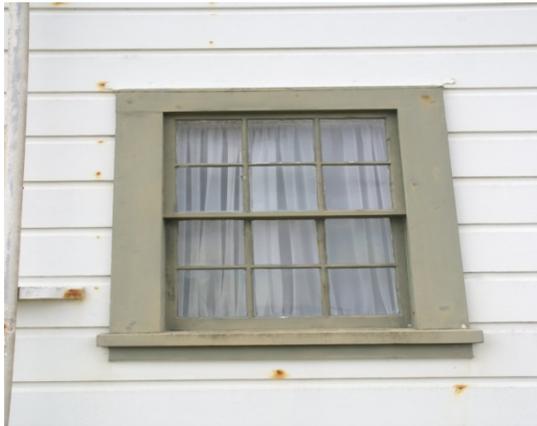
FAIR TO POOR.

Figure #26 & 27:-ORIGINAL 6/6 DOUBLE HUNG SASH WINDOW-FAIR to **POOR.**

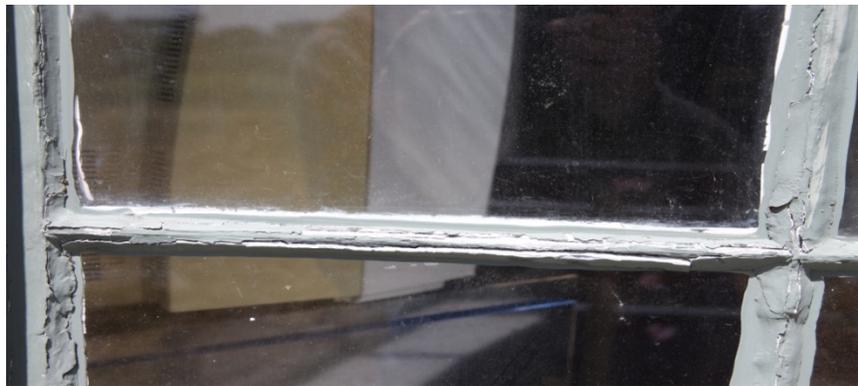
Overall window condition is rated **FAIR** to **POOR**. There is widespread loss of protective coatings, wood deterioration, wood rot, damage to window mullions, and extreme loss of glazing. We have included window repair in the **IMMEDIATE PHASE** of the preservation plan.

Figure #29: LOSS OF WINDOW GLAZING-POOR

In order to reduce the cost to the City of Pacific Grove, we recommend that volunteers be used to make necessary window repairs to the historic windows at the Point Pinos Lighthouse. While no conditions were rated **CRITICAL** –that would require complete replacement of a window unit, our survey did not include removal of failed coating systems in order to fully analysis existing conditions behind those coatings. Should damage be extensive beyond repair, then replacement fabric must match the historic in terms of quality, size, type, and craftsmanship of mill and installation labor.

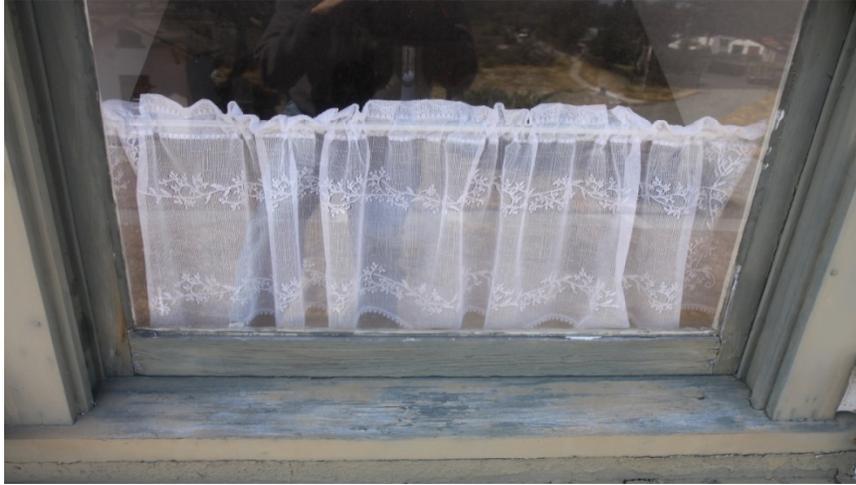
Figure # 30: LOSS OF PROTECTIVE COATINGS -WINDOW SILL-**POOR**

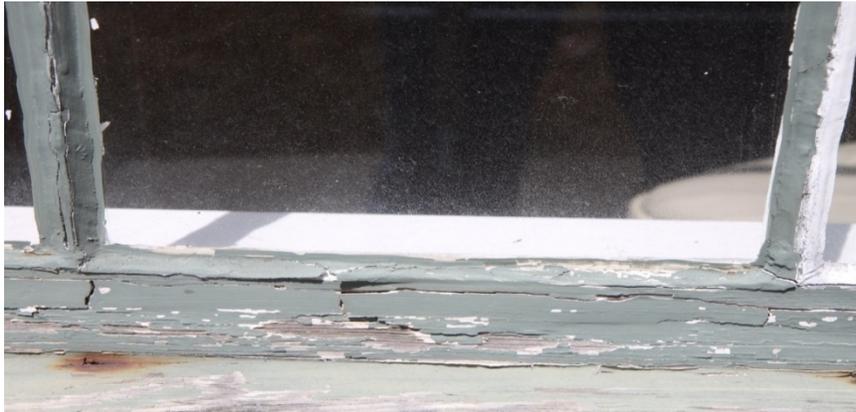
Figure #31: LOSS OF PROTECTIVE COATINGS WINDOW SASH-**POOR**

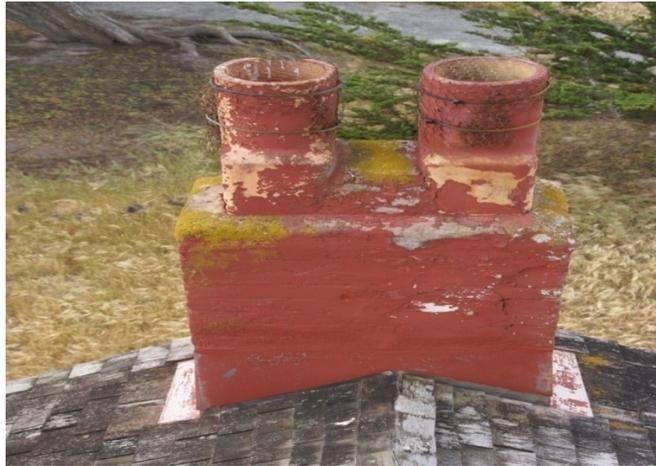
Figure #32 : TYPICAL CONDITION OF CHIMNEY SYSTEM **POOR**.

The overall condition of the chimney system is rated as **POOR**.

There is a widespread **CRITICAL** need to repair all sides of the chimneys as there is comprehensive failure of coating systems, stucco, mortar joints, brick faces, and extensive structural cracks throughout the chimneys. There is fungus contamination. During the last roof installation a stainless steel flashing material was used to provide water tightness between the chimneys and cedar shake shingles. While stainless steel is normally recommended in a hostile coastal environment, its use on a historic structure is inappropriate in areas that are highly visible. Stainless steel unless etched does not receive and retain paint coatings as well. Copper would be a material that was used historically, has longevity in a hostile coastal environment, and does not require painting. Flashing should be tucked into a mortar joint that has been scored and then sealed with appropriate material to prevent water entry behind or between brick and flashing.
