POINT PINOS LIGHTHOUSE

PACIFIC GROVE CALIFORNIA

PRESERVATION PLAN

SUBMITTED BY: LIGHTHOUSE
PRESERVATIONIST, LLC.

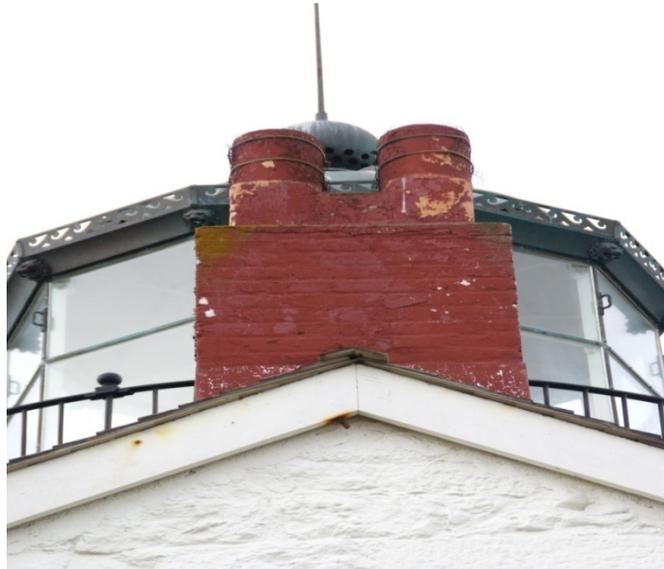
Figure#34 : CHIMNEY SYSTEM

Wire screen has been strapped to the top opening of the clay pipe flue in order to prevent bird entry. The wire and straps are in an advance state of deterioration and are rated as **POOR**. It is recommended that the strapped wire system be replaced by inserting a bronze disc into the flue opening in a manner that it cannot be seen yet will achieve the purpose of preventing bird entry.

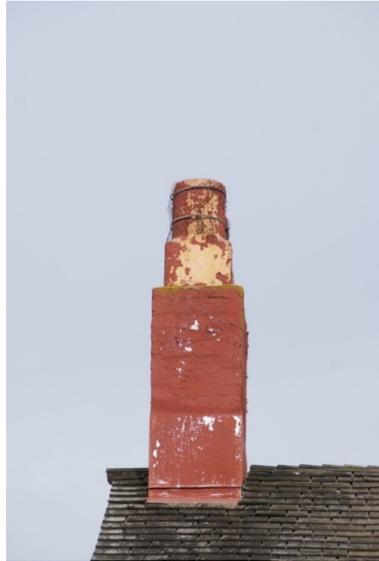
Figure #37: CHIMNEY SYSTEM

Flashing is a painted stainless steel which is not historically or aesthetically appropriate. It is recommended that during the next cedar shake shingle roof replacement, consideration be given to replacing the stainless steel with copper.

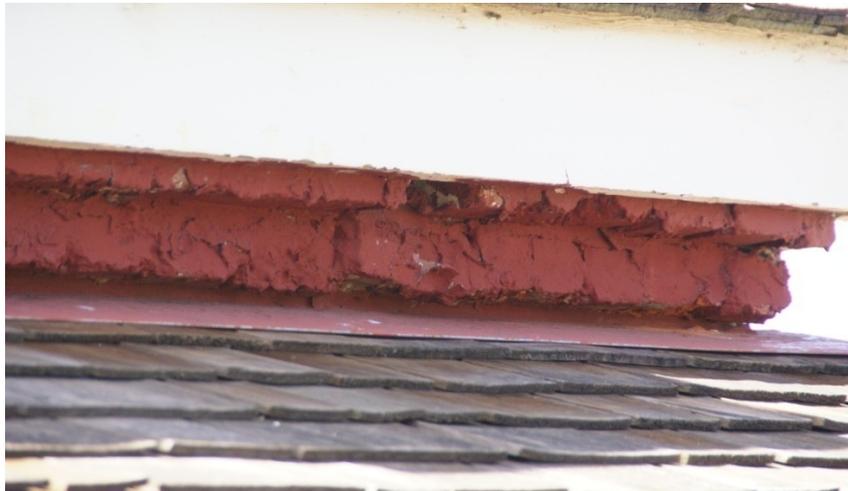
The brick corbels supporting the roof system on the rear-east elevation is rated **POOR**. A majority of the brickwork requires extensive repair and significant replacement. Replacement material must match original in size, character, and craftsmanship of installation.

Figure #41: TYPICAL CONDITION OF BRICK CORBEL-**POOR**

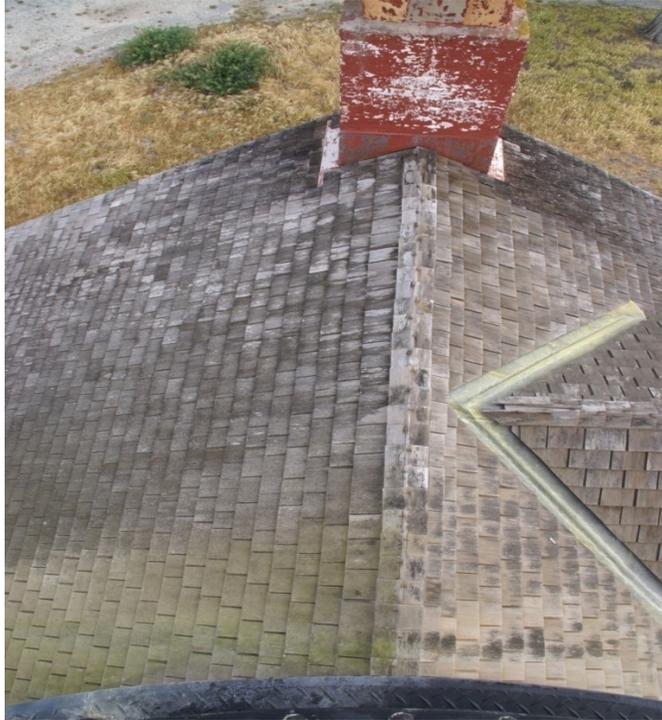
Figure #42 : ROOF SYSTEM-NORTH SECTION

The overall condition of the cedar shake shingle roof system is rated as **POOR**. There is a **SERIOUS** need to replace the roof system in the near future. Cedar shake roof repairs should be conducted soon to correct damage to ridge caps and fasteners in order to prolong the lifespan of the existing roof and defer cost of new roof system until other more **IMMEDIATE** needs are corrected and funding levels improve. When the roof system is scoped for replacement it is recommended that red cedar shake shingles be used and a high-grade stainless steel fastener be used for installation. (316 grade as a minimum grade)

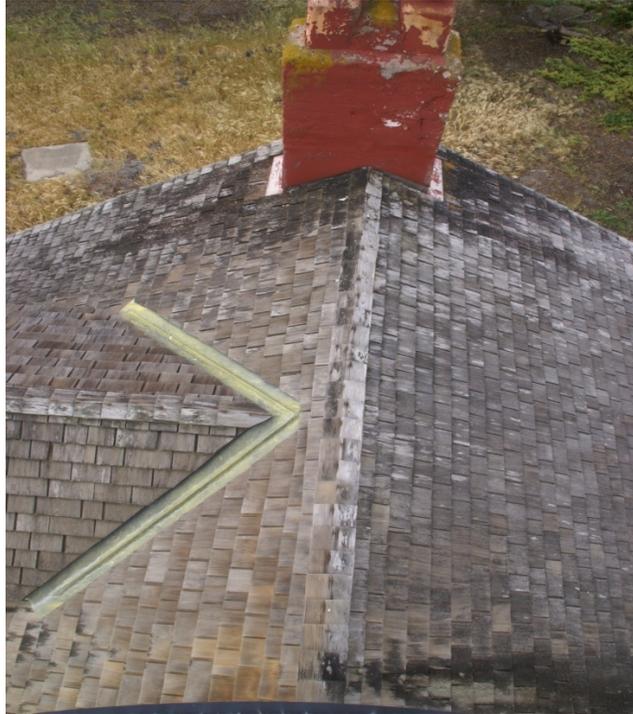
Figure #43: ROOF SYSTEM -SOUTH SECTION

There is widespread mold and fungus contamination which accelerates deterioration of the cedar shake shingles and fasteners. A gentle washing of the roof system with a mild mixture of water and bleach is recommended to reduce the concentration of mold and fungus.

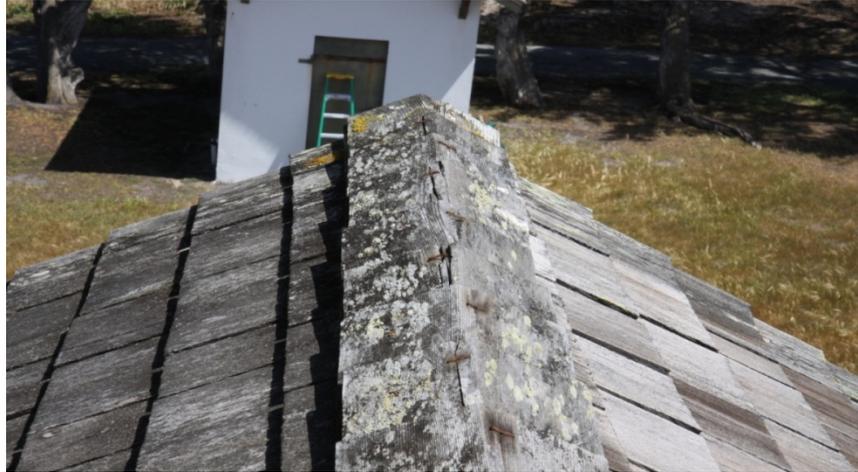
Figure #44: ROOF RIDGE CAP

Ridge caps have a high volume of fungus and mold contamination, have missing ridge cap shingles and have a great number of loose ridge cap shingles. These deficiencies should be corrected ASAP in order to prolong the limited remaining life span of the existing roof system.

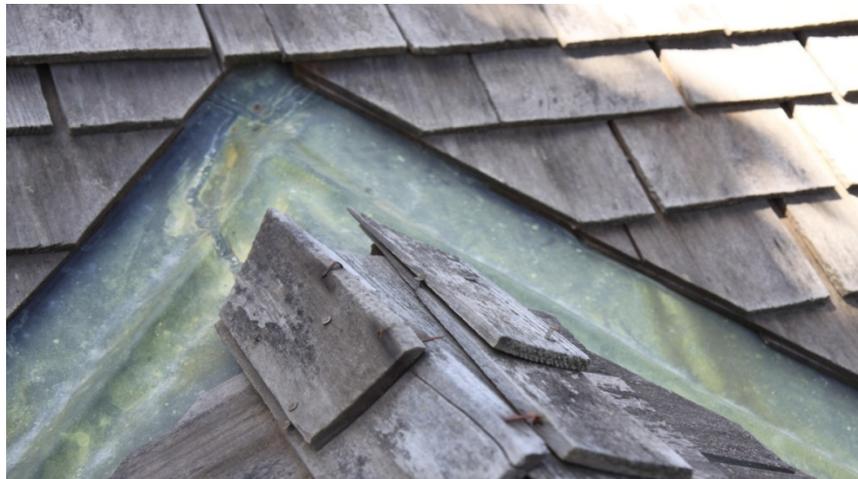
Figure #45 : RIDGE CAP DORMERS-NOTE MISSING RIDGE CAP.

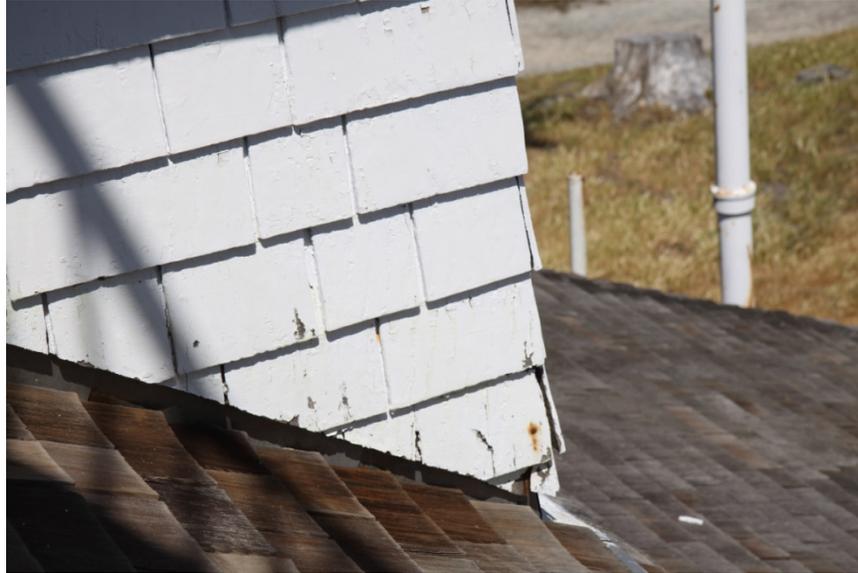
Figure #46: FLASHING AND SHINGLE SIDING DORMERS

The vertical cedar shake shingles installed on the dormers are rated **GOOD** to **POOR**. There are numerous split shingles particularly along the edge nearest the cedar shake shingle roof system and valleys. Rust oxidation stains from failed fasteners are also prevalent. Split shingles should be sealed with appropriate material until funding can provide replacements. Oxidized fasteners should be sprayed with rust inhibitors, neutralized, and then primed and painted.

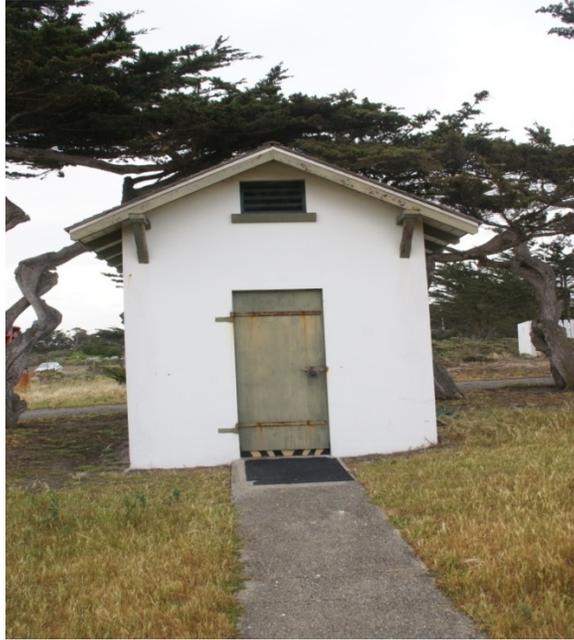
Figure #47: Historic oil house-front-west elevation.

The fuel storage building is rated **GOOD** to **POOR** and is constructed of stucco over fired brick with a wood truss roof system covered in cedar shake shingles. There are Louvre air vents on the west and east roof lines of the fuel storage building. There are corresponding air exchange vent openings along the floor area on the north and south which have been covered over by the exterior coat of stucco. These vent systems were designed and constructed within the walls to provide adequate air exchange in the fuel storage building interior. There is a replacement door hung on strap hinges. A concrete walkway connects the fuel storage building to the lighthouse. There are superficial cracks along the south, east, and north stucco walls. There is wood rot on several of the rafter tails on the roof system and several roof deck planks have rot and /or have been repaired with replacement boards. All wood surfaces which have been painted have widespread coating failure.

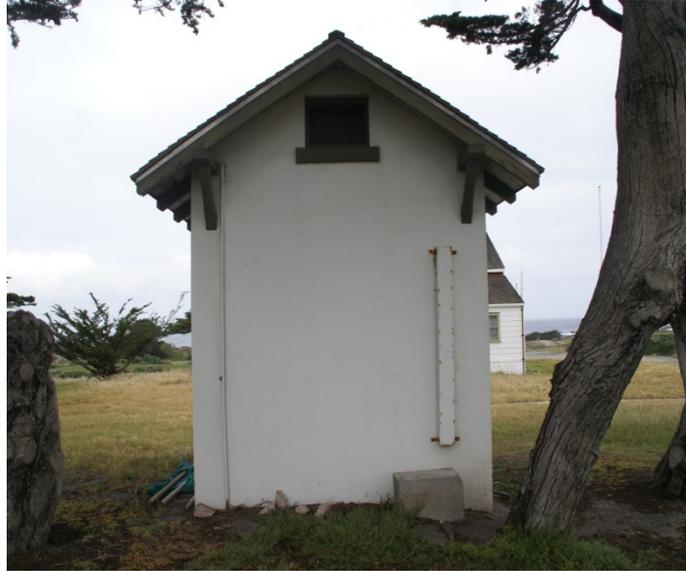
Figure #48: Historic oil house-rear-east elevation.

There are two major modifications mounted on the east elevation of the fuel storage building. One is a run of electrical metal conduit and the other is a metal elongated box of unknown purpose. It may be related to the Loran equipment currently in use in the fuel storage building as a backup navigational system.

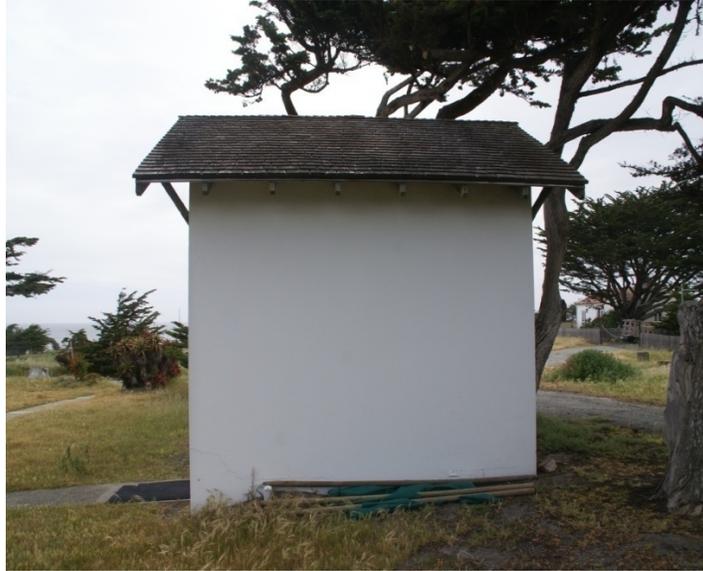
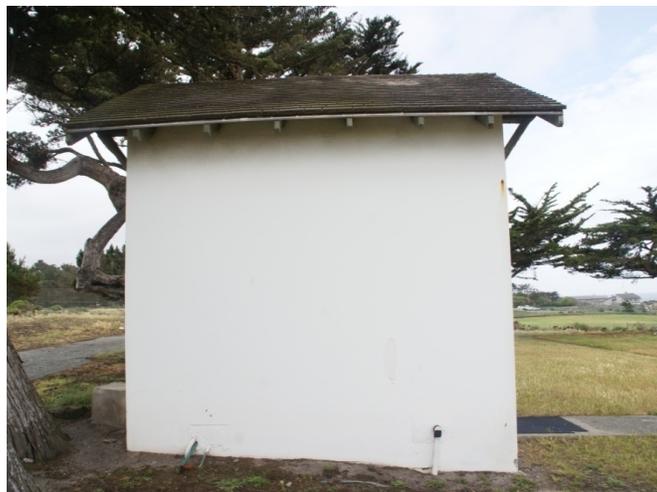
There are surface cracks in the protective stucco on both elevations. Cracks should be measured, recorded by volunteers, and monitored for activity that results in change of measurements. Temporary measures should include filling cracks with elastomeric caulking to prevent additional moisture entry between stucco and brick inner wall.

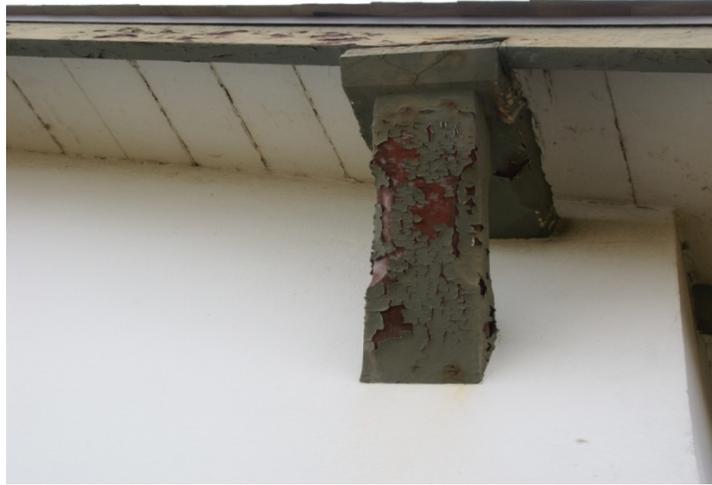
Figure# 51: FUEL STORAGE BUILDING- ROOF SUPPORT BRACKET.

The wood fabric on the exterior of the Fuel Storage Building is rated as **FAIR**. There is widespread coating failure, cracks, wood rot, and possible termite damage. A paint color analysis should be conducted prior to the removal of failed coatings. Failed coating systems should be scrapped off, wood sanded, gaps, cracks, and hollows filled with appropriate wood filler. Repaired and sanded areas should be primed and re-coated with paint colors based on paint color analysis.

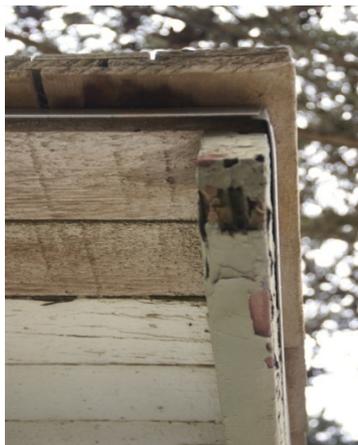
Figure #52: Example of wood rot on rafter tail.

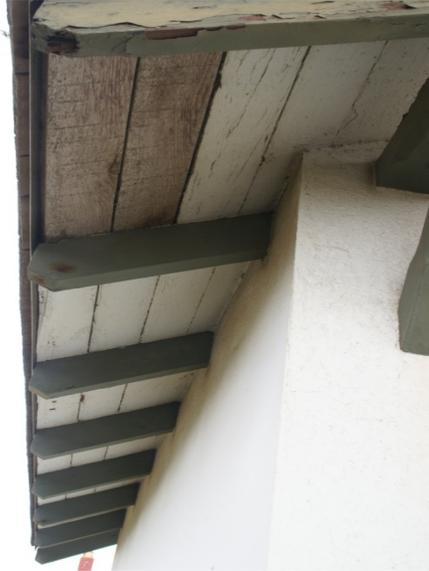
Figure#53: Example of roof deck plank which has been installed to replace damaged historic fabric.

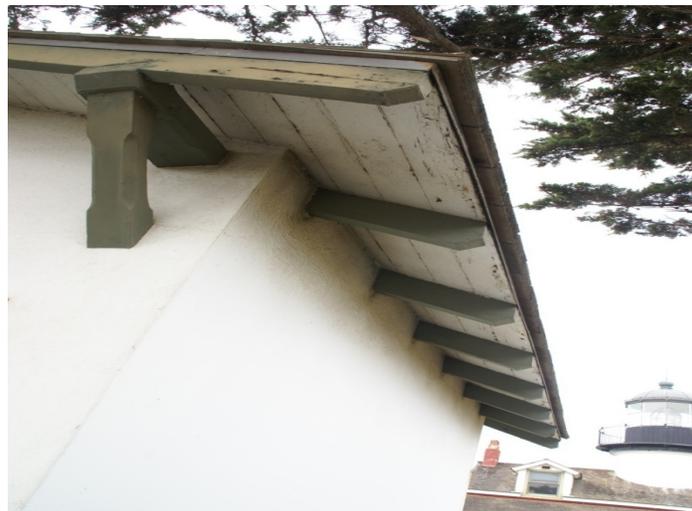
Figure #54: Example of severe crack in fascia board.

Wood roof system should be scrapped, sanded, carefully repaired, and painted based on paint color analysis. This scope of work can be conducted by volunteers as long as they were mask and protective coating and contain, collect, and dispose of all paint debris.

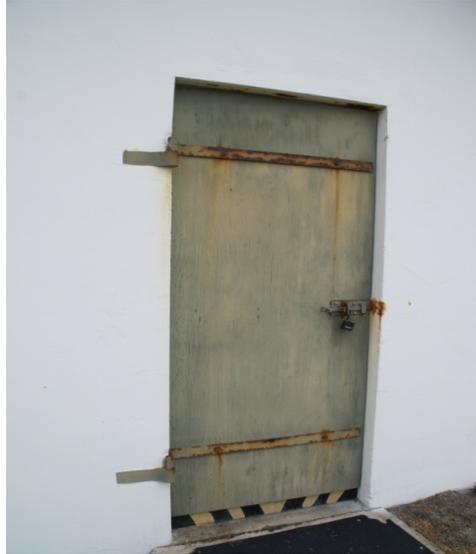
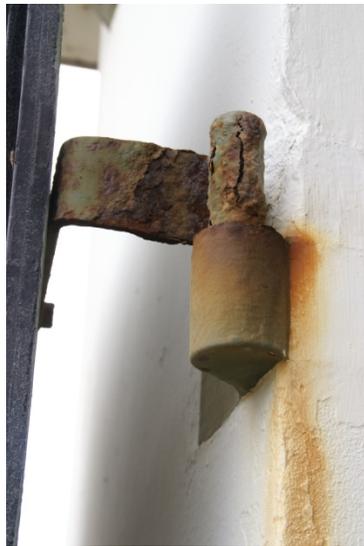
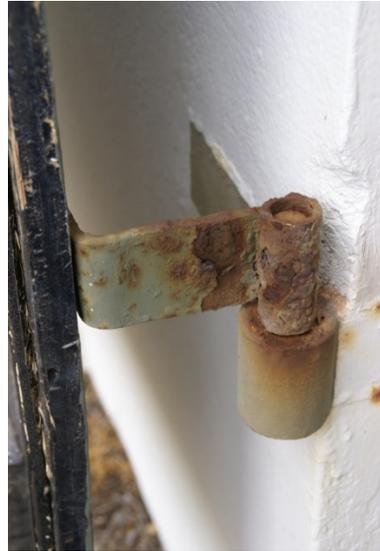
Figure #55, #56, #57: TYPICAL CONDITIONS DOOR.

Typical condition of iron hinge and strap system used to support and operate door. Advanced deterioration of metal requires replacement with matching materials and design. Door is a plywood replacement, is non-historic and inappropriate, and should be replaced with a ductile steel door based on documentation to match original iron door.

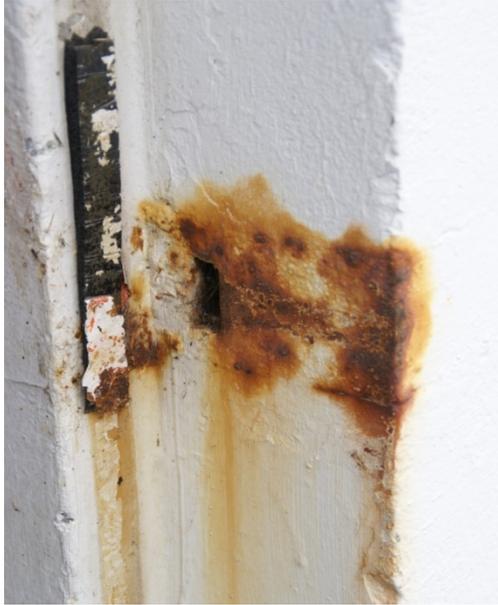
Figure #58 & #59: Typical conditions of iron door frame.

The doorframe is constructed inside the brick and stucco wall. There is severe oxidation of the ironwork in numerous sections of the frame. These areas should be sanded/cleaned to bare metal, treated with rust inhibitors, primed, and painted based on paint color analysis.

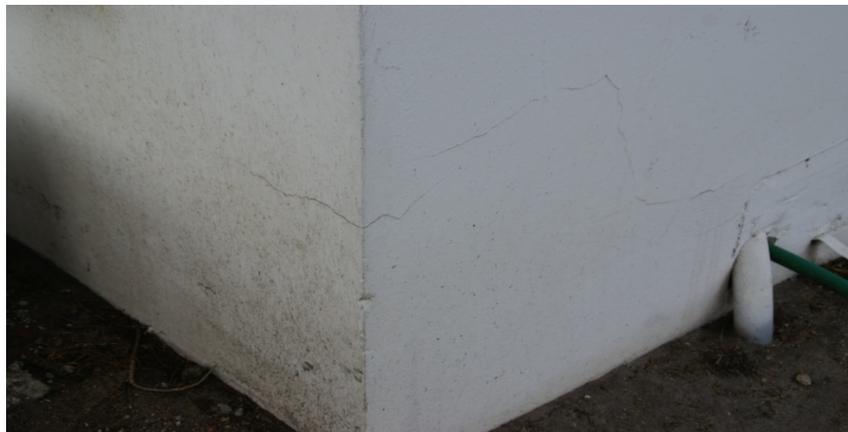
Figure # 60 & #61 : Showing cracks in the exterior stucco walls.

There are numerous hairline cracks located on several areas of the stucco walls. The source of these cracks is unknown. Staff/volunteers should measure and monitor cracks to determine if they are active and ongoing or a result of past building settling or tree root activity. Cracks should be sealed with caulking material to prevent additional water entry.

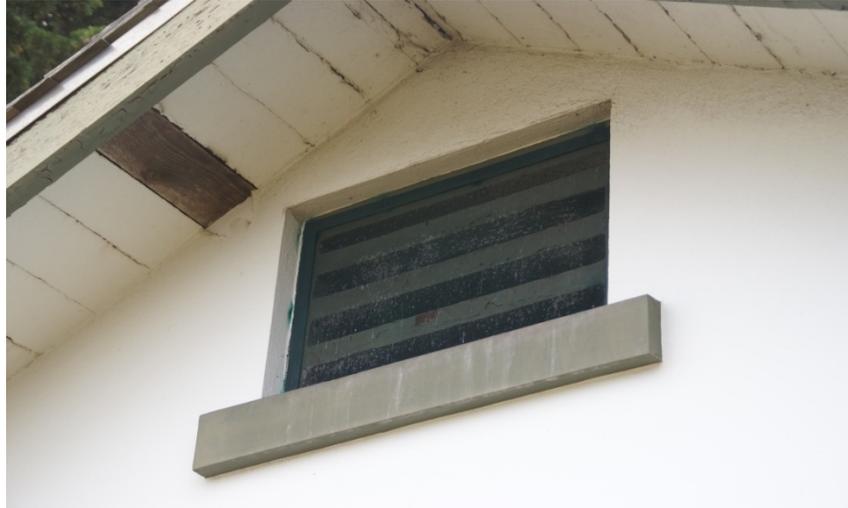
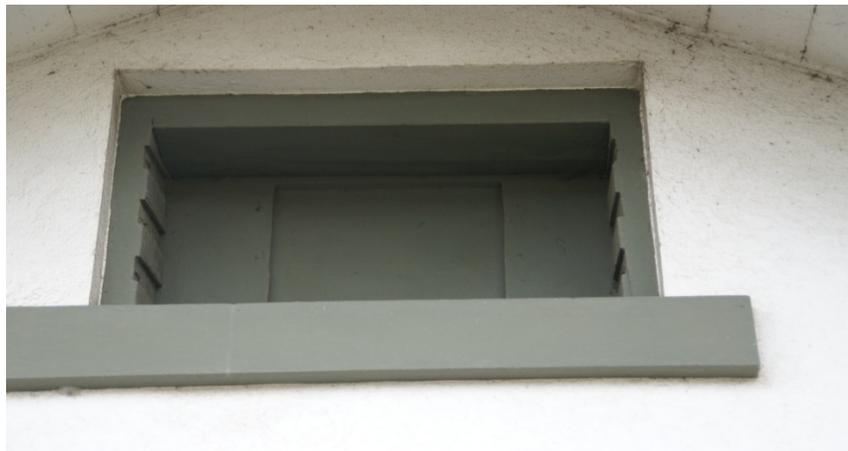
Figure # 62 & # 63 : Fuel Storage Building air vents.

The Louvre air vents located on the east and west rooflines provided a vital role in working in conjunction with those along the bottom of the walls to produce air exchange within the interior of the Fuel Storage Building. Currently, the vent system located on the east wall has been modified by the removal of the louvers and a ply-board panel installed to close the vent off from the inside. This modification is related to the use of Loran equipment inside the Fuel Storage Building. When and if that equipment is removed the vent system should be restored to match original. Copper screens should be installed to prevent insect entry.

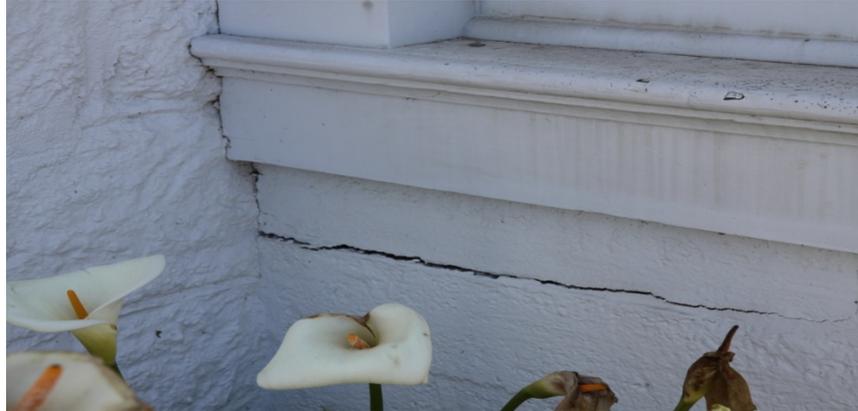
Figure # 66:

The horizontal crack in historic fabric along the north side of the front porch is extensive and of unknown source. Staff and or volunteers should measure length, width, and record. An elastomeric caulking should be used to fill the gap until repairs can be made.

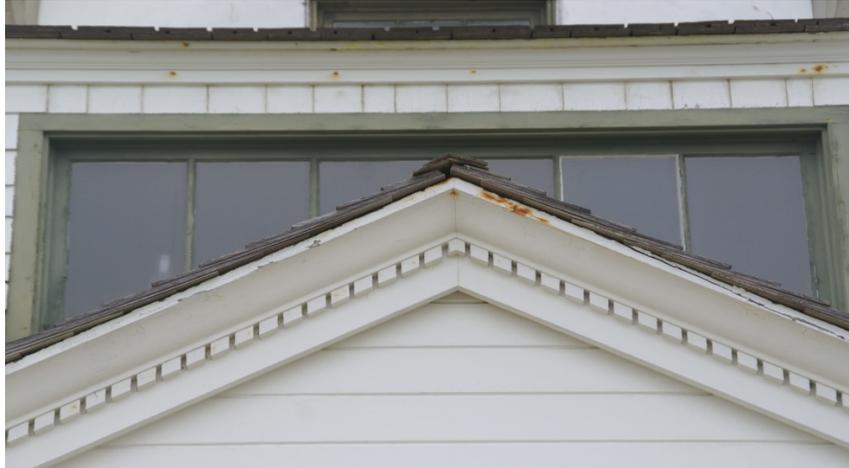
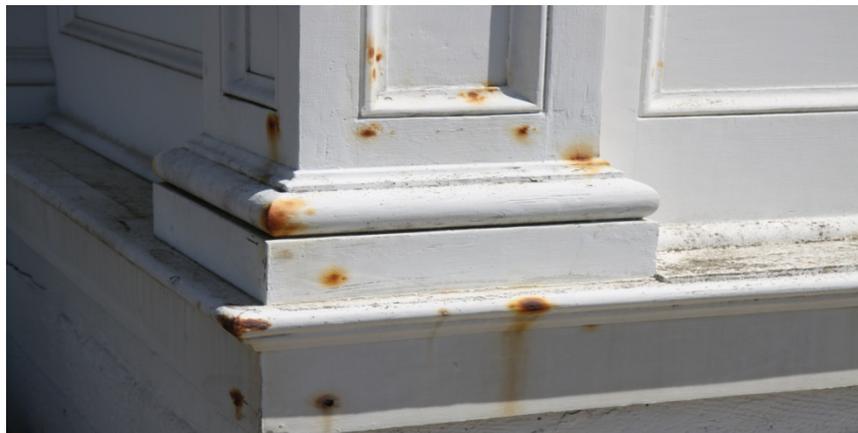
Figure # 67 & # 68 :

There is a high degree of decorative fenestration on the front porch of the lighthouse. The fenestration has been rated as **FAIR** to **POOR**. There is widespread oxidation stains and loss of protective coatings. These conditions could be repaired by volunteers to reduce City of Pacific Grove cost.

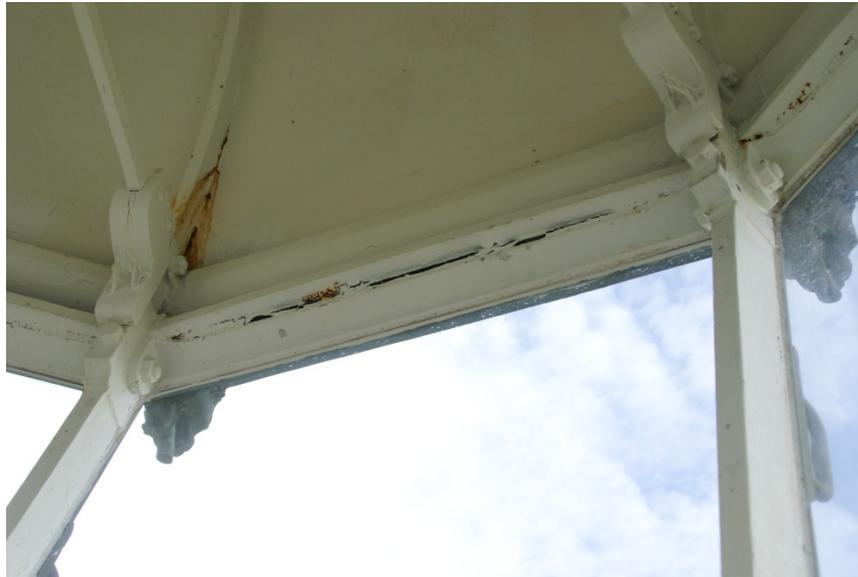
Figure #2: LANTERN ROOM CANOPY.

There are numerous indications of water leaks and or damage in the canopy of the Point Pinos Lantern Room. Rust stains between the bronze canopy (dome) and the iron framework suggest a break in the exterior canopy seam that has allowed water entry between the two components. A water test should be performed with staff and or volunteers inside the lantern room to monitor possible water leak areas. There is also a breakdown of caulking material that was used to fill gaps and cracks along the horizontal cross-tie bracing the vertical stiles. It is not known when or why this material was installed. It should be removed to determine the extent of the gaps and or cracks in order to develop a scope of work for repair. If the material was simply to fill natural gaps between the two components it should be re-placed with an elastomeric caulking material. If the material was used to fill in cracks, the cracks should be repaired.

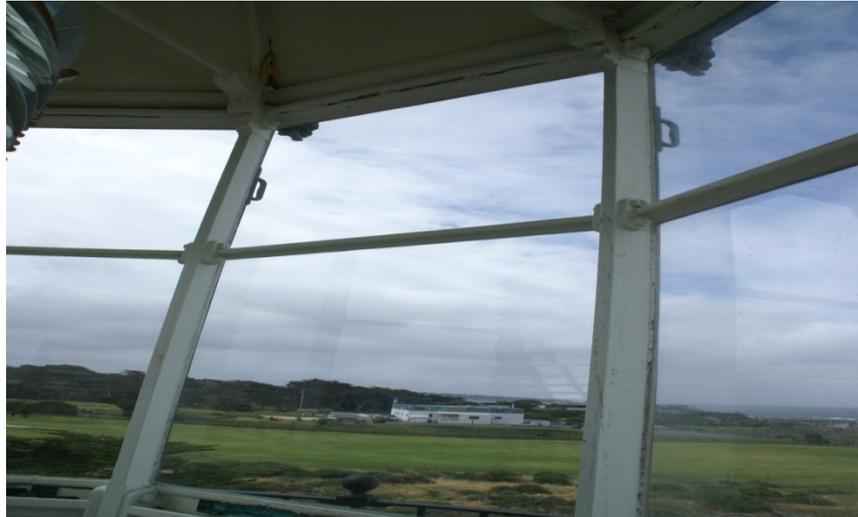
Figure # 3: STORM PANES.

The glass storm panes are secured in place by the use of bronze astragals fastened to the exterior stile. A caulking material was installed to attempt to provide a watertight seal to prevent water entry and entrapment between the bronze astragal, glass and iron stile. The caulking is in a state of failure and has allowed moisture into spaces between the components. The use of dissimilar metals in reaction to chlorides and moisture produce a catalytic reaction with a resultant corrosive process on the iron metal. Left unchecked that corrosive process will accelerate to a level of metal exfoliation which in turn will produce a high level of stress on the glass storm panes and bronze astragals. Rust staining is evident in several areas of the storm panes. More importantly, there is obvious stress related bending of the exterior bronze astragals. These areas are addressed in Specific Recommendations section and are part of the Immediate Treatment phase of work.

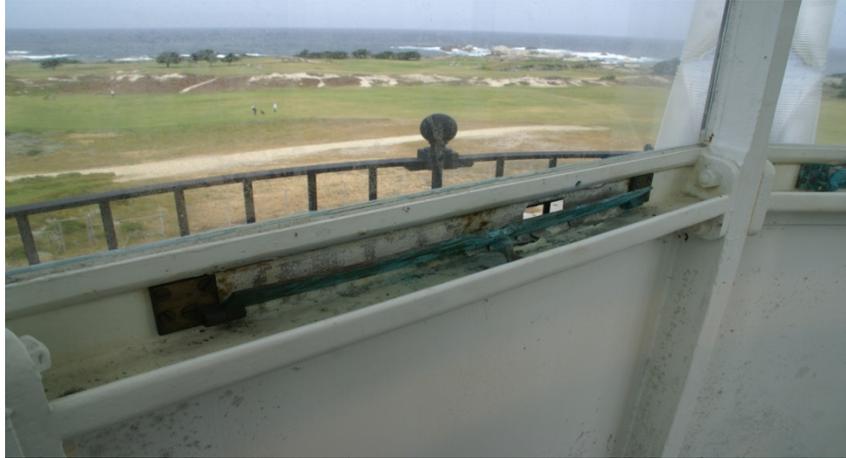
Figure #4: Bronze air vents.

The bronze vent systems in the Point Pinos Lantern Room are rated **FAIR** to **POOR** due to the overall deterioration and lack of maintenance. The repair and restoration of all vents should be undertaken carefully in order that no damage to historic fabric occurs.

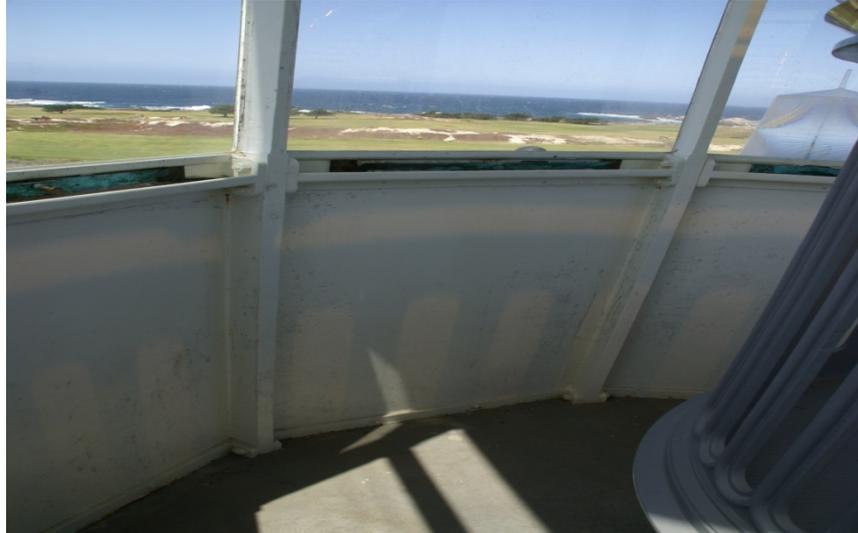
Figure #5: FLAT IRON LANTERN ROOM WALL PANELS.

The bottom section of the Point Pinos Lantern Room is constructed with flat iron plates secured in place by mechanical fasteners. The interior wall panels are rated **GOOD** to **POOR** based on our April site visit. There is **SERIOUS** deterioration of numerous areas of the wall panel on the interior surfaces. More significant is the **CRITICAL** need to stabilize and repair the areas with advanced exfoliation taking place as indicated in photographs below.

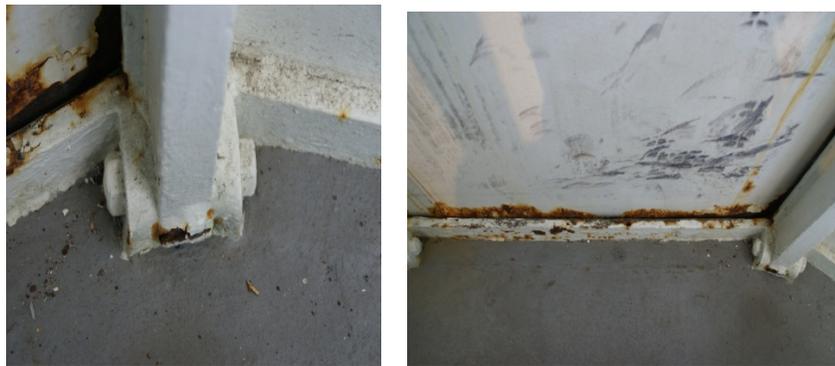
Figure #6 & # 7: The damage to metal and its cause should be corrected ASAP.

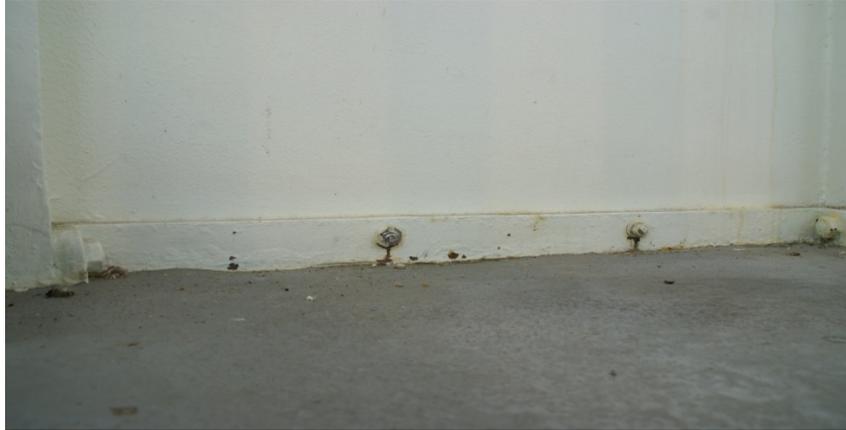
Figure #8 : Lantern Room deck.

The overall condition of the Lantern Room deck is rated as **GOOD**. Improved housekeeping isolated sanding and re-painting are all that are required on most areas of the deck. Areas which are in contact with moisture damage at lantern room wall plates need to be cleaned of loose metal, treated with a rust inhibitor, wiped with a solvent and then primed and finish coated with approved coatings based on historic paint color analysis.

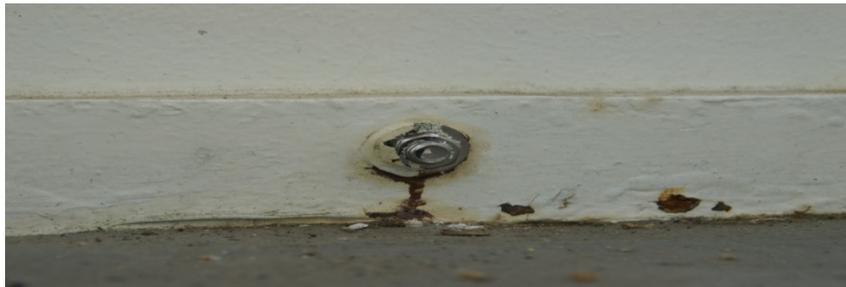
Figure #9: Stainless steel fasteners used to attach exterior flashing.

While the use of stainless steel in a hostile coastal environment is usually advised, their use in the Point Pinos Lighthouse may have not been necessary. It is believed that the aluminum flashing on the exterior lantern room wall was attached by these fasteners. The need of that flashing has yet to be determined. Its installation has created issues on the exterior deck historic fabric.

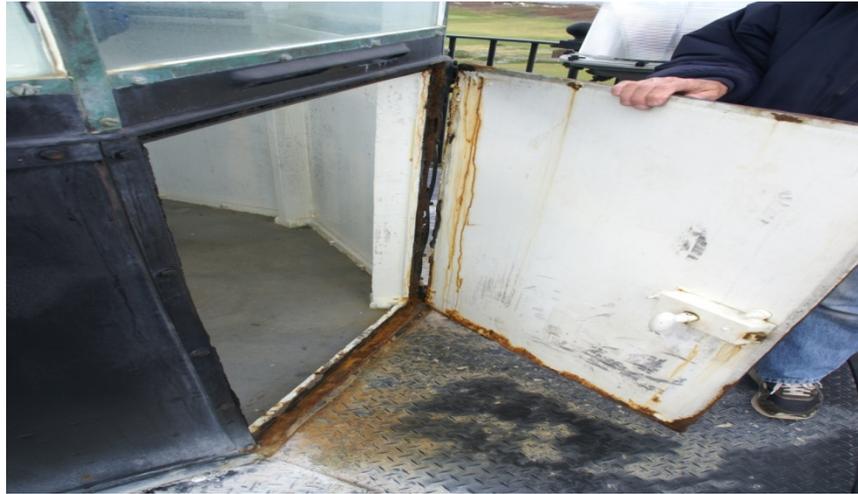
Figure#10: Inside surface of Lantern Room door requires immediate and extensive repair.

The lantern room door requires extensive repairs and should be conducted under **IMMEDIATE** phase.

Figure: Exfoliated metal creates stress on door and frame.

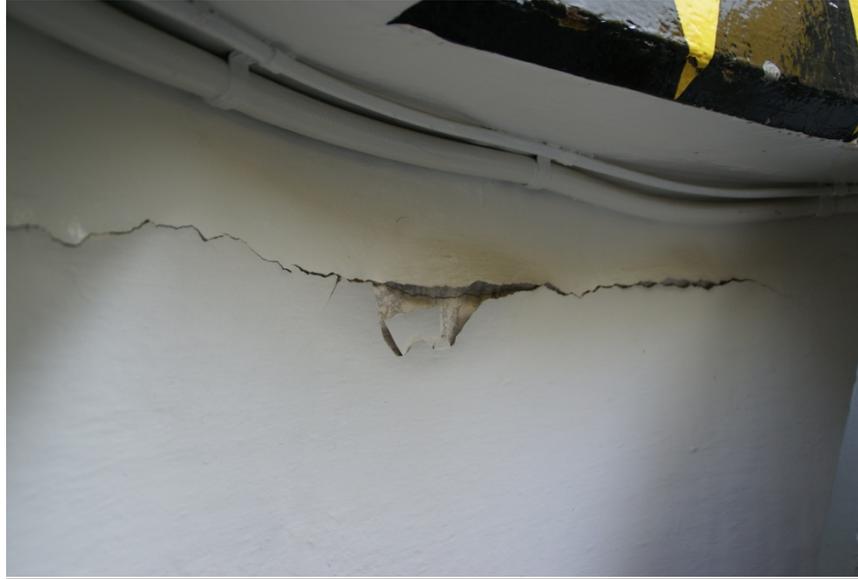
Figure# 17: STAIRWELL BELOW LANTERN ROOM.

The crack which has occurred in the support cylinder area just below the Lantern Room more than likely is related to the corresponding crack located on the exterior of the support cylinder. Further professional investigation is recommended. Loose plaster should be carefully removed to expose crack and concrete hidden by plaster in order to better determine cause and extent of damage. Staff/volunteers should measure length, depth, and width of crack and record. An elastomeric caulking should be inserted into the crack only to prevent moisture entry into interior. Any material used must be reversible and these recommendations are based on the concept that additional repair work will be conducted at a new future date. **Note: Volunteers can be used to remove failed plaster, perform measurements and documentation, and apply caulking.**

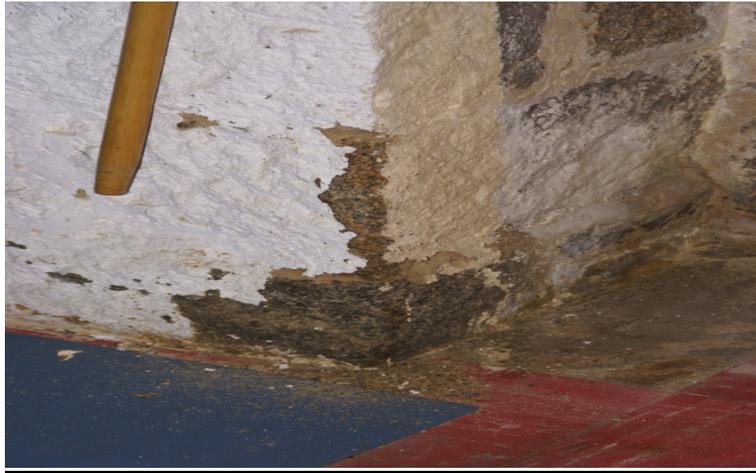
Figure #19: Stonework in Basement NORTH WALL.

The Overall condition of the stonework throughout the basement is rated as **GOOD** to **FAIR**. There is a concern regarding obvious moisture damage in isolated areas of the basement. Evidence of the damage is illustrated by yellowing of coating system, failure of coating system, discoloration of stonework, loss of mortar joints between stones and in rare areas actual loss of stone fabric. It is believed that the moisture creating the damage is from damp rising coming through the floor and lower stonewalls. Loose paint should be carefully removed to expose as much stone surface and mortar joints as possible. Moisture content readings should be conducted, dated, and recorded on a monthly basis to establish extent and frequency of moisture entry. Record weather occurrence on date or around dates of moisture reading. There may be a need to dig pits or make probes to the ground area on the exterior of the stonework to determine avenue and cause of moisture entry.

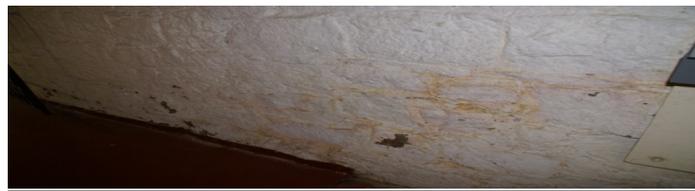
Figure #20: EXAMPLE OF MOISTURE DAMAGE WEST WALL.

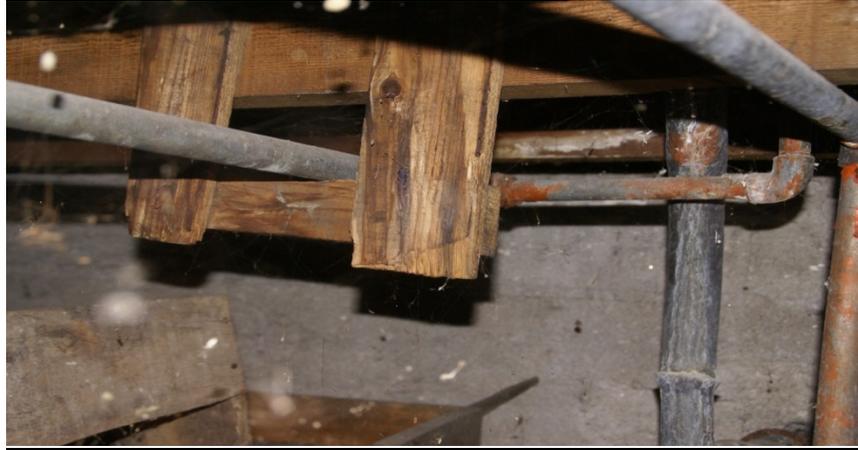
Figure #24: Leaking water pipe below bathroom.

Inspection of the crawl space below the bathroom area revealed a water pipe leak. Pipes below the bathroom are in poor condition with a high incidence of rust especially at areas where they make contact with the ground. If water use continues inside of historic building new pipes are highly recommended. Continuance of leaks will result in damage to wood and stone, and mold and mildew contamination. Periods of hard freeze will also increase extent of damage to stonework.

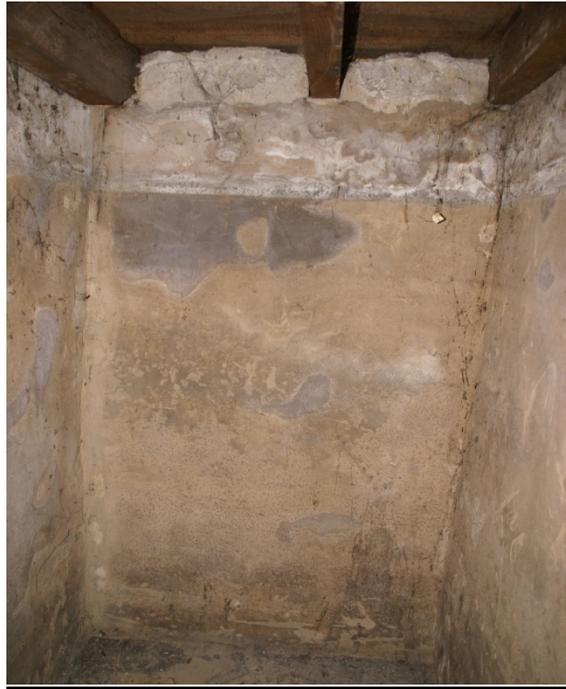
Figure #30: Water collection and storage cistern.

Access to the historic 1000-gallon cistern was gained by a small trap door in the floor of the north-parlor closet. The cistern is rated as **GOOD** but should not be relied upon for water storage. Photo documentation of this system should be used to interpret this significant system to visitors. There is a small amount of debris deposited on the cistern floor. Volunteers should carefully collect the debris, screen it and bag and tag any historic materials for identification and storage.

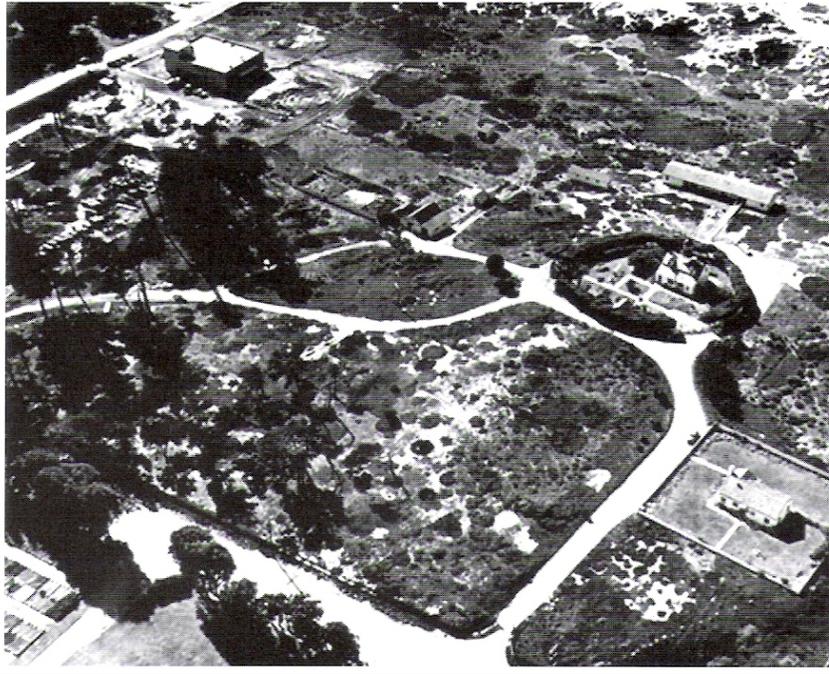
Figure #2: RESTORATION OF THE CEDAR TREE HEDGE.

The restoration of the cedar tree hedge would provide a natural barrier to the infill new construction that currently has an adverse impact on the historic context of the Point Pinos Lighthouse.

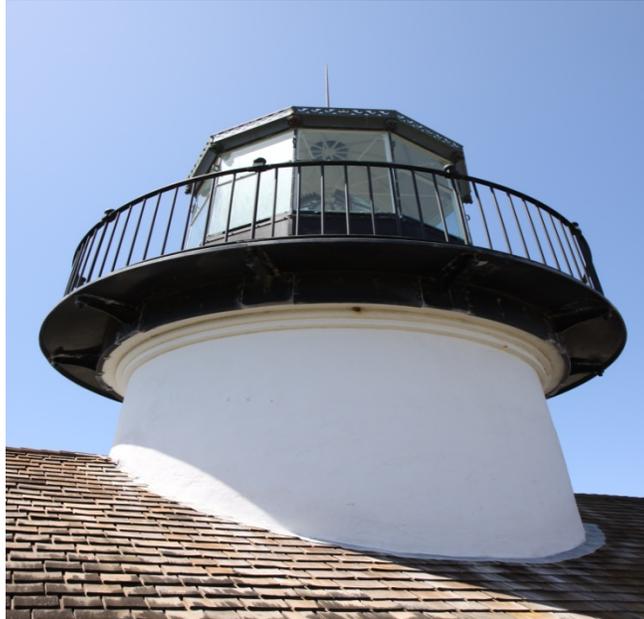
Photo: LR # 1.

QCR-GOOD-POOR - MDP -SERIOUS TO CRITICAL

It is our findings that the numerous exterior wall panels have reached a level of failure that will necessitate extensive repair and replacement of several of the iron Lantern Room wall panels.

Due to the degree and extent of damage to the Lantern Room we recommend that this area receive the most immediate attention and funds to correct. While Staff and volunteers can remove failed coating systems clean exfoliated metal, and use selected metal filler and prime and repaint safely, the replacement of extensively damaged metal work on the Lantern Room and related support system require professional and skilled contractors.

Some Lantern Room sections can be cleaned, repaired, and re-coated while removed from top of the Lighthouse.

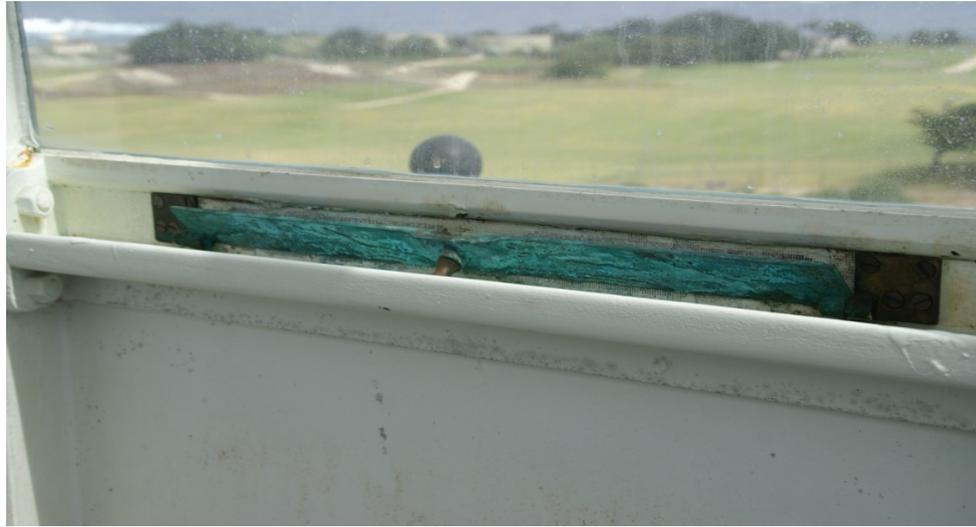
QCR-POOR -MDPR- SERIOUS

Photo: LRAEVG #1: Interior surface of Air Exchange Vent Grill.

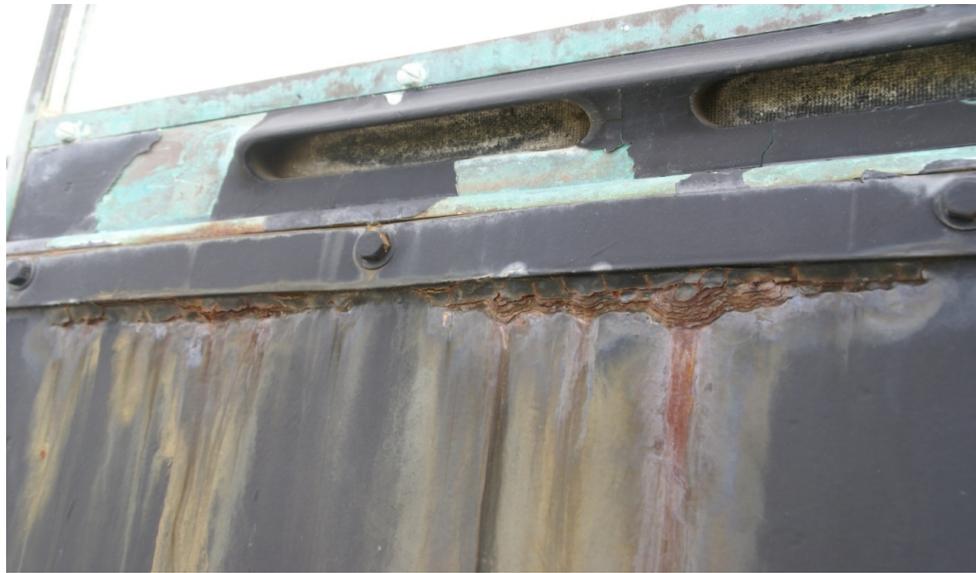
Photo: LRAEV #2: Exterior surface of Air Exchange Vent Grill.

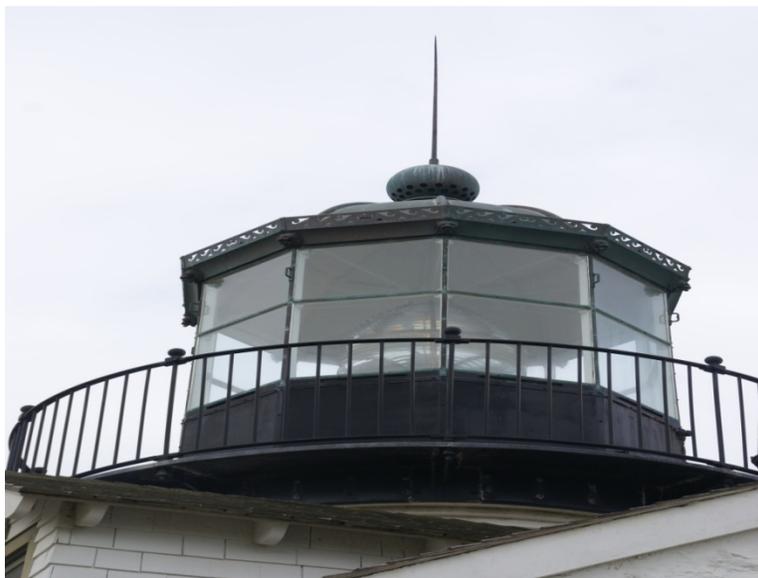
Photo: LRC&VB #1.

QCR- FAIR - MDPR -SERIOUS

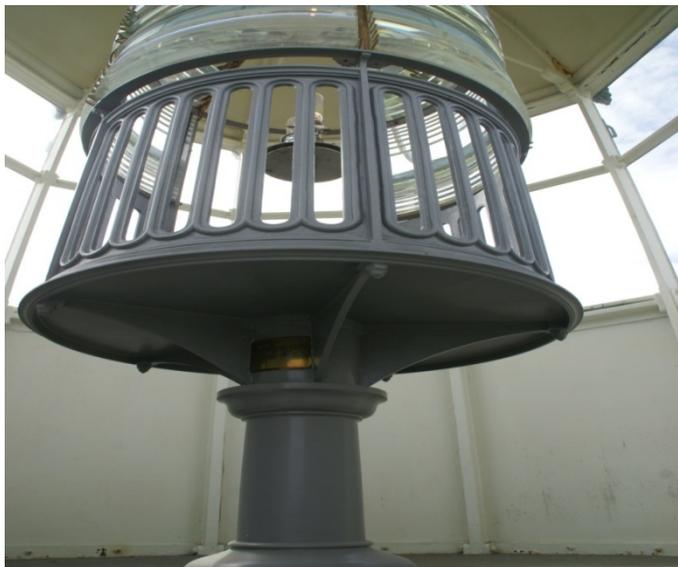
Figure 12: Extreme care must be taken to protect historic optic and support during any work activity.

QCR- GOOD/MDPR-MINOR

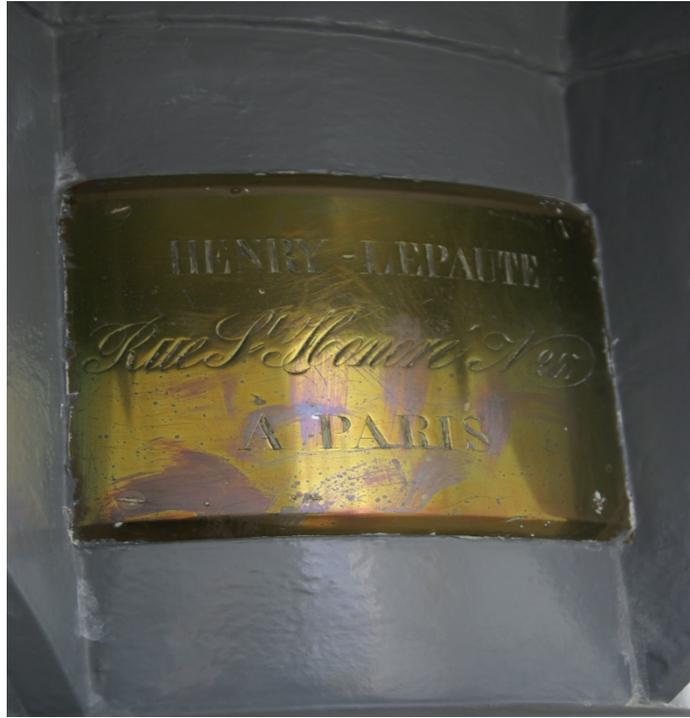
Figure 13: Extreme care should be taken to protect bronze manufacture's plate on pedestal.

- * Apply appropriate zinc based primer to affected areas as soon as area is sanded and wiped with mineral spirits to prevent re-oxidation.
- * Apply appropriate finish coat using correct color match to historic colors if available at time of maintenance.

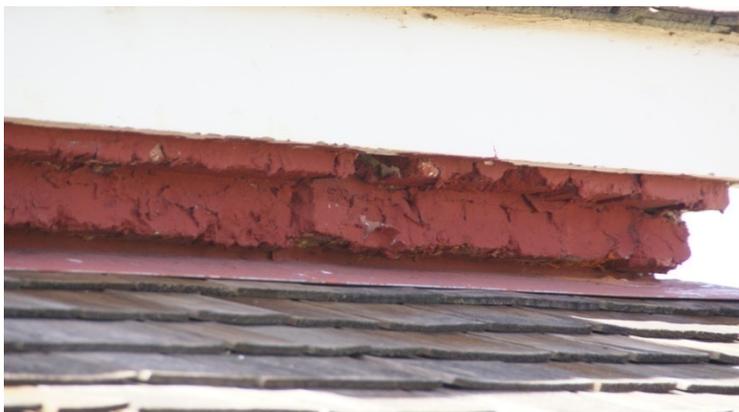
Photo: Brick corbel#2.

QCR-POOR / MDPR -CRITICAL to CATASTROPHIC

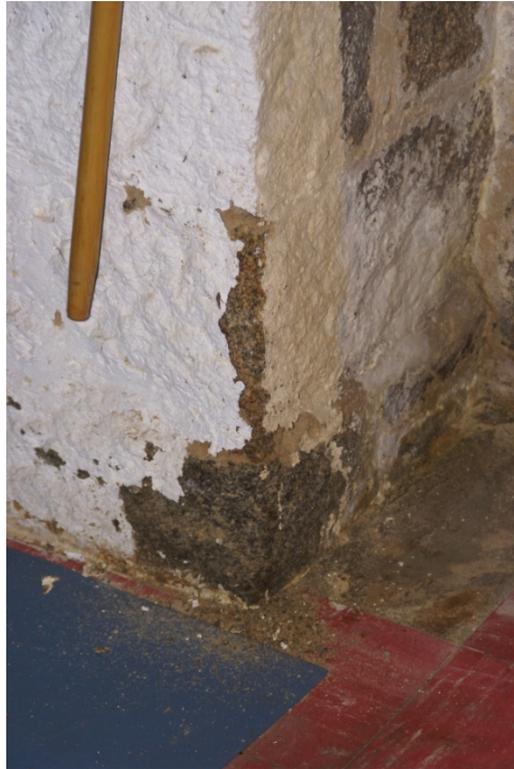
Photo: IBW#1.

QCR- GOOD to POOR/ MDPR -MINOR to SERIOUS
