POINT PINOS LIGHTHOUSE

PACIFIC GROVE CALIFORNIA

PRESERVATION PLAN

August 2009

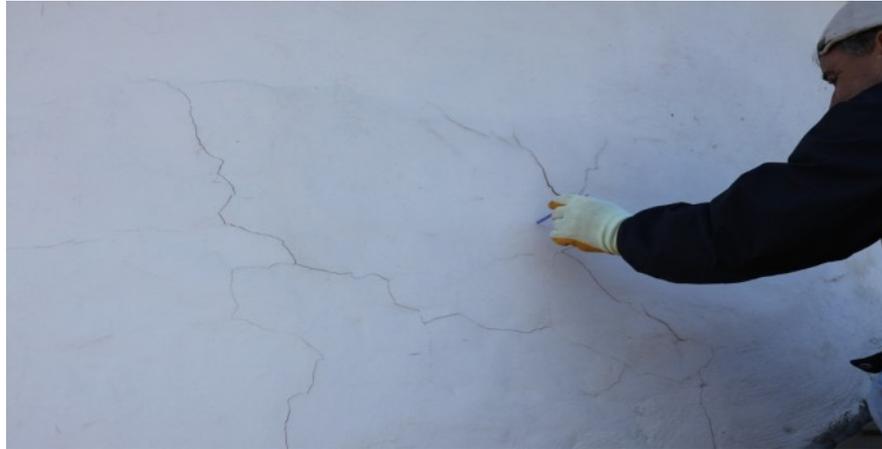
Figure 4: Example of failed stucco coat with resultant loss of protection and additional moisture entry behind stucco coat.

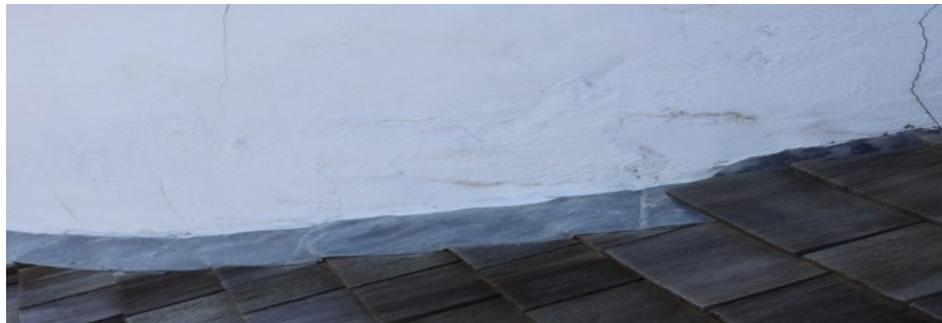
Figure 5: Example of failed stucco coat with resultant loss of protection and additional moisture entry behind stucco coat. Crack allows avenue for water behind metal flashing and into interior walls.

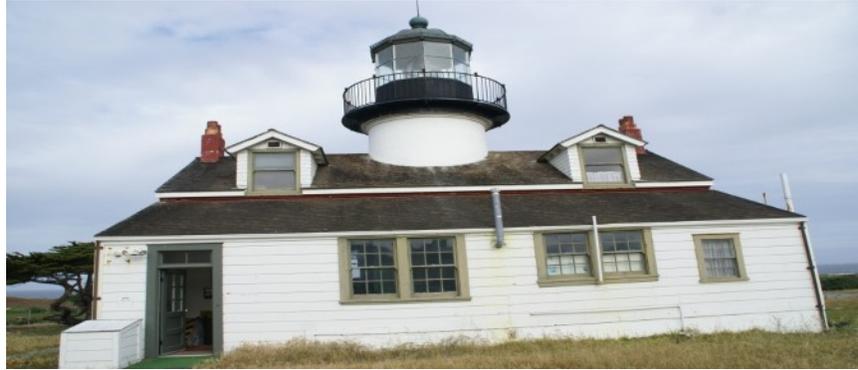
Figure 6: Window system east -rear.

WINDOWS- LIVING QUARTERS: The overall condition of the wood window systems have been rated **GOOD** to **POOR**. Loss of protective paint coatings and window pane glazing has resulted in extensive damage to many window sashes, aprons, sills and trim. Documentation of historic time periods should be established to determine which style /design of windows will be used in interpreting the Point Pinos Lighthouse living quarters. It is our recommendation that no change in window design take place as existing windows represent a significant period of interpretation and contributes to a diversity of window design which adds interest to the historic character of the living quarters. **Window repair has been ranked as one of the Immediate phases of the scope of work.** Qualified volunteers could conduct the repair of windows to reduce the budget cost to the City of Pacific Grove as long as they wear proper protective mask and garments and contain, collect and dispose of paint debris according to Federal and State of California law.

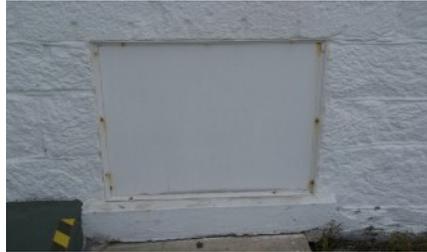
Figure 8: Example Dormer window Figure 9: Enclosed basement window.

Both enclosed basement windows located on the west elevation should be restored to improve historic character and provide light in basement areas.

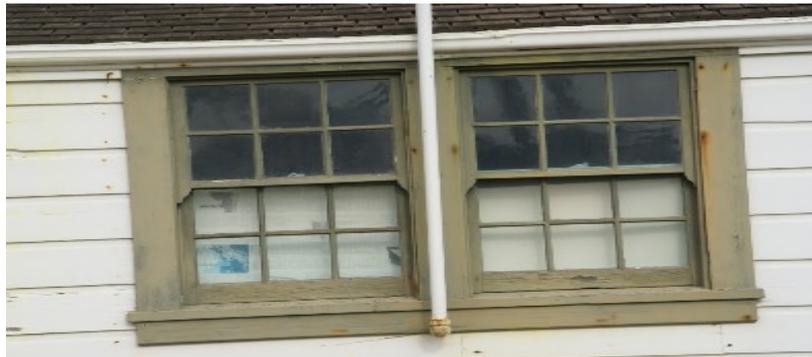
Figure 10: Example of 6/6 double hung sash windows- rear attachment.

The condition or existence of window weights, ropes/chains/ or pulley wheels was not determined during this inspection. Restoration of window systems to a functional condition should be determined based on budget constraints as well as security consideration.

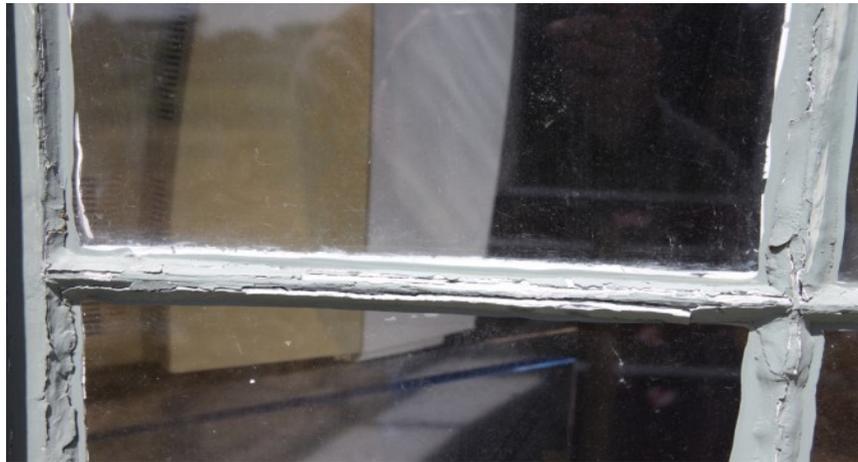
Figure 16: Example of damaged window- pane glazing has loss its integrity and has separated from wooden muntins. Gaps allow moisture between glass and wood fabric.

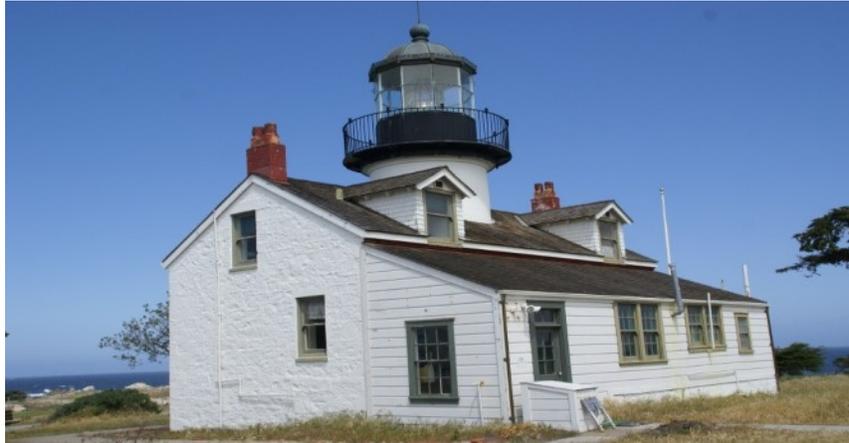
Figure 17: SOUTH-SIDE ELEVATION

LAPSIDING: The overall condition of the wood lap siding is **GOOD** to **FAIR**. The condition of the wood siding is still sound though there is a thinning and loss of protective coatings. Steel nail fasteners have failed in numerous areas and there is rust staining associated with loss of protective coatings. Previous use of metal connectors to attach other equipment has also produced holes for water entry behind lap siding as well as additional rust stains. All obsolete connectors should be removed. All holes should be filled with appropriate wood filler. Siding should be hand sanded, primed, and re-painted in order to prolong life span of siding. **Accumulated earth should be immediately raked away from contact with building and lap siding. This area would be excellent use of qualified volunteers to make repairs to offset budget cost to City of Pacific Grove.**

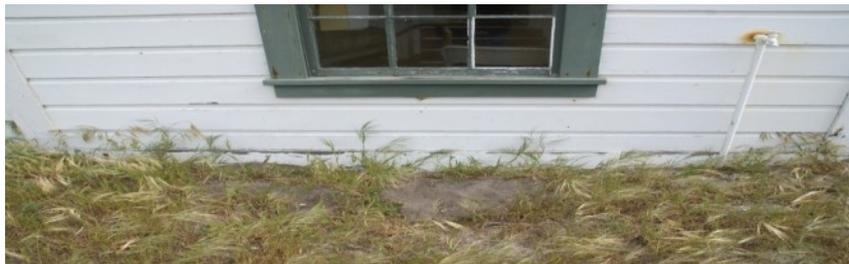
Figure 18: Accumulated dirt and vegetation should be raked away from contact with wood ASAP.

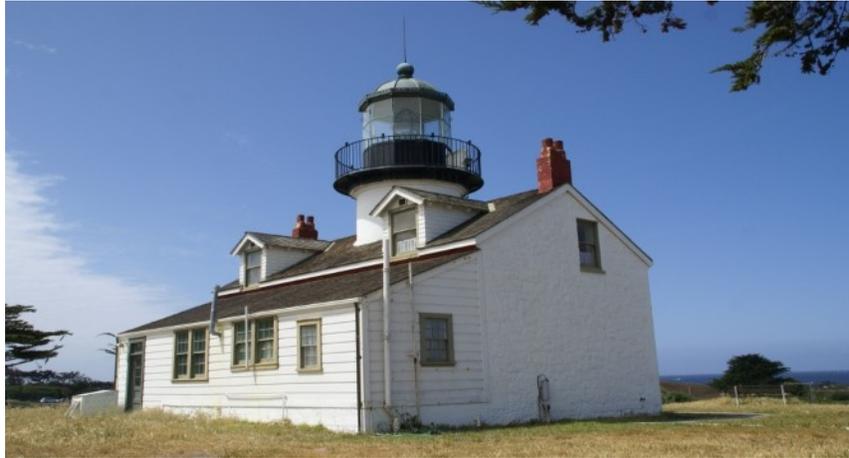
Figure 19: NORTH-SIDE ELEVATION

EXTRANOIUS ATTACHMENTS/FASTENERS.

There are numerous metal attachments/fasteners on the exterior of the living quarters of the lighthouse. All obsolete equipment, water piping, stovepipes etc should be removed and holes filled with appropriate material. Surfaces should be sanded and re-painted ASAP. **This activity could be conducted by qualified volunteers to offset budget cost to the City of Pacific Grove.**

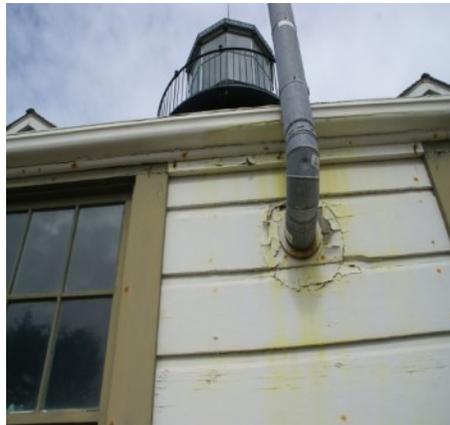
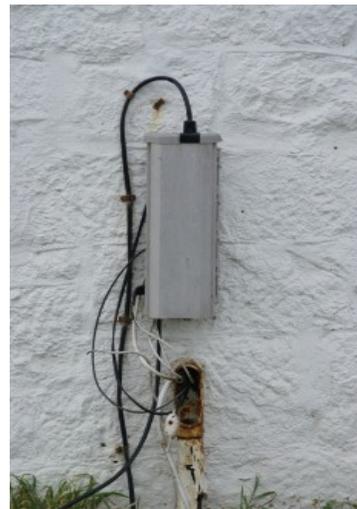
Figure 20 & 21: Obsolete equipment and attachments should be removed and historic fabric repaired.

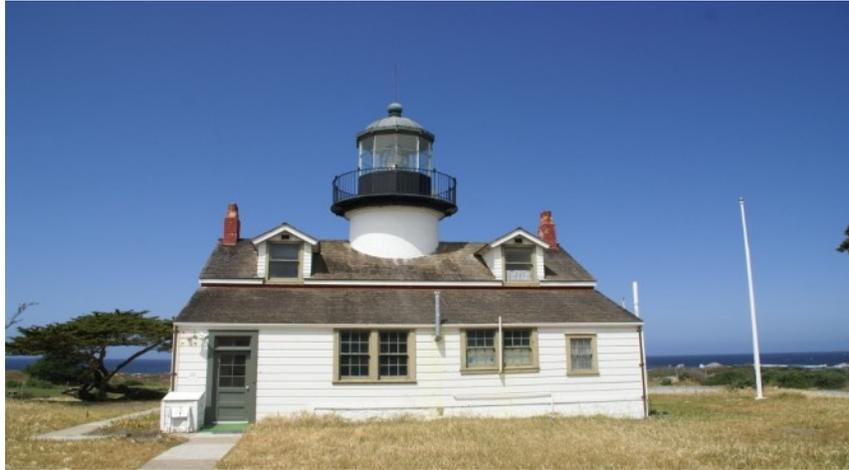
Figure 22: EAST-REAR ENTRANCE

ROOF SYSTEM: The roof material used on the living quarters of the lighthouse is wooden cedar shake shingles. The overall condition of the cedar shake shingle roof system is rated **FAIR** to **POOR**. The shakes are in the later period of their life span and have resultant cupping, cracking, separation, fungus contamination, and loss of nail fasteners. There are several areas with ridge caps missing entirely-potentially allowing moisture under the shakes and into the attic area of the lighthouse. There will be a need to replace the cedar shakes in the near future but repairs to damaged areas, including ridge caps should provide at least two more years of service. Staff/volunteers should inspect attic area on a regular basis following a rain event to monitor potential shake failure and leaks.

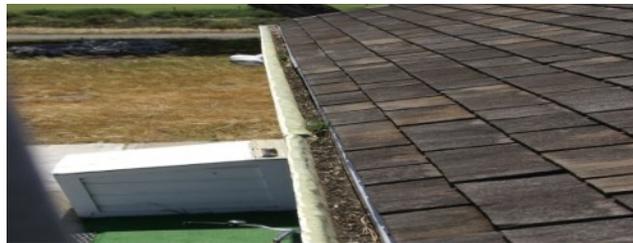
Figure 23: Roof gutters and downspouts should be cleaned ASAP.

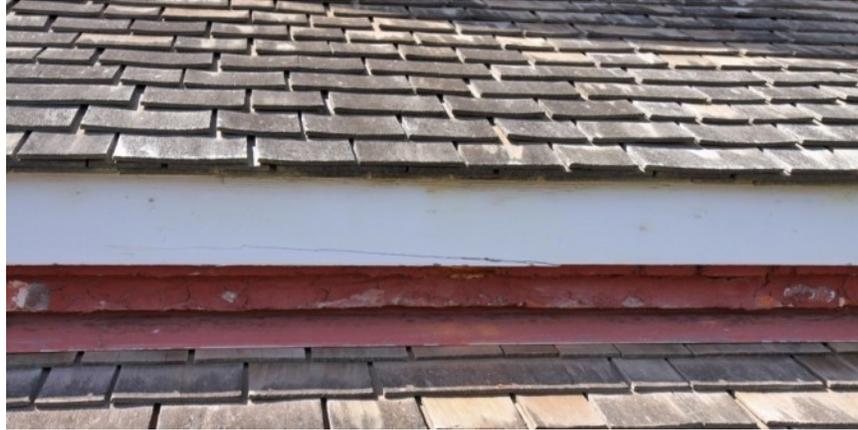
Figure 28: Condition of corbel bricks.

There is extensive damage to the brick corbel which helps support the roof system on the rear elevation of the living quarters. The overall condition of the brickwork on the corbel is rated **POOR**.

The repair of the brick corbels should be performed by qualified contractors.

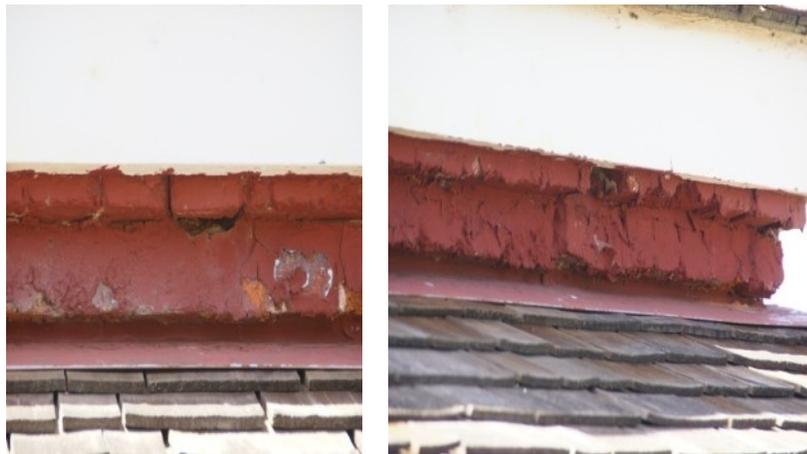
Figure 29 & 30: Examples of type of damage to roof brick corbel.

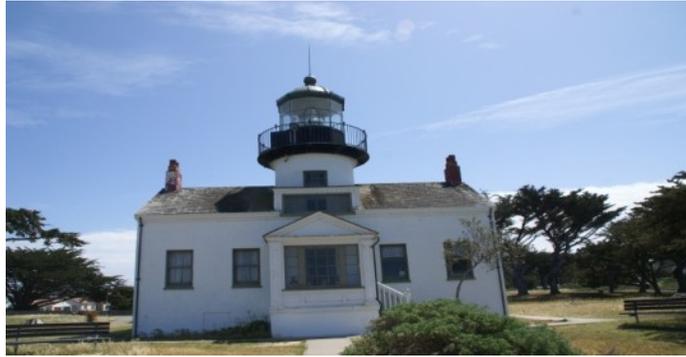
Figure 31: WEST-FRONT –ENTRANCE

STONE WORK: Overall condition of the stone- work of the Point Pinos Lighthouse is **GOOD** with no apparent structural damage or serious surface deficiencies. Numerous layers of coating systems prevent more extensive investigation. There are rust stains and limited damage related to the use of steel fasteners which attached conduit or other apparatus to the exterior of the lighthouse. These metal fasteners should be carefully removed to prevent additional damage or staining. It was noted that in basement area of lighthouse there were signs of moisture penetration evidenced by yellow staining and damage to the paint coating ranging from peeling to absence of coating.

It is believed that in the near future some additional investigation into the source of moisture entry should be conducted by selected digging along the base of the stonework corresponding to the damage on the interior.

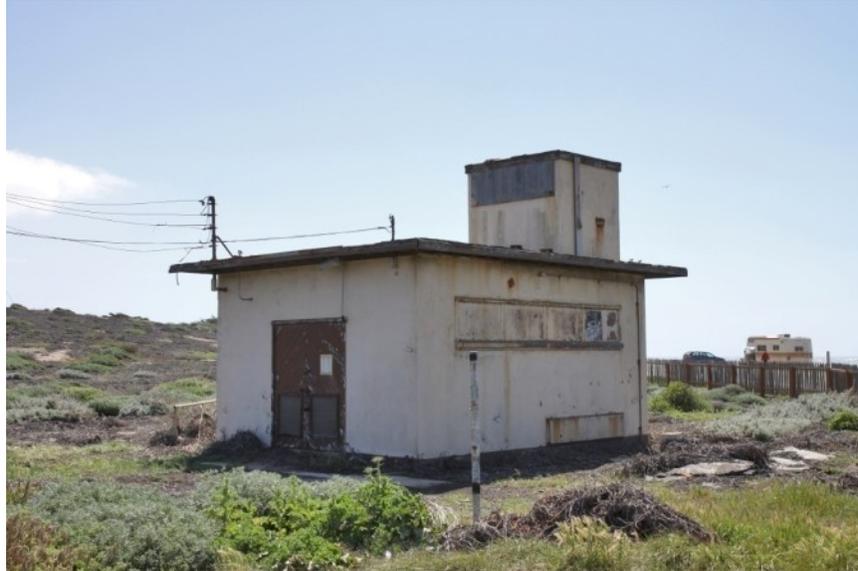
Figure 40: Historic Fog Horn building.

The Fog Horn Building was constructed to provide Fog warnings in this especially treacherous area of California coastline. There are numerous examples of fatal and highly destructive loss of shipping in the waters covered by the operation of a fog signal operated by the staff of the Point Pinos Light Station. This particular structure was built in the 1940s' out of poured concrete and concrete block with a concrete slab roof. Lying nearby is a iron/steel frame which is believed to be the housing for the historic fog horn apparatus. This system should be researched to determine its historic significance and removed for safe keeping accordingly.

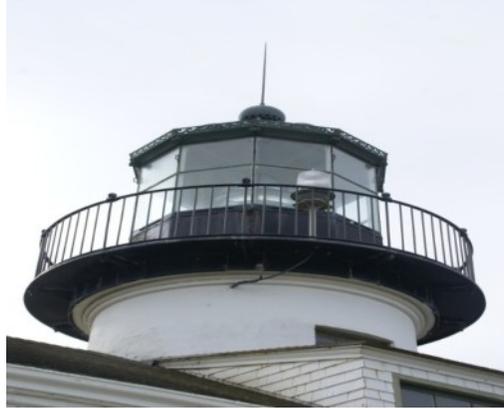
Figure : LANTERN ROOM

The Lantern Room of the Point Pinos Lighthouse is composed of a mixture of metals which include cast iron , wrought iron, bronze, brass, steel and recent (within ten years) use of aluminum flashing along the exterior base of the wall of the Lantern Room and deck plates. The Lantern Room is enclosed by a bronze dome or cupola which is topped by a bronze vent ball designed to vent heat, soot, smoke, and humidity from the interior of the Lantern Room. This device was especially important during the period fossil fuels were used as a means of lighting the lamps which illuminated the historic beacon. There is a bronze lightning rod atop the vent ball. It is not known at the time of this report as to whether the lightning rod is properly grounded and functions as designed.

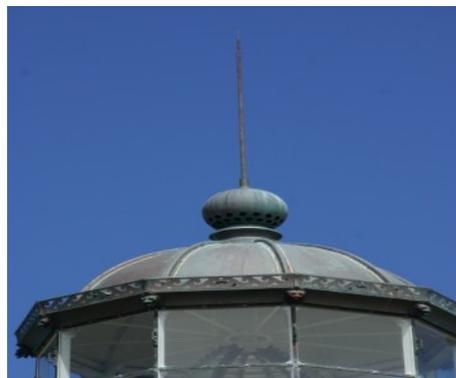
Figure 7 : Lightning rod and vent ball.

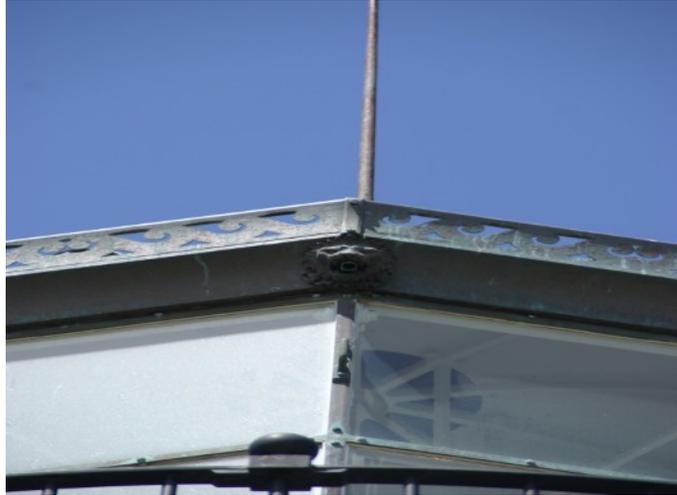
Figure: Gutter and downspout system.

The canopy is outlined with a highly decorative and unique scroll and lion's head gutter and downspout system to direct rainwater runoff away from the dome of the lighthouse. The drain system should be checked for proper function.

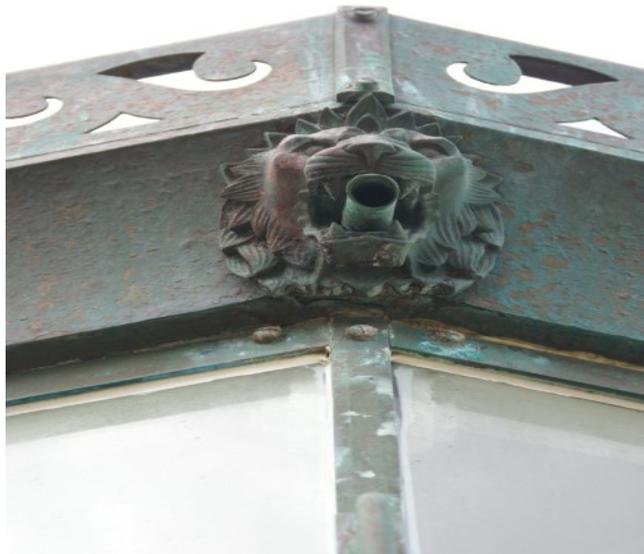
Figure: Bronze Lion Head gutter/downspout

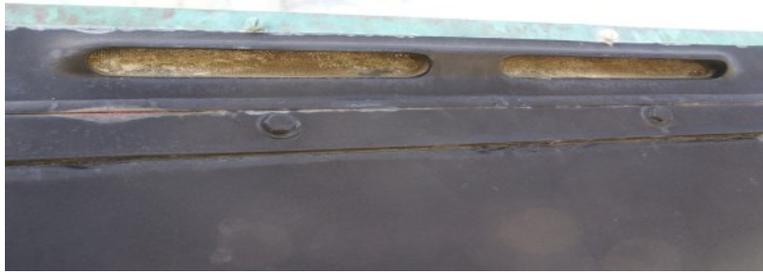
Figure: Bronze vent system.

There is a system of bronze air vents which are located along the bottom of the storm panes and atop the iron Lantern Room parapet walls. This vent system worked in conjunction with the vent ball to provide air exchange within the Lantern Room. There are bronze screens in the vents to prevent insect entry into the Lantern room which would create problems during the nighttime use of the lamps or lights provided to illuminate the lens/optic.

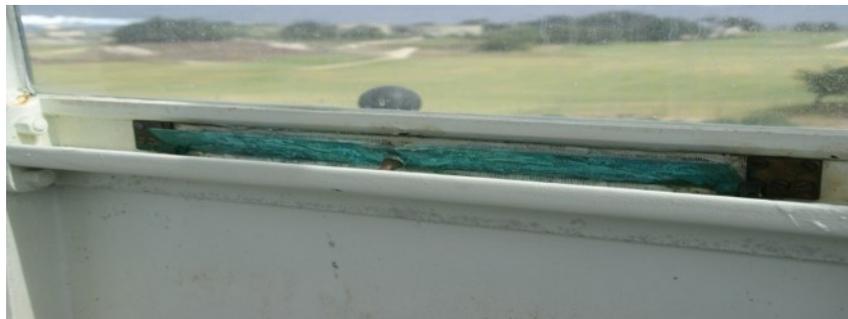
Figure : Interior vent system.

There is also a condensation collection system built into the interior wall of the Lantern Room just below the storm panes. As ambient temperatures changed moisture condensation would form on interior storm pane surfaces which could be collected in narrow basins or troughs just below the glass storm panes. These collectors are made of bronze in order to withstand the high chloride content of the moisture. Keepers would drain the basins as part of their daily maintenance schedules.

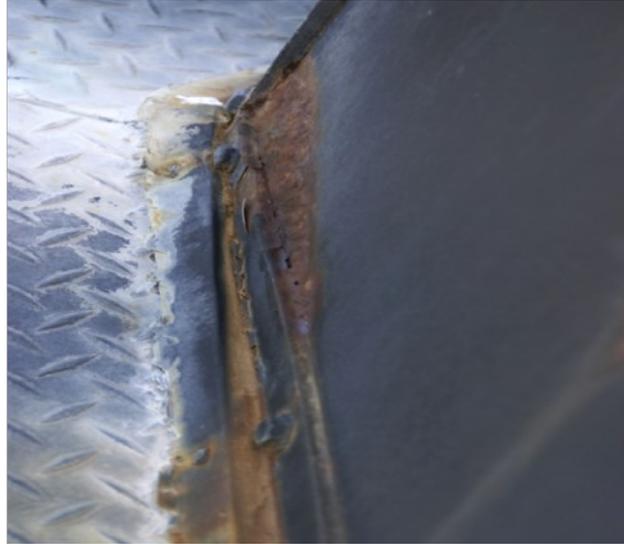
Figure: Base of Lantern Room wall as it connects to deck plate.

The extreme degree of adverse effect of the catalytic reaction of the use of dissimilar metals is pronounced separation of metal connections and waterproofing as well as extensive damage to both historic and new materials. It was noted during our site visit that recent repairs to the lantern and lantern deck area included the use of modern materials (aluminum) as flashing to waterproof the gaps between the iron lantern wall and the iron gallery deck. There is pronounced “jacking” of the softer aluminum flashing as well as an extensive “bled off” of what appears to be aluminum oxide. The volume of white powder is so great it has produced extensive and widespread staining of all areas adjoining or near the placement of the aluminum and caulking material. Budget permitting it might be advisable to remove the aluminum flashing and replace it with an appropriate fabric.

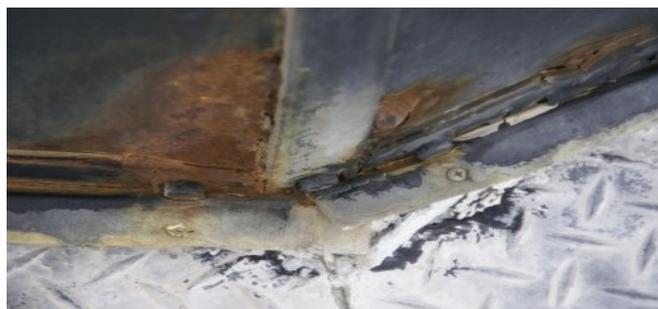
Figure: Damage to deck plate and aluminum flashing.

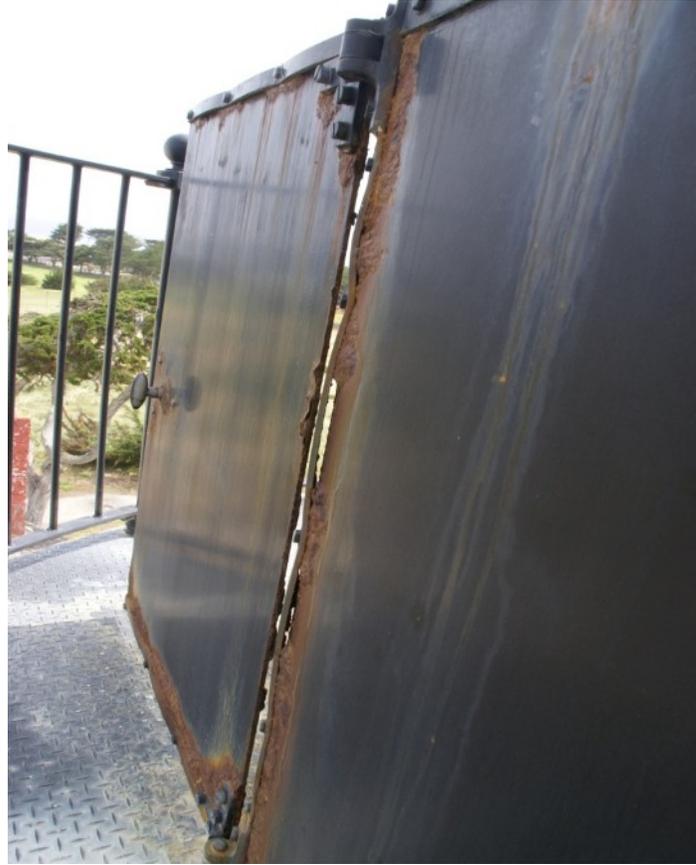
Figure : Iron Lantern Room Door.

The door enclosing the exit/egress to and from the Lantern Room Gallery deck is flat iron plate with attached re-enforcement bars. The hinges which support the door and the hardware which secure the door are original and historic to the Point Pinos Lighthouse. There is widespread coating failure with resultant metal oxidation, scaling, blistering and exfoliation. “Rust jacking” is creating enormous stress on the hinges, and doorframe which currently causes the door to bind when in use. Bronze astragals which secure the doorframe are in advance state of movement due to the stress. This condition poses great risk to the historic fabric and ultimate future loss of the historic door and related framework. Immediate steps should be taken to stabilize the door and adjoining metal fabric.

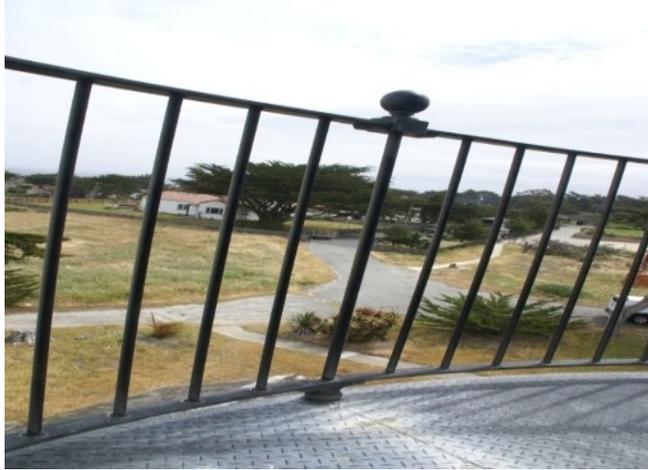
Figure: Gallery Deck safety rail and post system.

The Lantern is surrounded by an iron plate gallery deck which is enclosed by safety rail system made up of an iron rod and flat bar top and bottom rail which secures the round rail rods. The railing system is connected to the deck and gallery bracket support system by wrought iron posts which are threaded on each end to receive the ball cap on top and to thread through the deck plate and into the support bracket on the underside of the gallery deck.

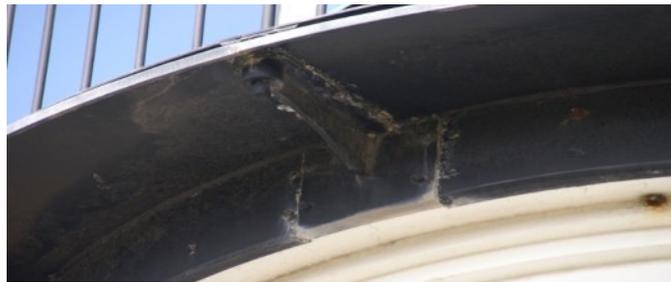
The gallery deck is supported by iron brackets arms which extend under the gallery plates at the ends of the iron deck plate which provide strength and connection to both edges of the adjoining deck plates. The bracket arms are bolted through the cast iron collar which encircles the top of the brick/stucco support cylinder. There are numerous support brackets which have bolt nuts missing from heads. These nuts help secure the railing post above.

Figure: Gallery deck support brackets.

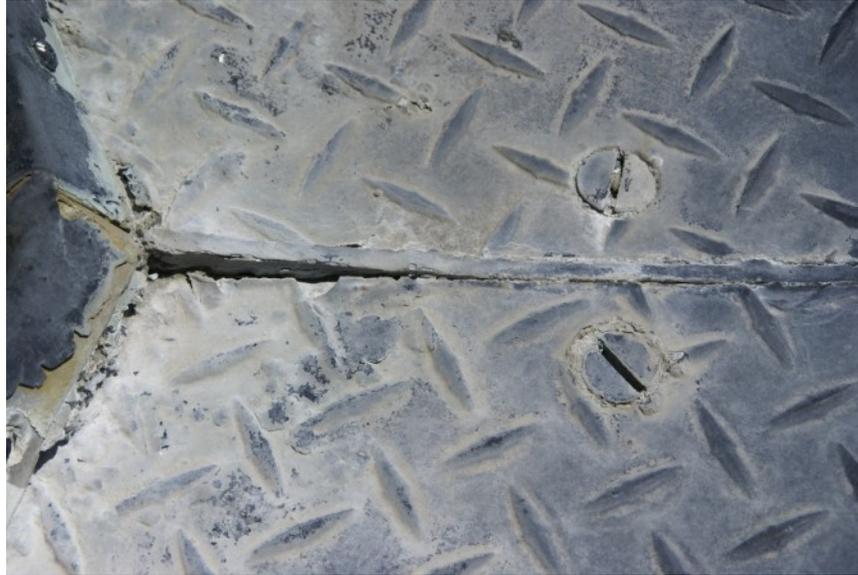
Figure Gallery deck plate-adjointing plate seams.

The gallery deck plates are supported by the bracket system underneath. The brackets are installed under each of the sections of deck plates that meet the adjoining plate. Historically, gaps were filled with soft lead seals to prevent water entry between deck plates. Currently the material used to fill those gaps is in an advance state of deterioration and failure. Thick oxidation staining has contaminated deck plates surfaces and undersides, including metal collar and bracket support systems under the deck plate. Counter-sunk bolts should be sealed as well. These areas should be thoroughly cleaned and re-caulked prior to re-painting.

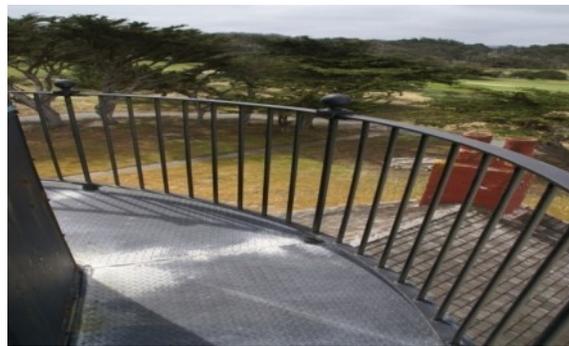
Figure 8: Textured deck plates. Note oxidation of surface.

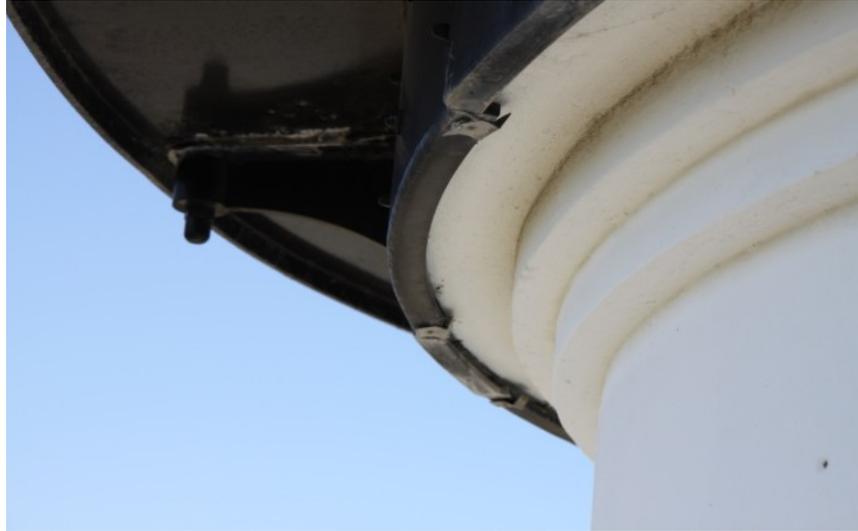
Figure 9: Brick corbel serves as part of lantern room support system.

The entire lantern and lens system is supported by the 1906 concrete cylinder which extends from the Lantern Room to the basement floor. At the top edge of the cylinder is a concrete corbel which extends out to offset the weight of the lantern deck. At the bottom of the roof edge of the cylinder is a lead flashing system to protect from rainwater entry under the cedar shake shingle roof.

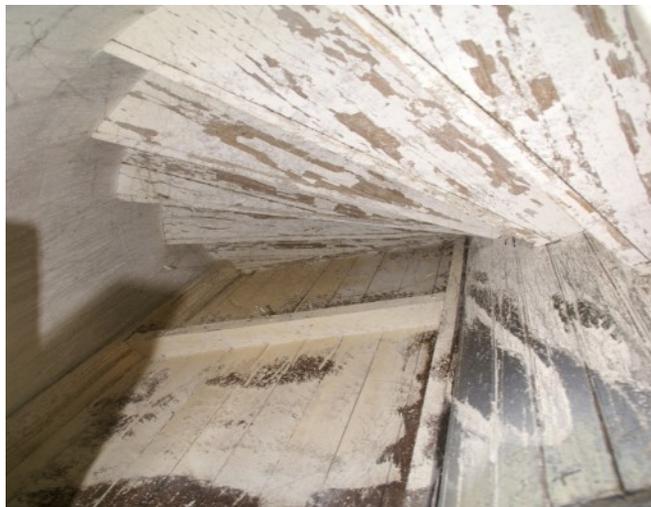
Figure Final/first section of support cylinder located in basement.

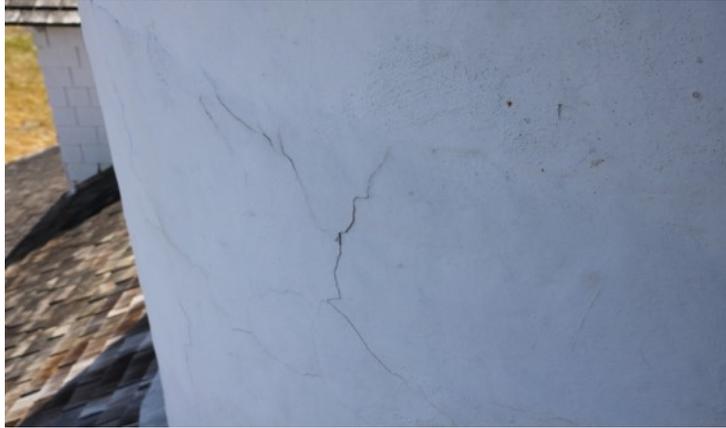
Figure : LANTERN ROOM SUPPORT CYLINDER

There are extensive surface cracks on the support cylinder which are most evident on the north –east elevation. The source and cause or extent of these cracks in the stucco is not known at the time of this report. The width of the cracks range from hairline to 1/4” with significant separation of stucco from the wall. This separation indicates the cracks may in fact be structural in degree. Further selective investigation by qualified architect/structural engineer is highly recommended. Until full- scale repair work can take place it is recommended that careful application of an approved elastomeric caulking material be used to seal cracks from water entry. The application must be performed in a manner which can be easily reversed. There is a corresponding adverse effect of the exterior cracks and related moisture entry on the interior plaster wall of the support cylinder.

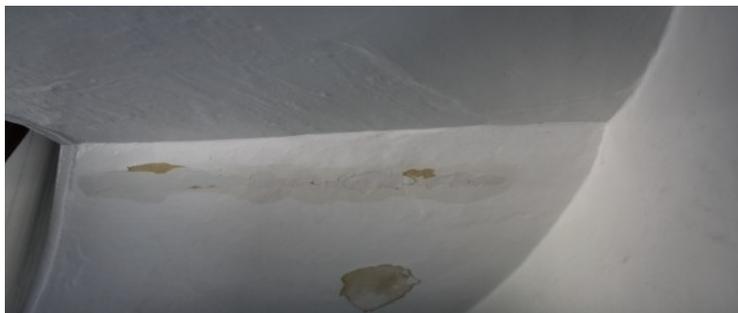
Figure :Moisture stains on inside of lantern support cylinder/stairwell.

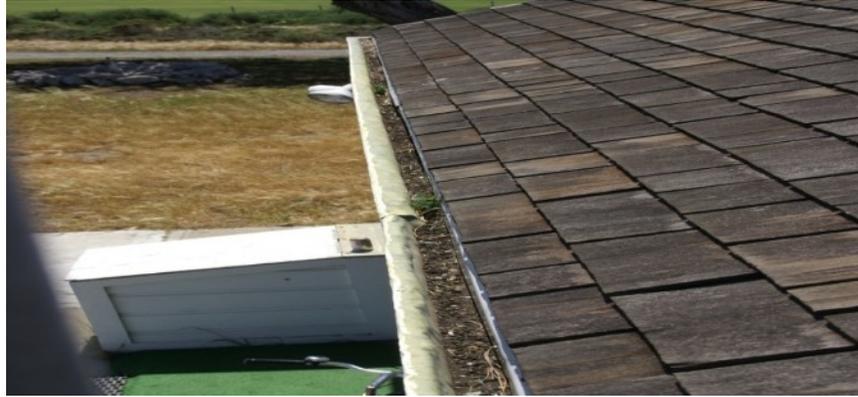
Figure: Gutters filled with debris.

The gutter system along the roofline on the living quarters is metal lined with bronze. There are lead soldered seams. There are several sections of the gutter and downspout system which are poorly connected. Some attachments to the roof have failed. The gutters are shallow and do not carry a large volume of water. Even the same amount of accumulated debris greatly restricts the effectiveness of the gutter system. Volunteers should be used to clean the gutter system and be recruited to check their function on a monthly basis as part of a preventive maintenance plan. **Note: Extensive repair of all gutter and downspouts should be conducted as part of scope of work during replacement of cedar shake shingles.**

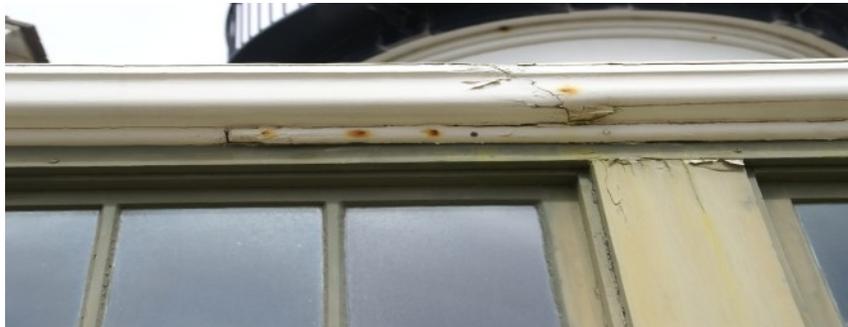
Figure: Gutter system has numerous areas of damage related to failed fasteners.

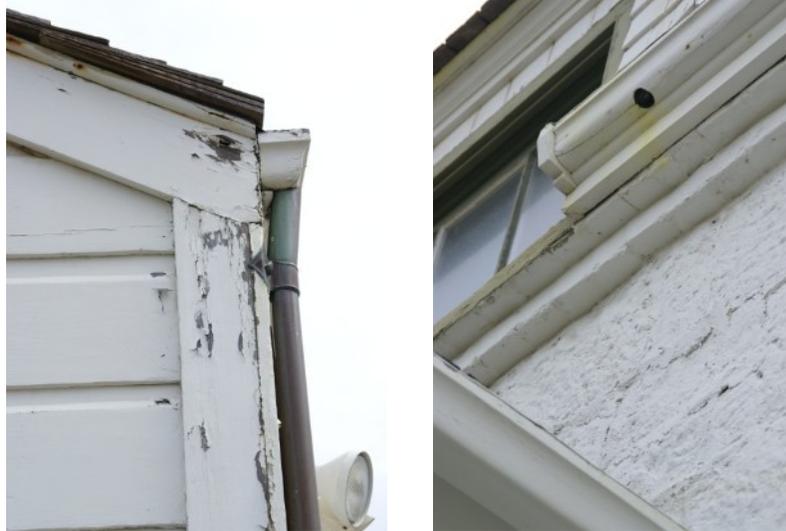
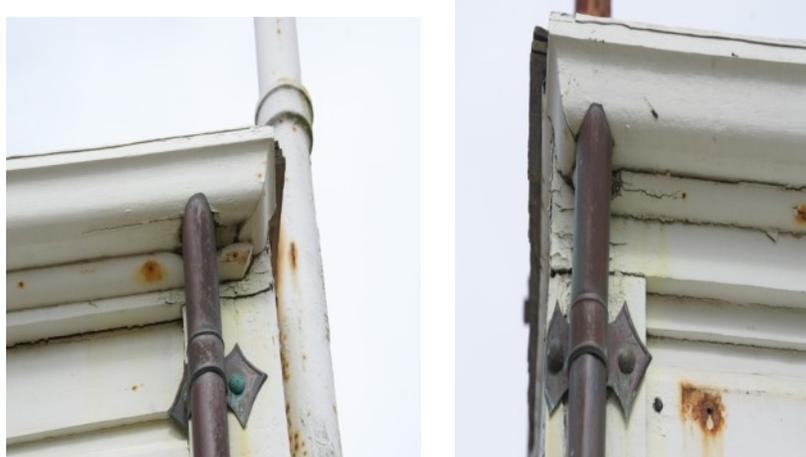
Figures : downspout system.

The entire downspout system is rated as **POOR** and requires comprehensive repairs. Work should be performed a qualified contractors as this downspout design is historic to the building, is constructed of metal and wood and has delicate wood trim. Where possible the copper downspouts should be repaired rather than replaced. There is a section of downspout entirely missing on the front elevation of the lighthouse. Replacement downspouts should be of same material as existing and of equal quality of materials.

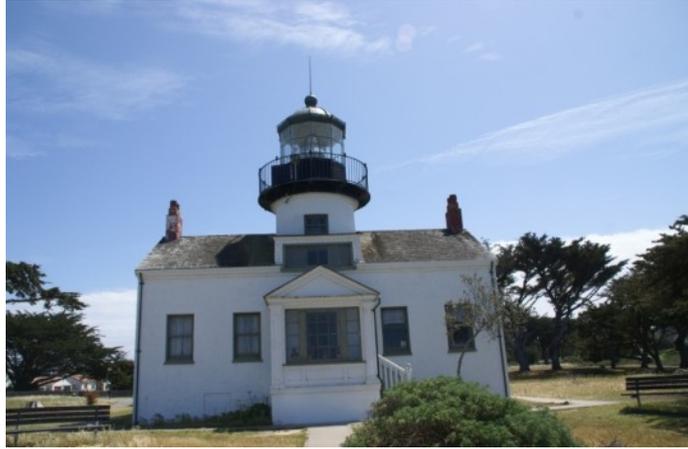
Figure 10: Window system front elevation.

There have been several modifications to the window system on the Point Pinos Lighthouse over its history. The existing windows reflect those numerous changes, including the large window incorporated into the front enclosed porch which was a later but nevertheless historic modification to the west elevation of the lighthouse. Currently 1/1 wood window sashes are in place on the front ground floor of the lighthouse living quarters. Photo documentation clearly indicated that in an earlier period 6/6 double sash windows were in use. It is our recommendation to continue to use all existing windows on the front elevation and to proceed with repairs **immediately**.

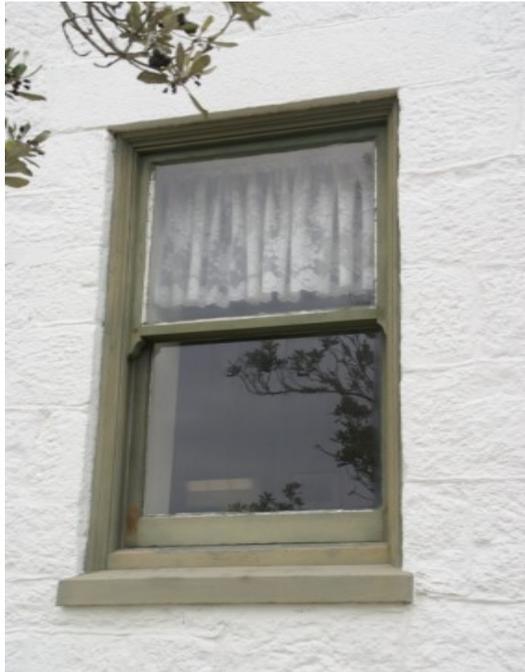
Figure #1.1/1 DOUBLE HUNG SASH WINDOW WEST ELEVATION GOOD to FAIR.

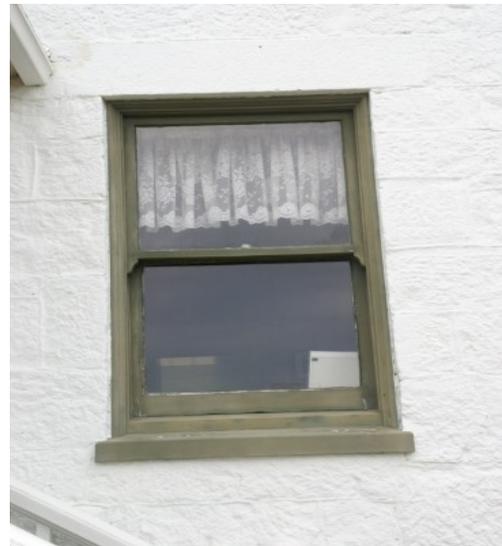
Figure #2.WINDOW SYSTEM WEST ELEVATION GOOD to FAIR.

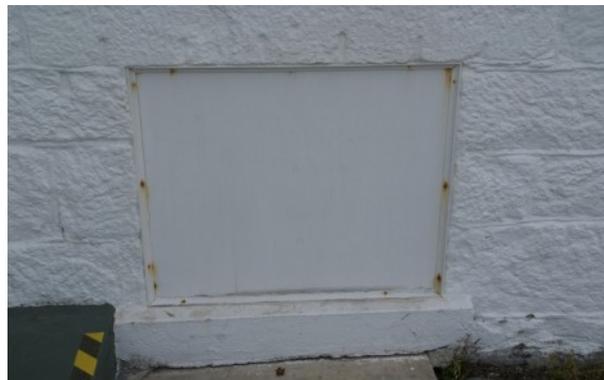
Figure#4 : ENCLOSED BASEMENT WINDOW WEST ELEVATION-POOR.

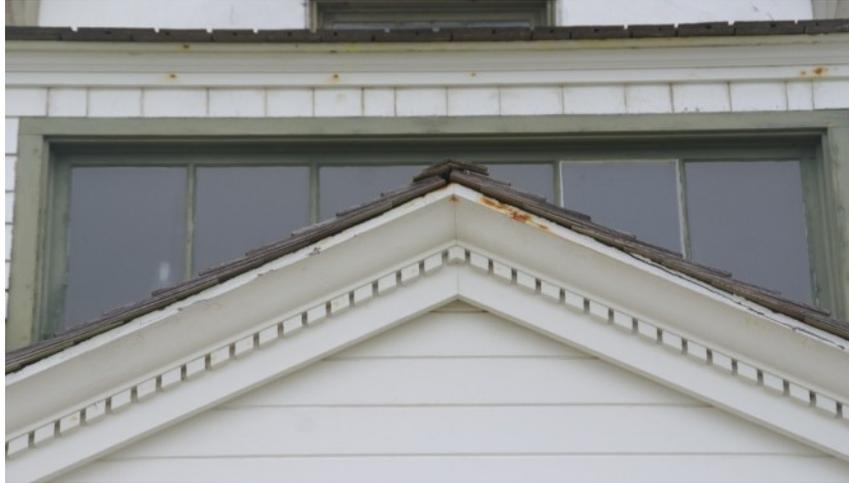
Figure#5 : WATCH ROOM WINDOW-GOOD to FAIR.

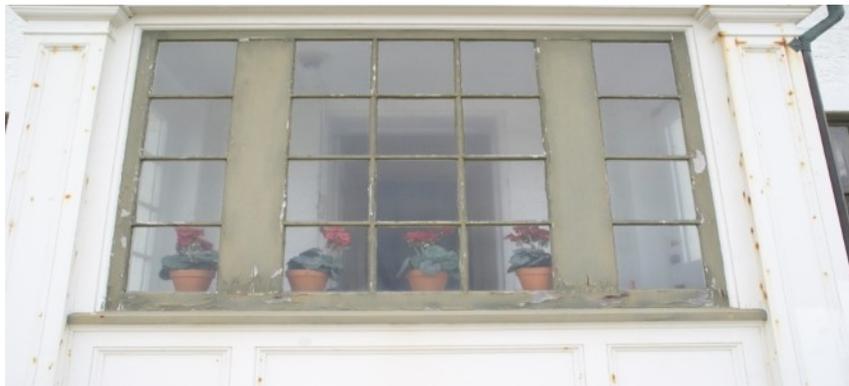
Figure#6 : FRONT PORCH/ENTRANCE WINDOW-GOOD to FAIR.

The 1907 modification of the original design of the Point Pinos lighthouse front porch window system should be treated and preserved as historic. Very careful treatment of failed coating system, glazing and wood repair should be conducted by qualified staff or volunteers. Oxidation stains should be treated to reduce their damaging effect.

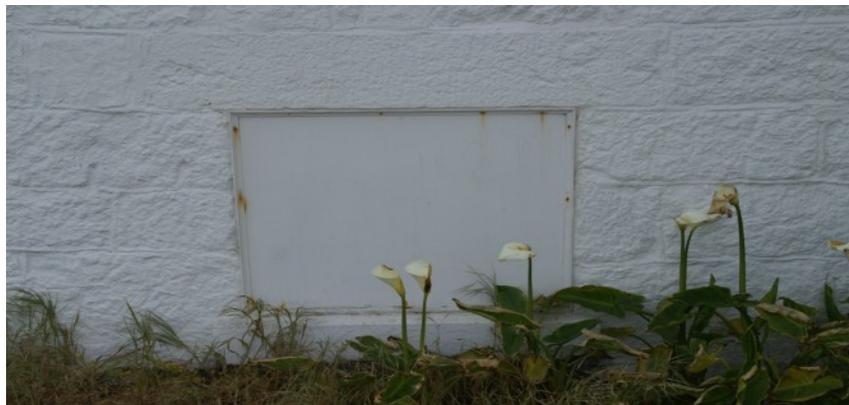
Figure #8: ENCLOSED BASEMENT WINDOW-NORTH-POOR.

Fenestration around historic windows should be repaired rather than replaced where possible. Enclosed basement windows should be restored based on documentation.

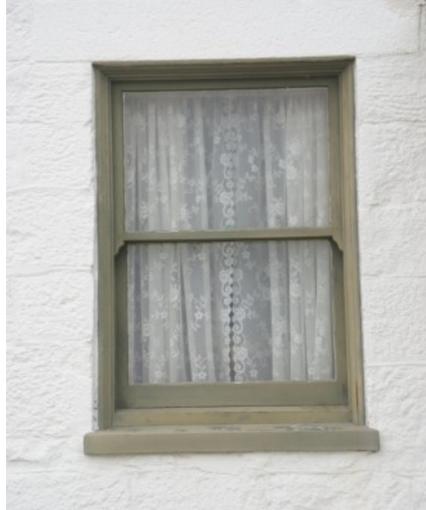
Figure #9-WEST ELEVATION WINDOW-GOOD to FAIR.

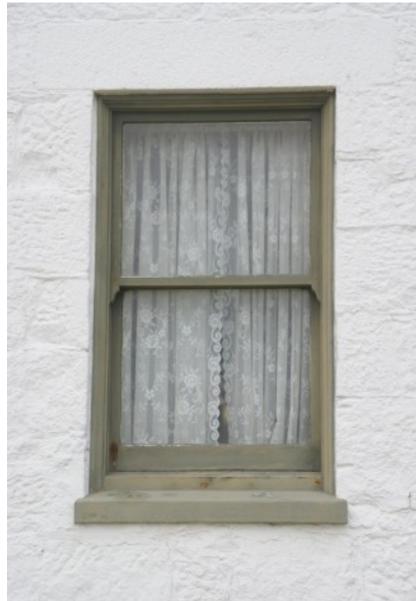
Figure #10: WEST ELEVATION-WINDOW- FAIR to POOR.

Existing windows should be retained, repaired, and restored.

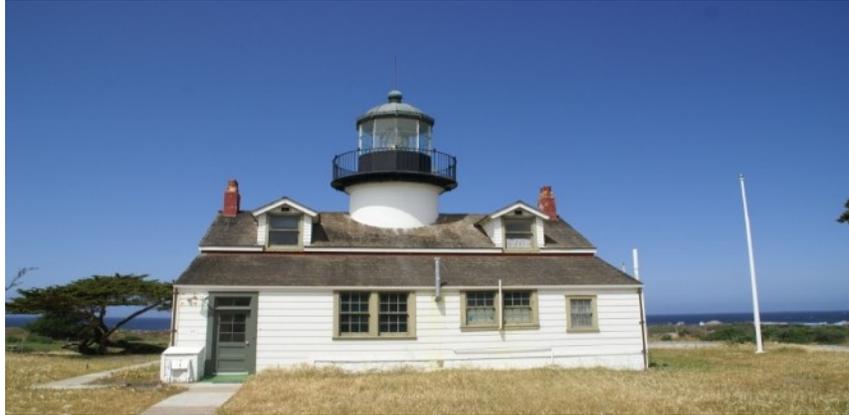
Figure#11: WINDOW SYSTEMS -EAST ELEVATION

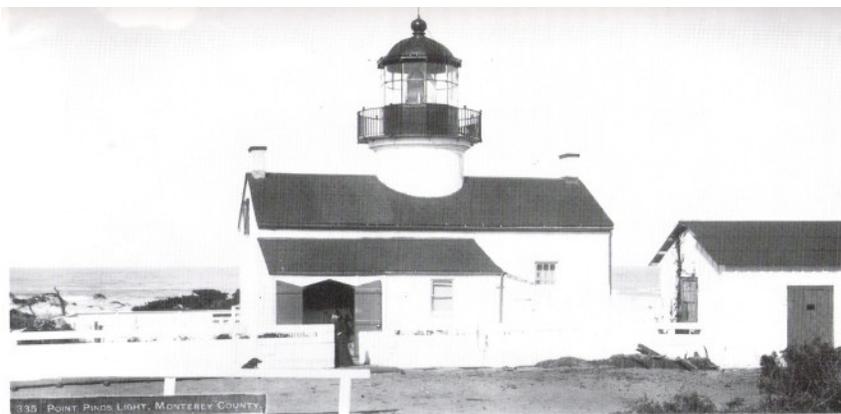
Figure #12: The window system on the rear -east elevation has also been modified over the years.

One of the major changes affecting window design and modifications was the 1907 construction of the attached lean-to addition. The addition also underwent modifications over the years. Existing window systems should be retained and restored as a singular period of interpretation of the lighthouse would require removal of significant historic material and distort the historic changes to the lighthouse. 6/6 windows were also in place during earlier periods of the Point Pinos Lighthouse.

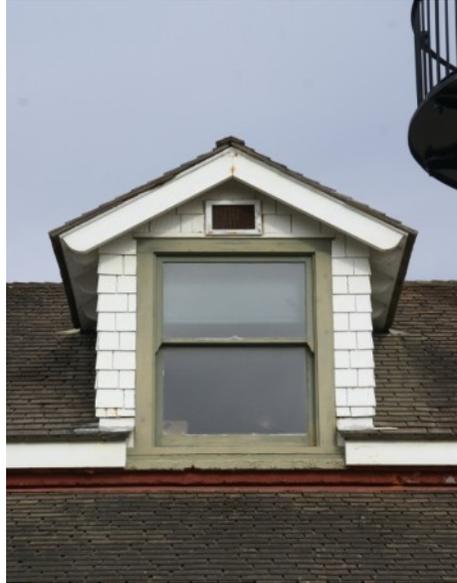
Figure #13: EAST ELEVATION DORMER WINDOWS-FAIR to **POOR**.

Paint analysis should be conducted to determine historic colors prior to removal of existing coating system. Screens in air exchange vents above dormer windows should be repaired as needed.

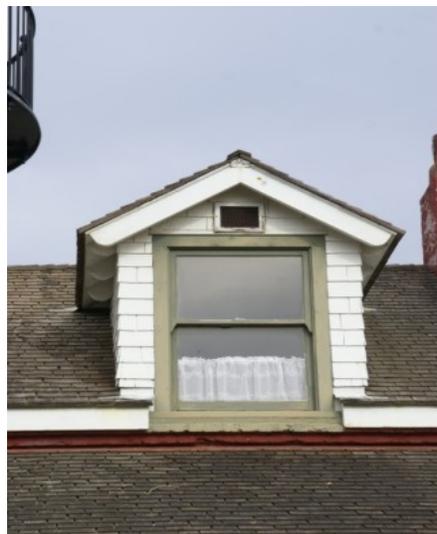
Figure #14: DORMER WINDOW EAST ELEVATION-FAIR to **POOR**.

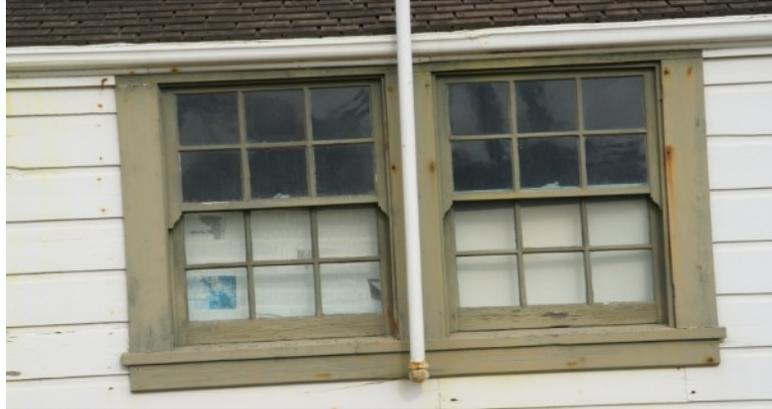
Figure#15 : EAST ELEVATION WINDOWS 6/6 double hung sash windows.-**POOR.**

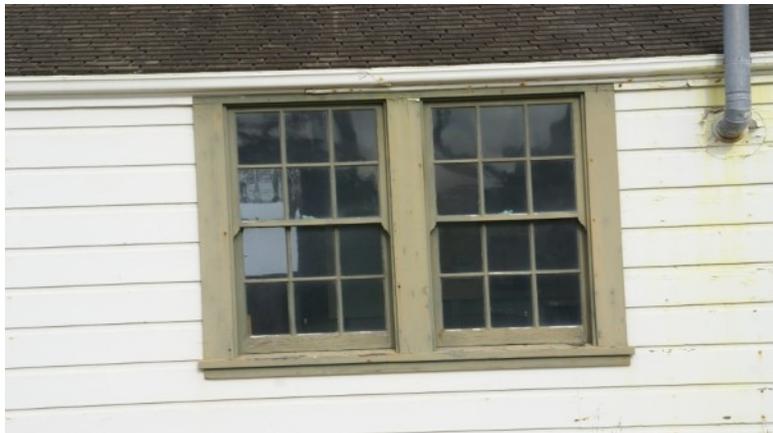
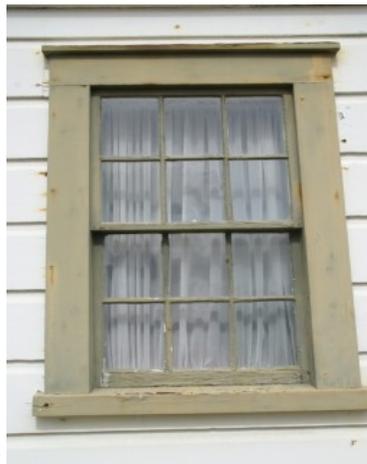
Figure# 16 & 17: 6/6 DOUBLE HUNG SASH
WINDOWS-**POOR.**

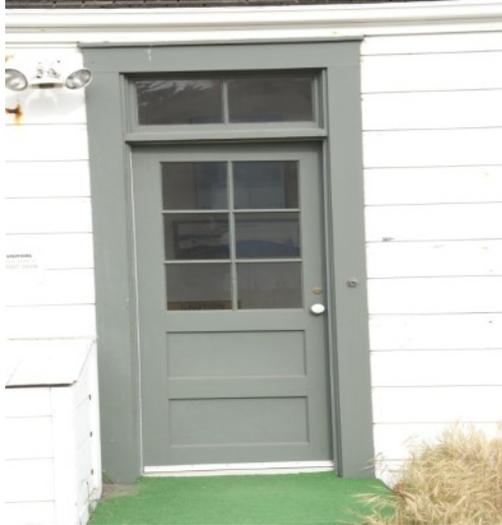
Figure #18: EAST ELEVATION REAR DOOR-GOOD.

The existing rear door is not original to the attached lean-to addition located on the east elevation. The age of the two-panel door is of unknown. The six light door design provides the ability for visitors and staff entering or exiting the door to view opposing traffic. **Note: mass of dry vegetation along side of lap siding and door stoop.**

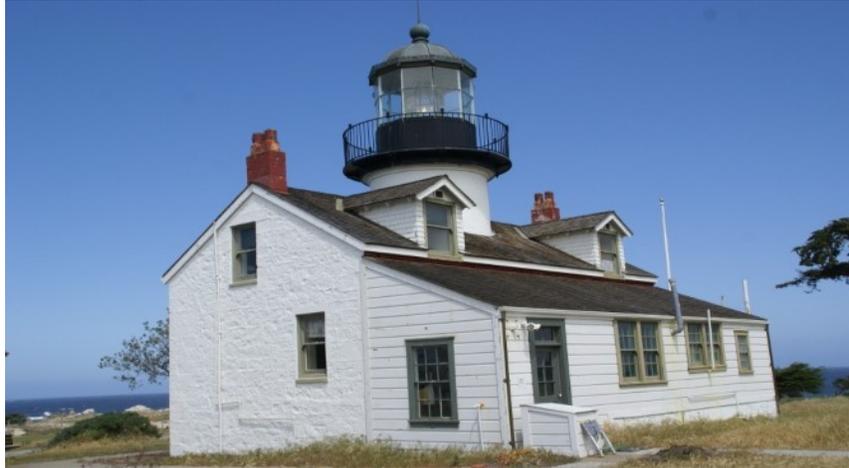
Figure#19: WINDOW SYSTEM-SOUTH ELEVATION

The circa 1900 lower window system on the south elevation reflects the same evolution as the other elevations. Vegetation growth obscures some of the detail of the earlier period captured in the photo below but clearly existing 6/6 windows in place today existed in the earlier photo. One major change is the rear door which was a solid four panel door with transom as opposed to the existing two panel six light door.
