POINT PINOS LIGHTHOUSE

PACIFIC GROVE CALIFORNIA

PRESERVATION PLAN

August 2009

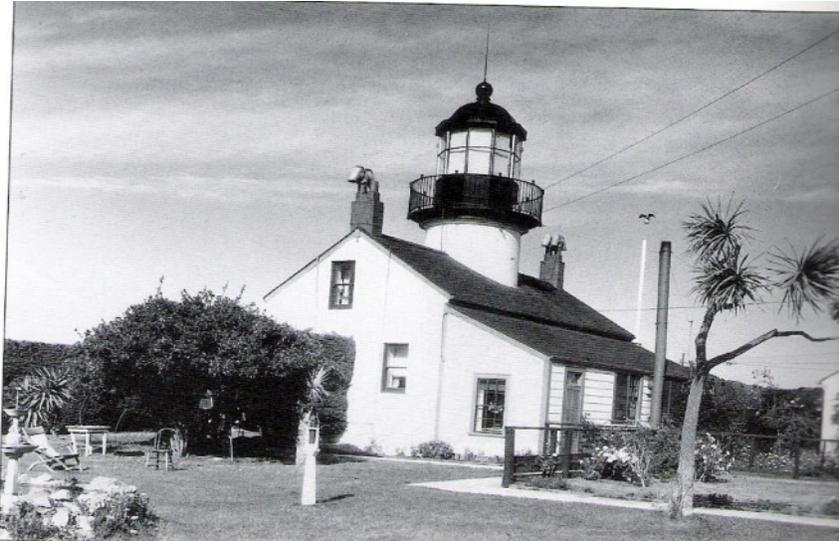
The circa 1900 lower window system on the south elevation reflects the same evolution as the other elevations. Vegetation growth obscures some of the detail of the earlier period captured in the photo below but clearly existing 6/6 windows in place today existed in the earlier photo. One major change is the rear door which was a solid four panel door with transom as opposed to the existing two panel six light door.

Figure#20: South elevation of Point Pinos Light.

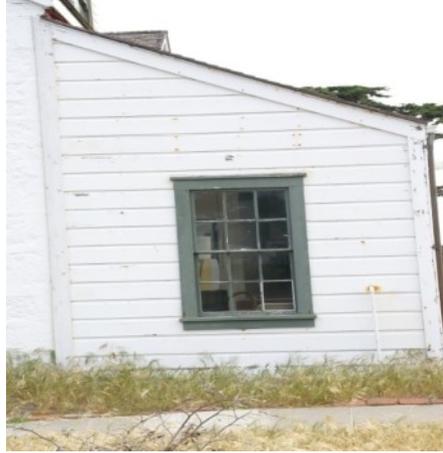
Figure #21: 6/6 DOUBLE HUNG WINDOW -REAR ATTACHMENT-**POOR**.

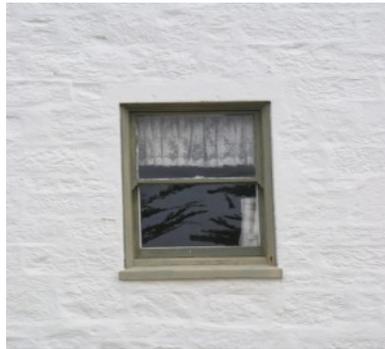
Figure#22: -SOUTH ELEVATION LOWER WINDOW

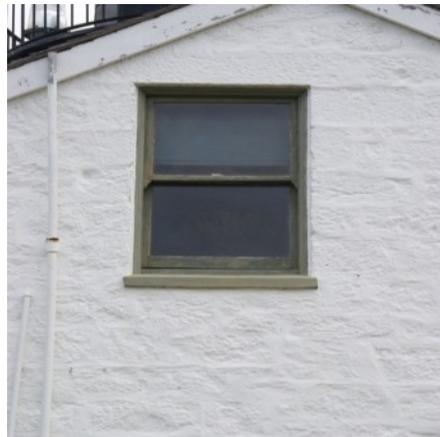
Figure#23 & #24: SOUTH ELEVATION-2nd FLOOR WINDOW-FAIR to **POOR**

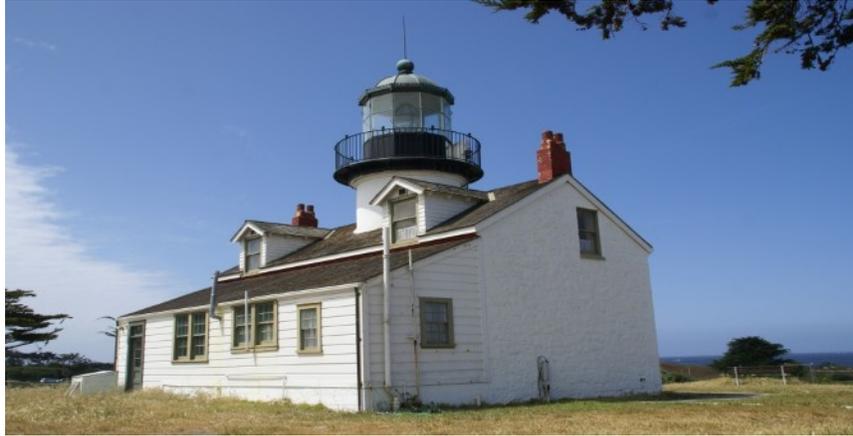
Figure#25: WINDOW SYSTEM NORTH ELEVATION

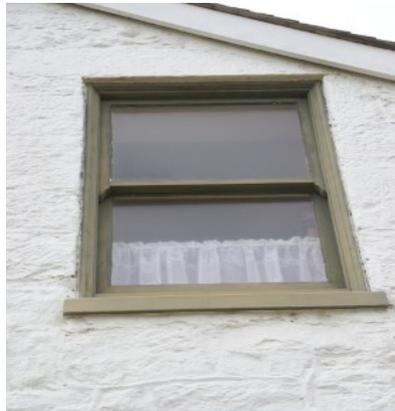
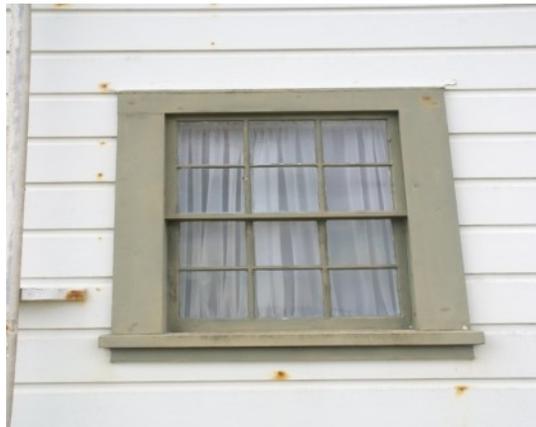
2ND FLOOR WINDOW

FAIR TO POOR.

Figure #26 & 27:-ORIGINAL 6/6 DOUBLE HUNG SASH WINDOW-FAIR to **POOR.**

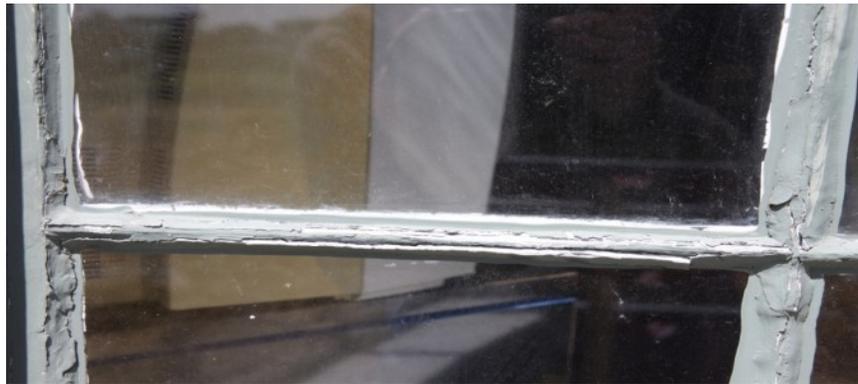
Overall window condition is rated **FAIR** to **POOR**. There is widespread loss of protective coatings, wood deterioration, wood rot, damage to window mullions, and extreme loss of glazing. We have included window repair in the **IMMEDIATE PHASE** of the preservation plan.

Figure #29: LOSS OF WINDOW GLAZING-**POOR**

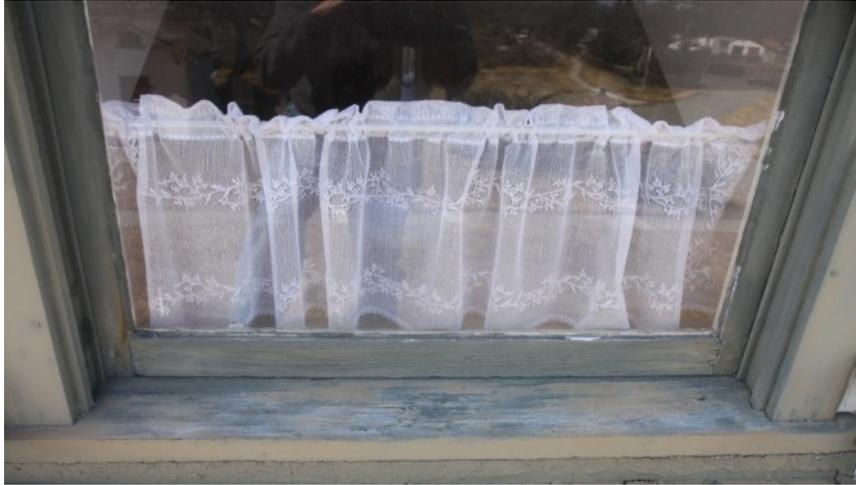
Figure # 30: LOSS OF PROTECTIVE COATINGS -WINDOW SILL-**POOR**

In order to reduce the cost to the City of Pacific Grove, we recommend that volunteers be used to make necessary window repairs to the historic windows at the Point Pinos Lighthouse. While no conditions were rated **CRITICAL** –that would require complete replacement of a window unit, our survey did not include removal of failed coating systems in order to fully analysis existing conditions behind those coatings. Should damage be extensive beyond repair, then replacement fabric must match the historic in terms of quality, size, type, and craftsmanship of mill and installation labor.

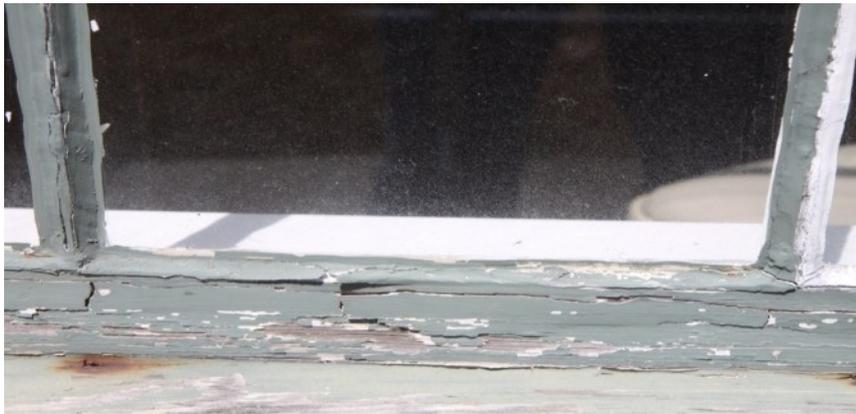
Figure #31: LOSS OF PROTECTIVE COATINGS WINDOW SASH-**POOR**

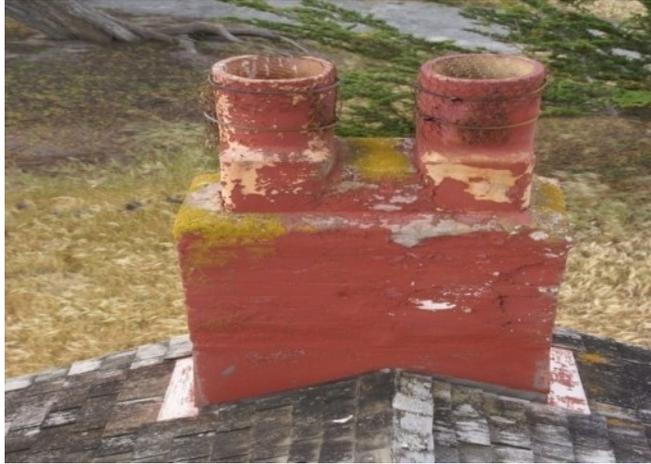
Figure #32 : TYPICAL CONDITION OF CHIMNEY SYSTEM **POOR**.

The overall condition of the chimney system is rated as **POOR**.

There is a widespread **CRITICAL** need to repair all sides of the chimneys as there is comprehensive failure of coating systems, stucco, mortar joints, brick faces, and extensive structural cracks throughout the chimneys. There is fungus contamination. During the last roof installation a stainless steel flashing material was used to provide water tightness between the chimneys and cedar shake shingles. While stainless steel is normally recommended in a hostile coastal environment, its use on a historic structure is inappropriate in areas that are highly visible. Stainless steel unless etched does not receive and retain paint coatings as well. Copper would be a material that was used historically, has longevity in a hostile coastal environment, and does not require painting. Flashing should be tucked into a mortar joint that has been scored and then sealed with appropriate material to prevent water entry behind or between brick and flashing.

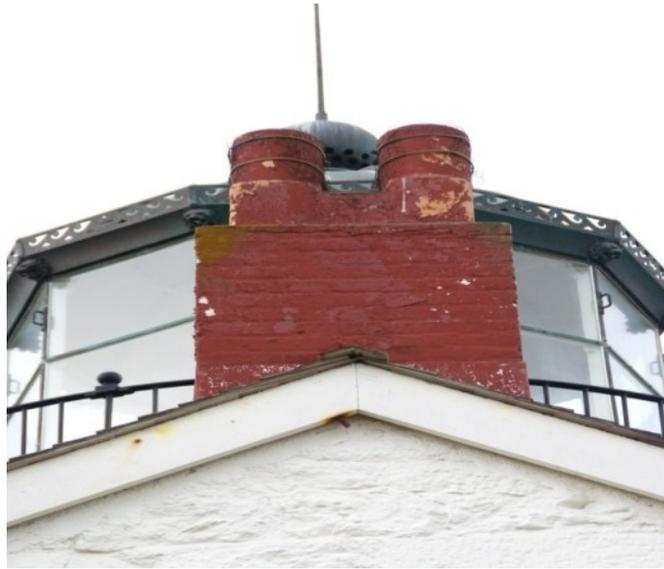
Figure#34 : CHIMNEY SYSTEM

Wire screen has been strapped to the top opening of the clay pipe flue in order to prevent bird entry. The wire and straps are in an advance state of deterioration and are rated as **POOR**. It is recommended that the strapped wire system be replaced by inserting a bronze disc into the flue opening in a manner that it cannot be seen yet will achieve the purpose of preventing bird entry.

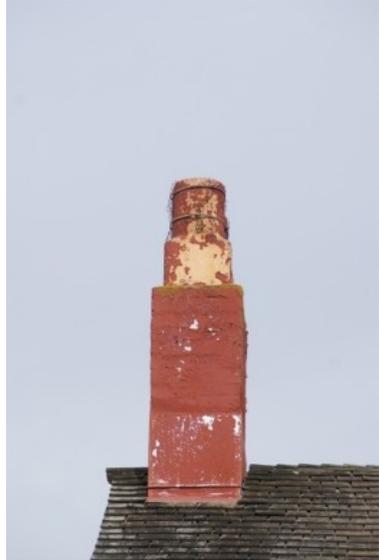
Figure #37: CHIMNEY SYSTEM

Flashing is a painted stainless steel which is not historically or aesthetically appropriate. It is recommended that during the next cedar shake shingle roof replacement, consideration be given to replacing the stainless steel with copper.

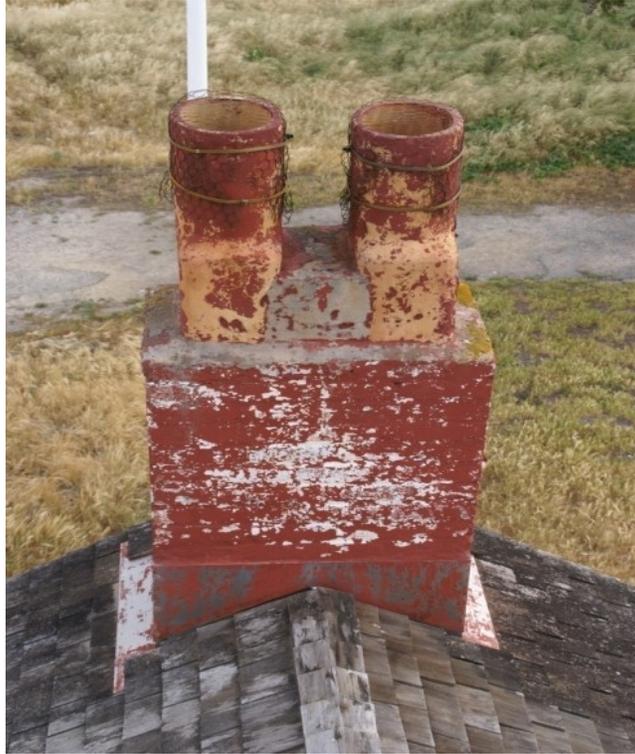
Figure #39: TYPICAL EXISTING CONDITION OF HISTORIC CHIMNEY SYSTEM.

Under no circumstances should the firebox and chimneys ever be used as designed for open flame heating. A qualified electrician should be contracted to determine if a lightning suppression system should be installed on the tops of the chimney system. Staff and /or volunteers should monitor for any leaks around ceilings on interior of living quarter's rooms.

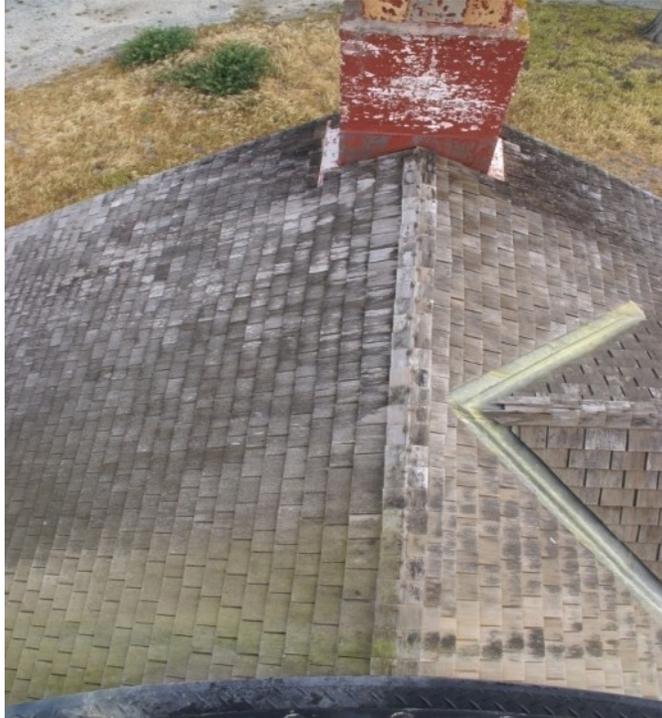
Figure #42 : ROOF SYSTEM-NORTH SECTION

The overall condition of the cedar shake shingle roof system is rated as **POOR**. There is a **SERIOUS** need to replace the roof system in the near future. Cedar shake roof repairs should be conducted soon to correct damage to ridge caps and fasteners in order to prolong the lifespan of the existing roof and defer cost of new roof system until other more **IMMEDIATE** needs are corrected and funding levels improve. When the roof system is scoped for replacement it is recommended that red cedar shake shingles be used and a high-grade stainless steel fastener be used for installation. (316 grade as a minimum grade)

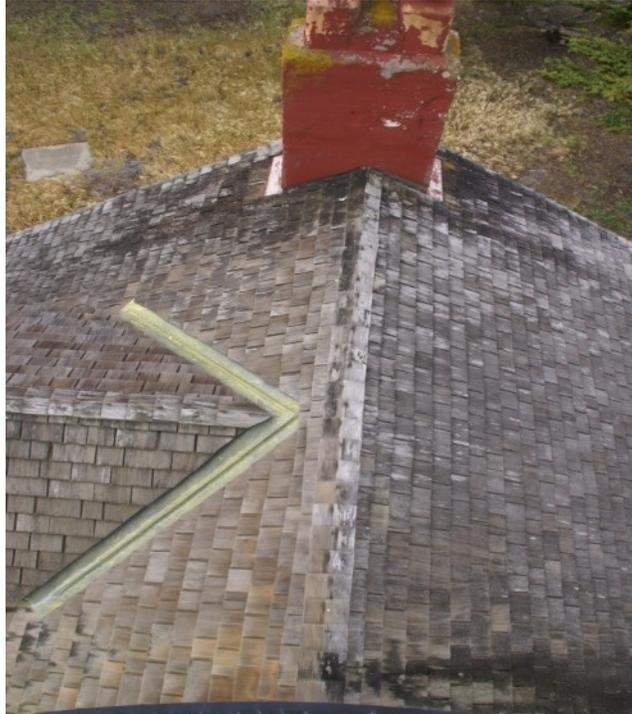
Figure #43: ROOF SYSTEM -SOUTH SECTION

There is widespread mold and fungus contamination which accelerates deterioration of the cedar shake shingles and fasteners. A gentle washing of the roof system with a mild mixture of water and bleach is recommended to reduce the concentration of mold and fungus.

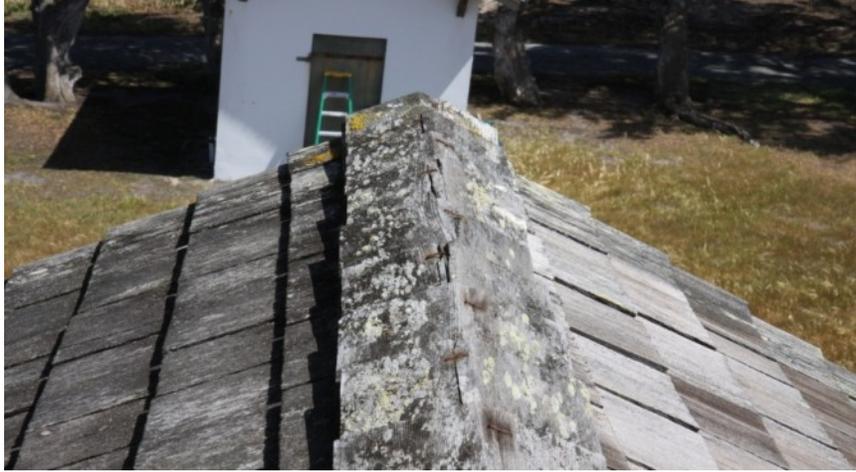
Figure #44: ROOF RIDGE CAP

Ridge caps have a high volume of fungus and mold contamination, have missing ridge cap shingles and have a great number of loose ridge cap shingles. These deficiencies should be corrected ASAP in order to prolong the limited remaining life span of the existing roof system.

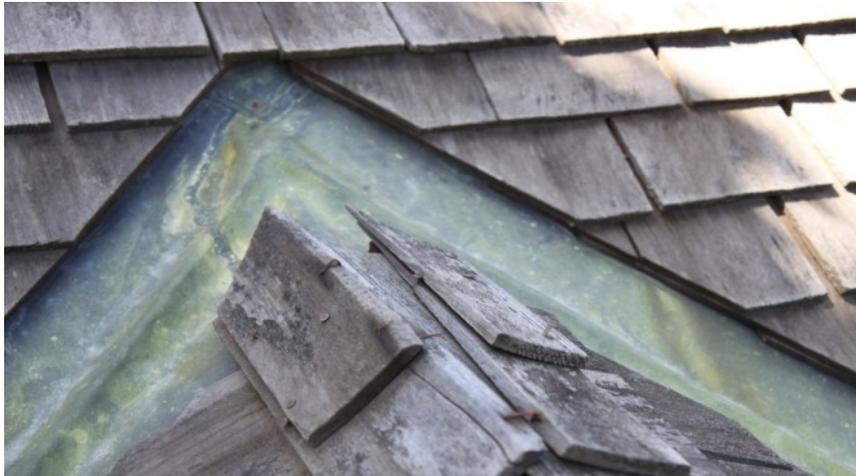
Figure #45 : RIDGE CAP DORMERS-NOTE MISSING RIDGE CAP.

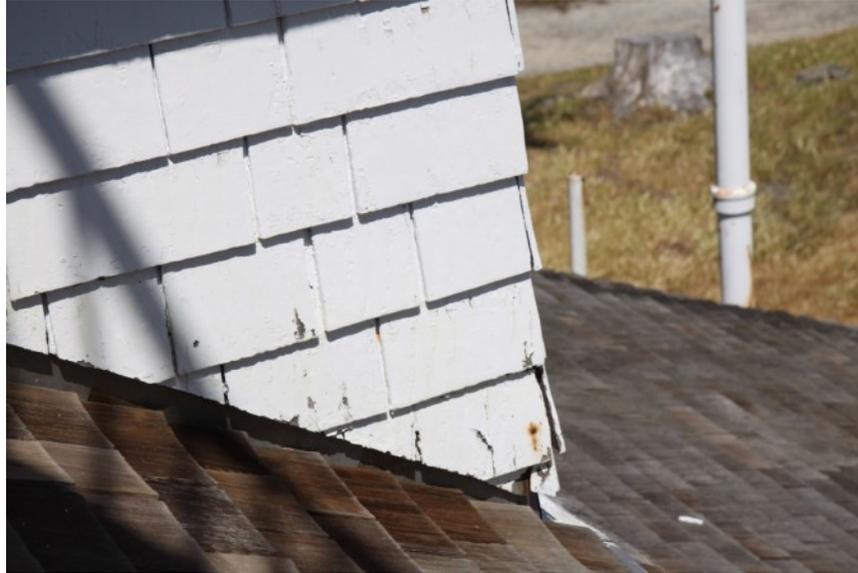
Figure #46: FLASHING AND SHINGLE SIDING DORMERS

The vertical cedar shake shingles installed on the dormers are rated **GOOD** to **POOR**. There are numerous split shingles particularly along the edge nearest the cedar shake shingle roof system and valleys. Rust oxidation stains from failed fasteners are also prevalent. Split shingles should be sealed with appropriate material until funding can provide replacements. Oxidized fasteners should be sprayed with rust inhibitors, neutralized, and then primed and painted.

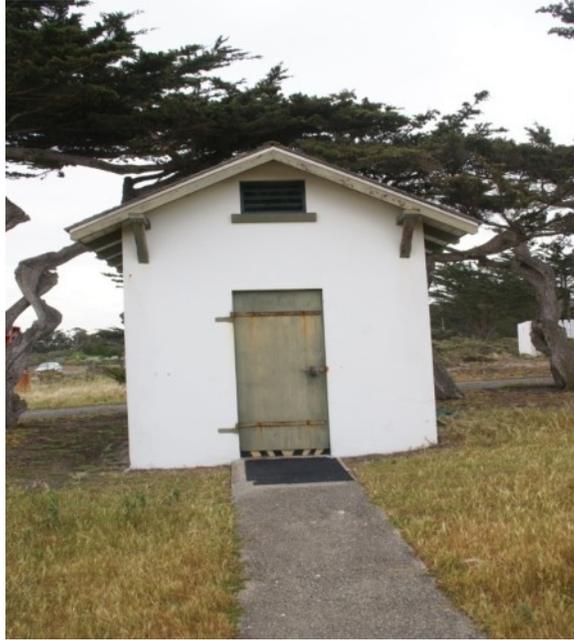
Figure #47: Historic oil house-front-west elevation.

The fuel storage building is rated **GOOD** to **POOR** and is constructed of stucco over fired brick with a wood truss roof system covered in cedar shake shingles. There are Louvre air vents on the west and east roof lines of the fuel storage building. There are corresponding air exchange vent openings along the floor area on the north and south which have been covered over by the exterior coat of stucco. These vent systems were designed and constructed within the walls to provide adequate air exchange in the fuel storage building interior. There is a replacement door hung on strap hinges. A concrete walkway connects the fuel storage building to the lighthouse. There are superficial cracks along the south, east, and north stucco walls. There is wood rot on several of the rafter tails on the roof system and several roof deck planks have rot and /or have been repaired with replacement boards. All wood surfaces which have been painted have widespread coating failure.

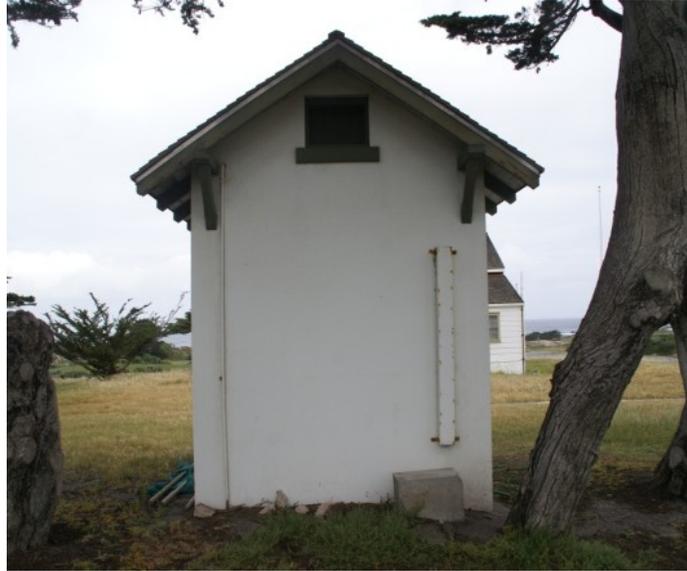
Figure #48: Historic oil house-rear-east elevation.

There are two major modifications mounted on the east elevation of the fuel storage building. One is a run of electrical metal conduit and the other is a metal elongated box of unknown purpose. It may be related to the Loran equipment currently in use in the fuel storage building as a backup navigational system.

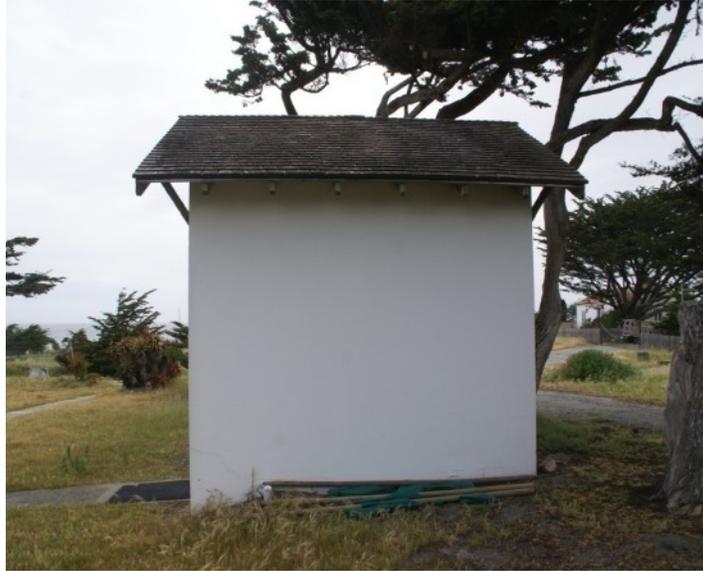
Figure #49: SOUTH ELEVATION

There are surface cracks in the protective stucco on both elevations. Cracks should be measured, recorded by volunteers, and monitored for activity that results in change of measurements. Temporary measures should include filling cracks with elastomeric caulking to prevent additional moisture entry between stucco and brick inner wall.

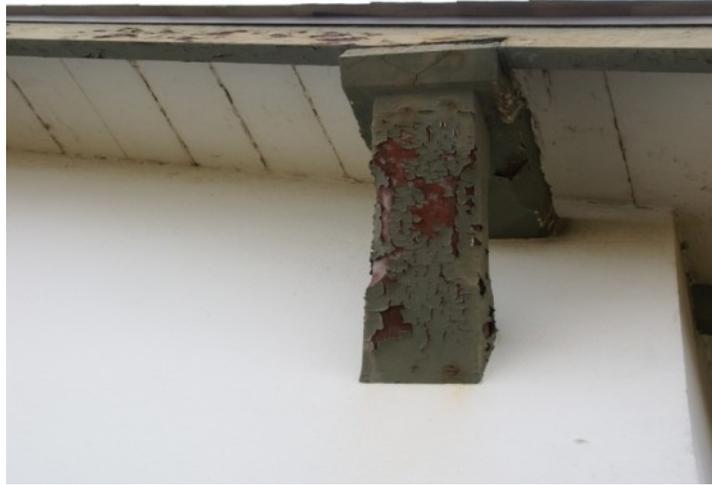
Figure# 51: FUEL STORAGE BUILDING- ROOF SUPPORT BRACKET.

The wood fabric on the exterior of the Fuel Storage Building is rated as **FAIR**. There is widespread coating failure, cracks, wood rot, and possible termite damage. A paint color analysis should be conducted prior to the removal of failed coatings. Failed coating systems should be scrapped off, wood sanded, gaps, cracks, and hollows filled with appropriate wood filler. Repaired and sanded areas should be primed and re-coated with paint colors based on paint color analysis.

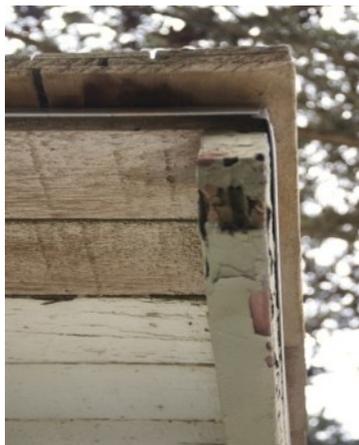
Figure #52: Example of wood rot on rafter tail.

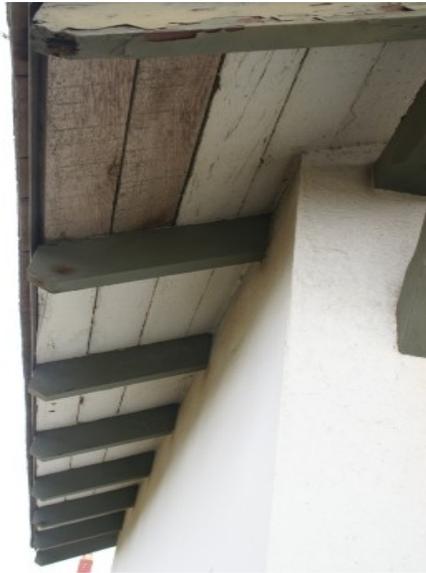
Figure#53: Example of roof deck plank which has been installed to replace damaged historic fabric.

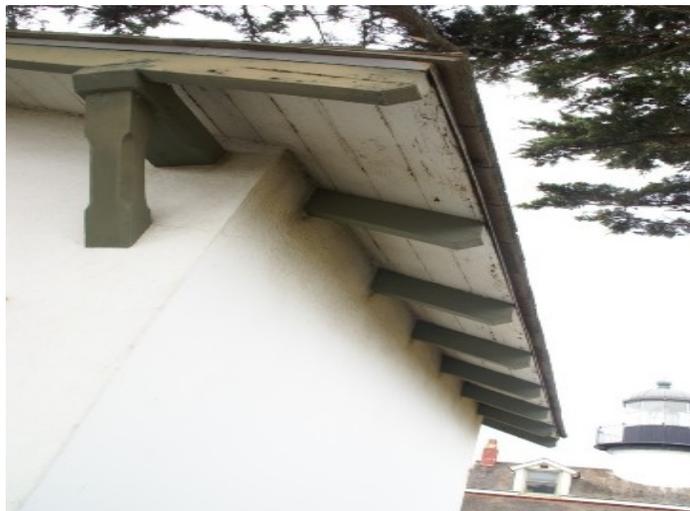
Figure #54: Example of severe crack in fascia board.

Wood roof system should be scrapped, sanded, carefully repaired, and painted based on paint color analysis. This scope of work can be conducted by volunteers as long as they were mask and protective coating and contain, collect, and dispose of all paint debris.

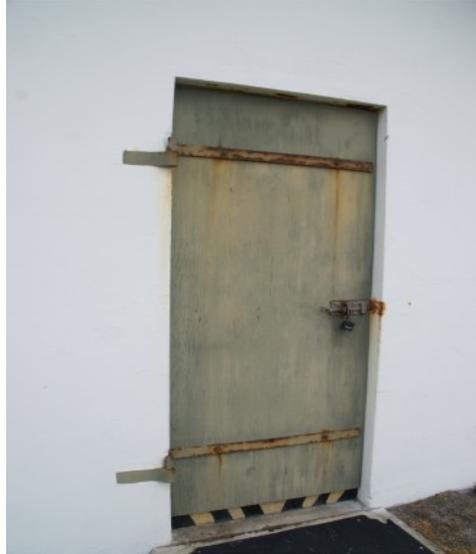
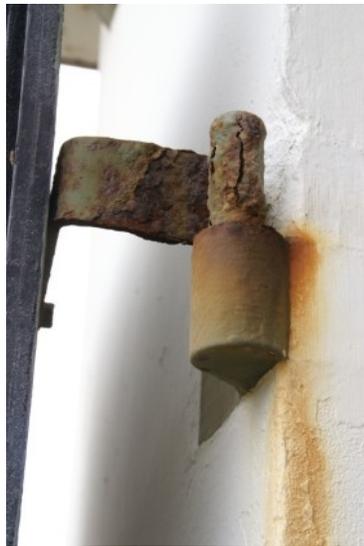
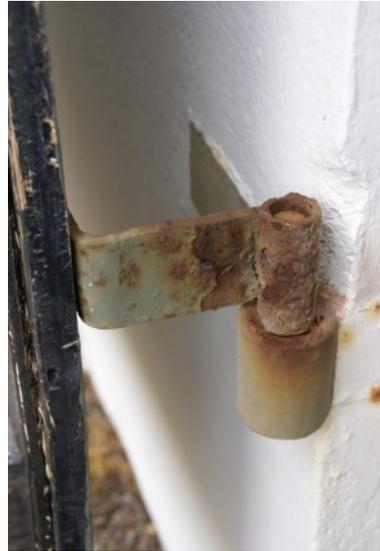
Figure #55, #56, #57: TYPICAL CONDITIONS DOOR.

Typical condition of iron hinge and strap system used to support and operate door. Advanced deterioration of metal requires replacement with matching materials and design. Door is a plywood replacement, is non-historic and inappropriate, and should be replaced with a ductile steel door based on documentation to match original iron door.

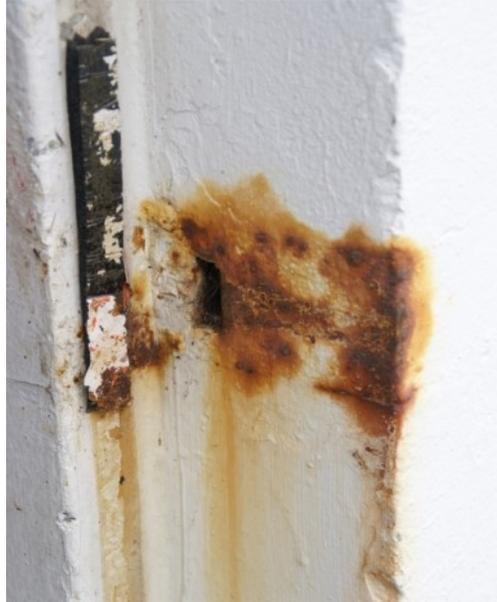
Figure #58 & #59: Typical conditions of iron door frame.

The doorframe is constructed inside the brick and stucco wall. There is severe oxidation of the ironwork in numerous sections of the frame. These areas should be sanded/cleaned to bare metal, treated with rust inhibitors, primed, and painted based on paint color analysis.

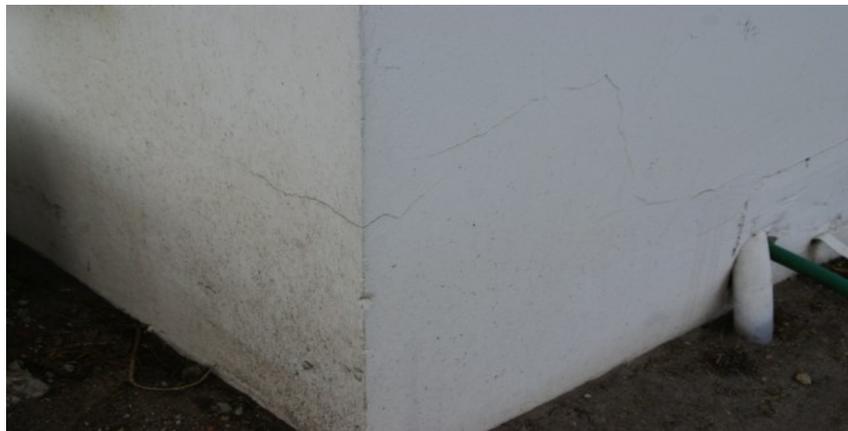
Figure # 60 & #61 : Showing cracks in the exterior stucco walls.

There are numerous hairline cracks located on several areas of the stucco walls. The source of these cracks is unknown. Staff/volunteers should measure and monitor cracks to determine if they are active and ongoing or a result of past building settling or tree root activity. Cracks should be sealed with caulking material to prevent additional water entry.

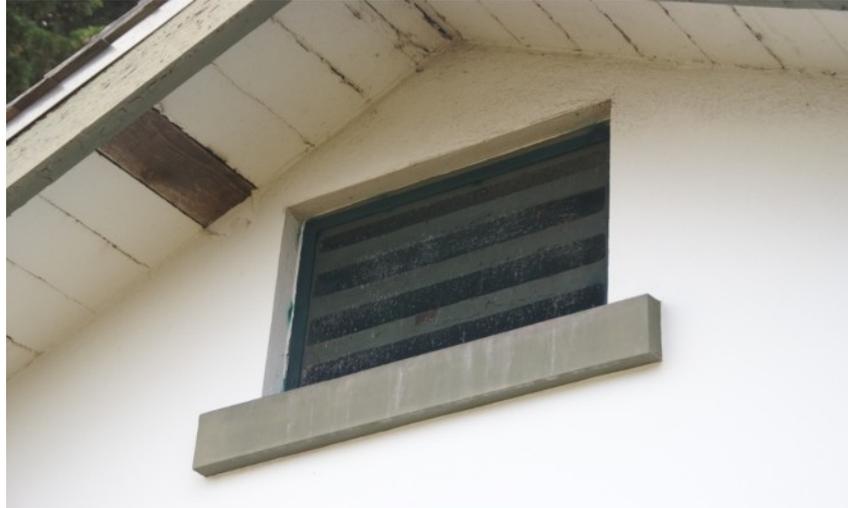
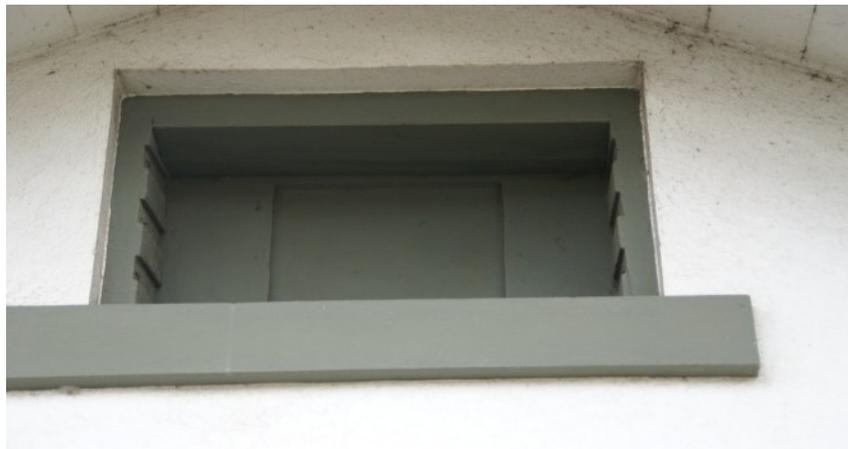
Figure # 62 & # 63 : Fuel Storage Building air vents.

The Louvre air vents located on the east and west rooflines provided a vital role in working in conjunction with those along the bottom of the walls to produce air exchange within the interior of the Fuel Storage Building. Currently, the vent system located on the east wall has been modified by the removal of the louvers and a ply-board panel installed to close the vent off from the inside. This modification is related to the use of Loran equipment inside the Fuel Storage Building. When and if that equipment is removed the vent system should be restored to match original. Copper screens should be installed to prevent insect entry.

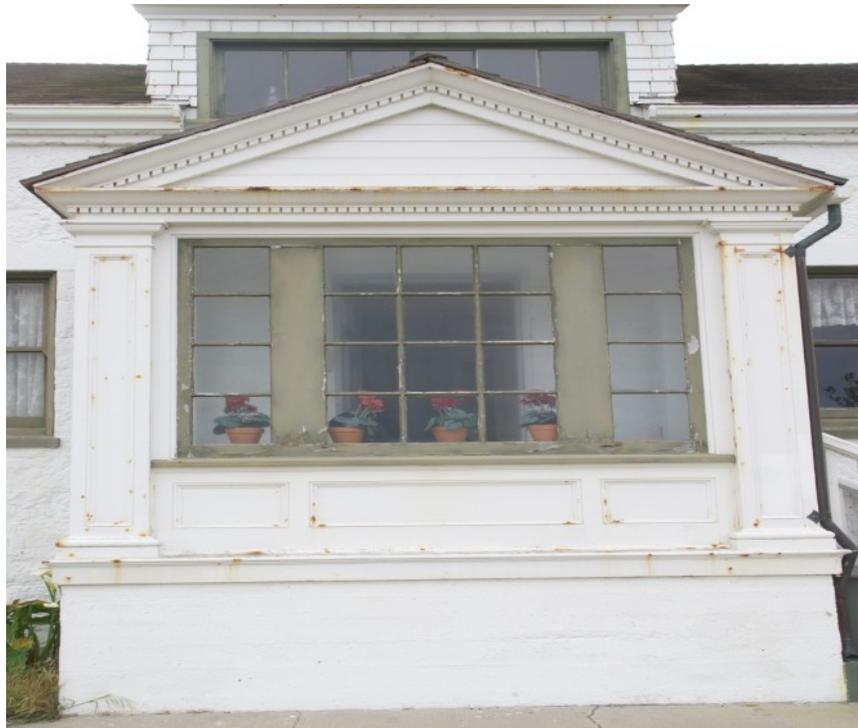
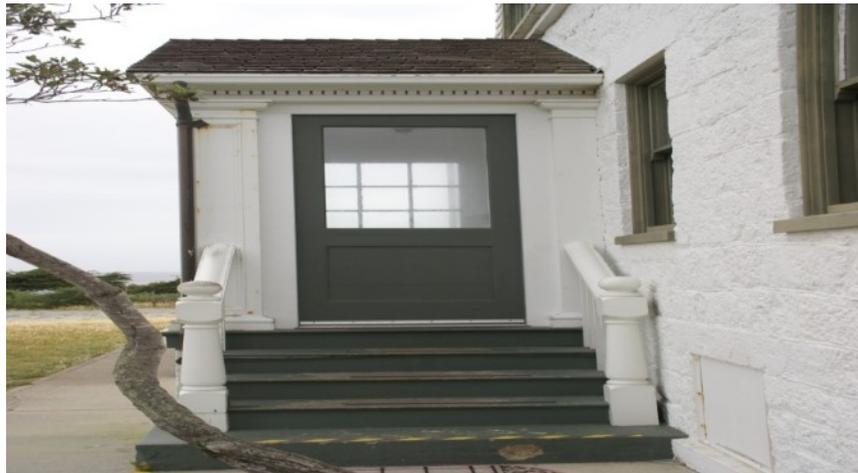
Figure #64 & # 65: Front entrance porch

The entrance steps have been rated **FAIR** to **POOR**. There are small areas of spalled concrete requiring patchwork to prevent additional damage and moisture entry.

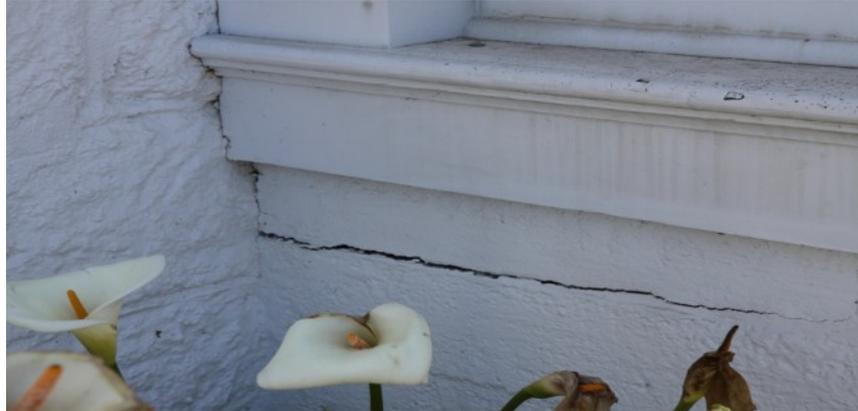
Figure # 66:

The horizontal crack in historic fabric along the north side of the front porch is extensive and of unknown source. Staff and or volunteers should measure length, width, and record. An elastomeric caulking should be used to fill the gap until repairs can be made.

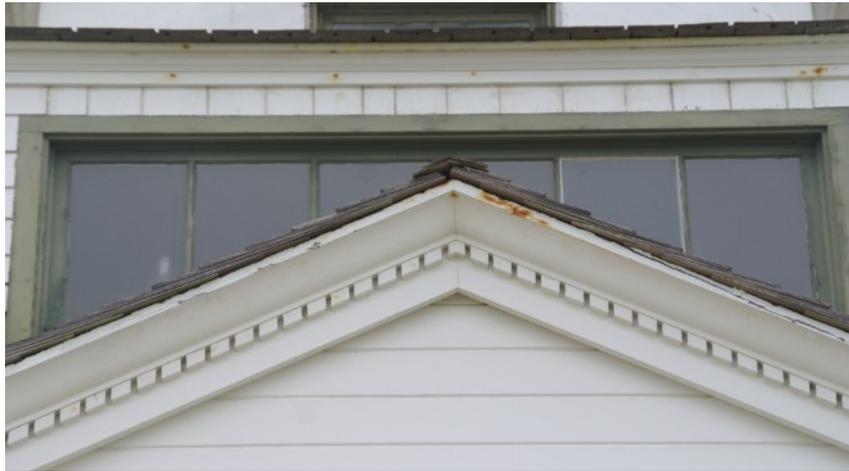
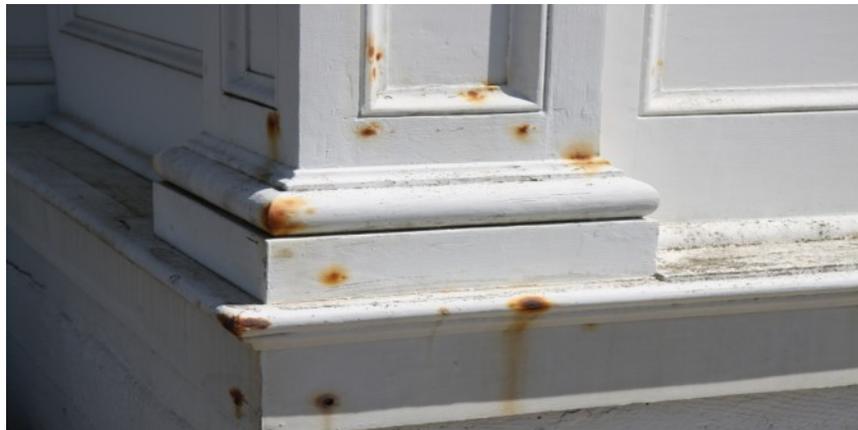
Figure # 67 & # 68 :

There is a high degree of decorative fenestration on the front porch of the lighthouse. The fenestration has been rated as **FAIR** to **POOR**. There is widespread oxidation stains and loss of protective coatings. These conditions could be repaired by volunteers to reduce City of Pacific Grove cost.

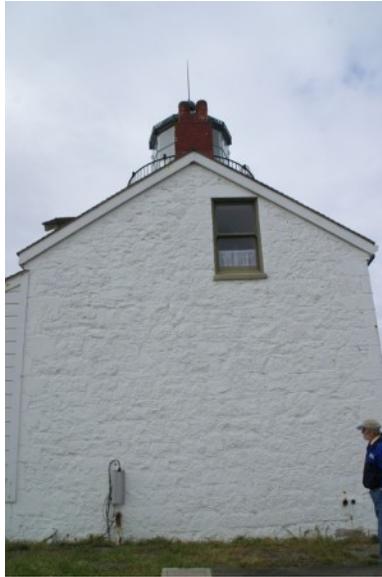
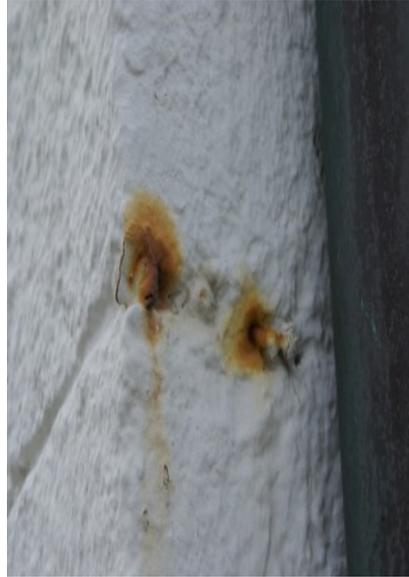
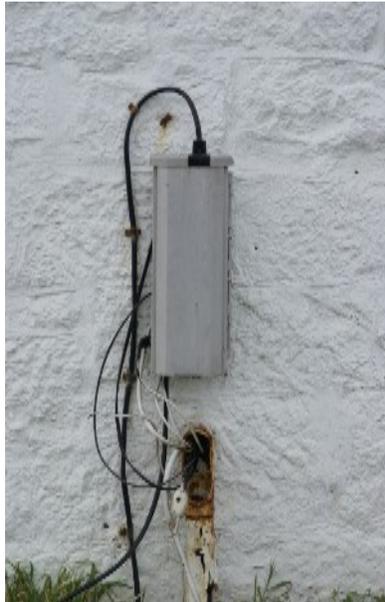
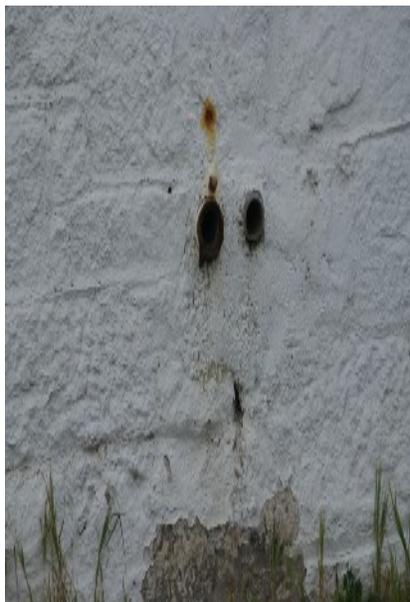
Figure #69, #70, #71, #72:

Outdated equipment, piping, and fasteners should be carefully removed from the exterior. Holes and damage should be filled in with appropriate material and painted with colors to blend in with adjoining surfaces.

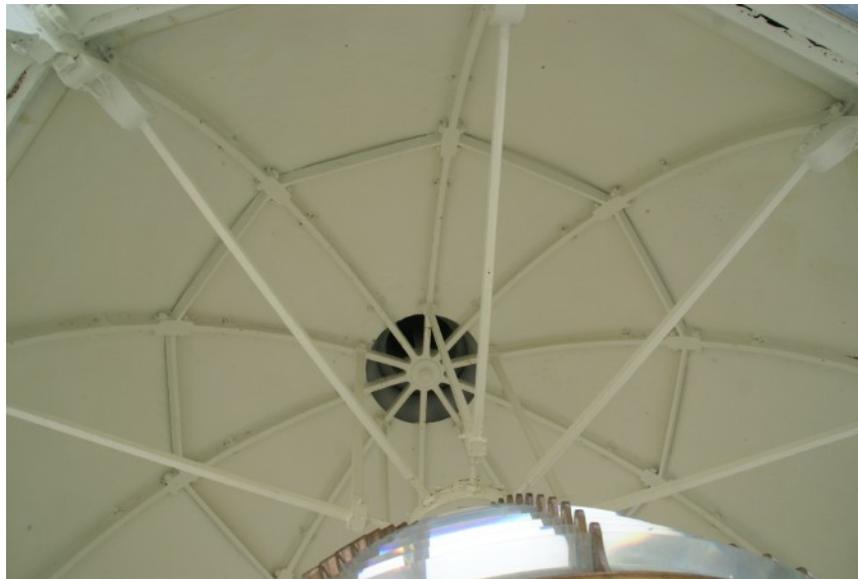
Figure #1: Lantern Room canopy and framing.

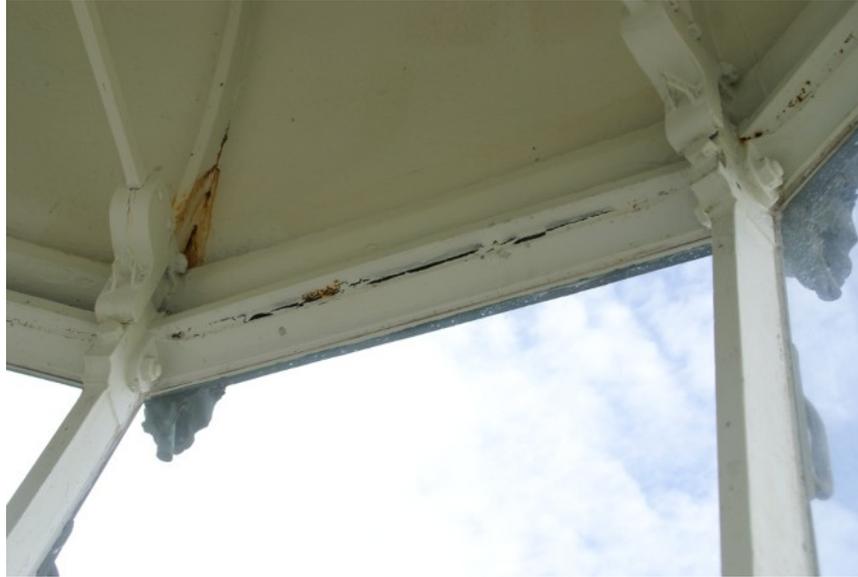
Figure #2: LANTERN ROOM CANOPY.

There are numerous indications of water leaks and or damage in the canopy of the Point Pinos Lantern Room. Rust stains between the bronze canopy (dome) and the iron framework suggest a break in the exterior canopy seam that has allowed water entry between the two components. A water test should be performed with staff and or volunteers inside the lantern room to monitor possible water leak areas. There is also a breakdown of caulking material that was used to fill gaps and cracks along the horizontal cross-tie bracing the vertical stiles. It is not known when or why this material was installed. It should be removed to determine the extent of the gaps and or cracks in order to develop a scope of work for repair. If the material was simply to fill natural gaps between the two components it should be re-placed with an elastomeric caulking material. If the material was used to fill in cracks, the cracks should be repaired.

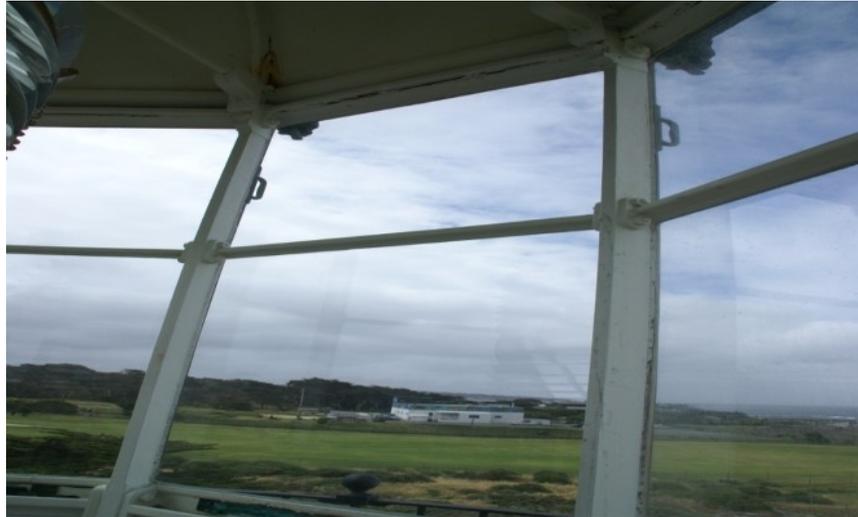
Figure # 3: STORM PANES.

The glass storm panes are secured in place by the use of bronze astragals fastened to the exterior stile. A caulking material was installed to attempt to provide a watertight seal to prevent water entry and entrapment between the bronze astragal, glass and iron stile. The caulking is in a state of failure and has allowed moisture into spaces between the components. The use of dissimilar metals in reaction to chlorides and moisture produce a catalytic reaction with a resultant corrosive process on the iron metal. Left unchecked that corrosive process will accelerate to a level of metal exfoliation which in turn will produce a high level of stress on the glass storm panes and bronze astragals. Rust staining is evident in several areas of the storm panes. More importantly, there is obvious stress related bending of the exterior bronze astragals. These areas are addressed in Specific Recommendations section and are part of the Immediate Treatment phase of work.

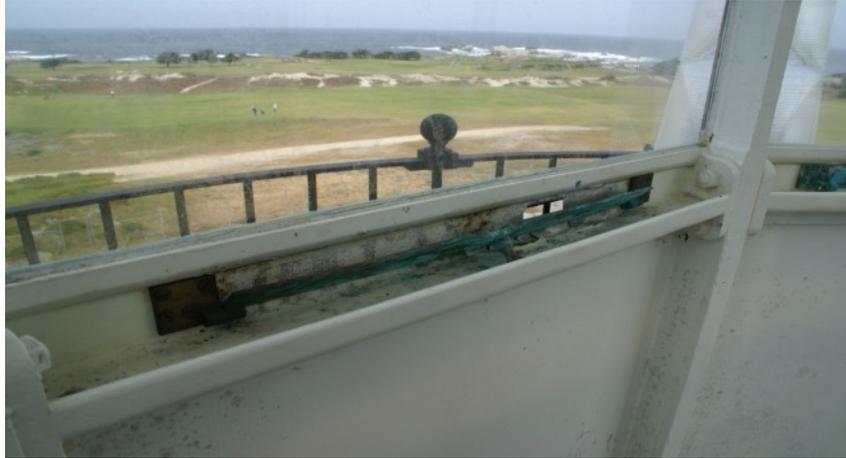
Figure #4: Bronze air vents.

The bronze vent systems in the Point Pinos Lantern Room are rated **FAIR** to **POOR** due to the overall deterioration and lack of maintenance. The repair and restoration of all vents should be undertaken carefully in order that no damage to historic fabric occurs.

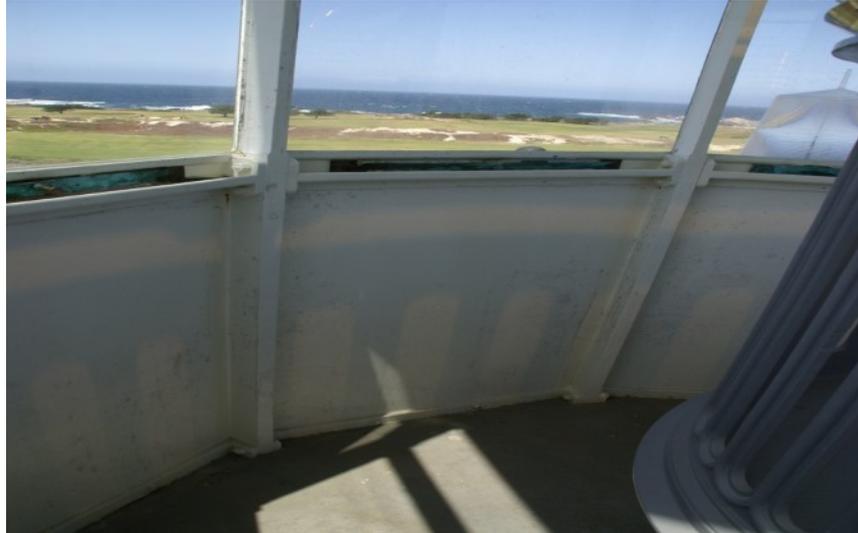
Figure #5: FLAT IRON LANTERN ROOM WALL PANELS.

The bottom section of the Point Pinos Lantern Room is constructed with flat iron plates secured in place by mechanical fasteners. The interior wall panels are rated **GOOD** to **POOR** based on our April site visit. There is **SERIOUS** deterioration of numerous areas of the wall panel on the interior surfaces. More significant is the **CRITICAL** need to stabilize and repair the areas with advanced exfoliation taking place as indicated in photographs below.

Due to the degree and extent of damage to the Lantern Room we recommend that this area receive the most immediate attention and funds to correct. While Staff and volunteers can remove failed coating systems clean exfoliated metal, and use selected metal filler and prime and repaint safely, the replacement of extensively damaged metal work on the Lantern Room and related support system require professional and skilled contractors.

It is our findings that the numerous exterior wall panels have reached a level of failure that will necessitate extensive repair and replacement of several of the iron Lantern Room wall panels.

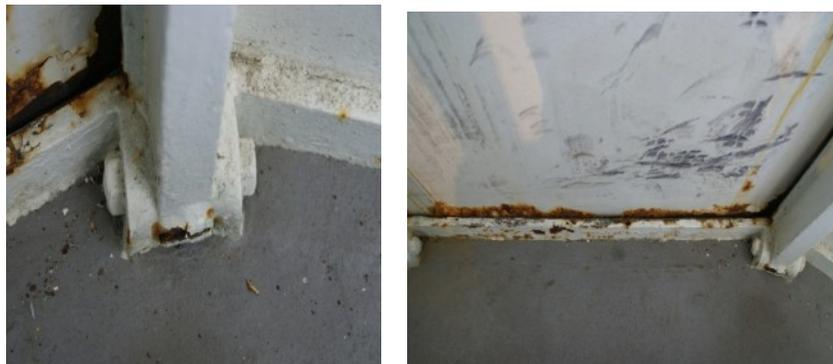
Figure #6 & # 7: The damage to metal and its cause should be corrected ASAP.

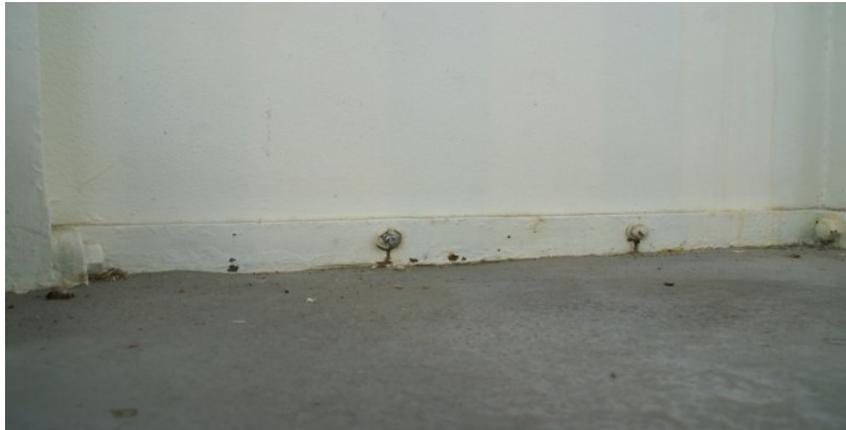
Figure #8 : Lantern Room deck.

The overall condition of the Lantern Room deck is rated as **GOOD**. Improved housekeeping isolated sanding and re-painting are all that are required on most areas of the deck. Areas which are in contact with moisture damage at lantern room wall plates need to be cleaned of loose metal, treated with a rust inhibitor, wiped with a solvent and then primed and finish coated with approved coatings based on historic paint color analysis.

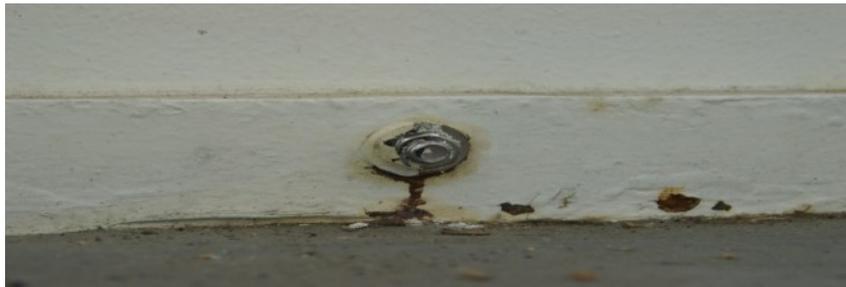
Figure # 9: Stainless steel fasteners used to attach exterior flashing.

While the use of stainless steel in a hostile coastal environment is usually advised, their use in the Point Pinos Lighthouse may have not been necessary. It is believed that the aluminum flashing on the exterior lantern room wall was attached by these fasteners. The need of that flashing has yet to be determined. Its installation has created issues on the exterior deck historic fabric.

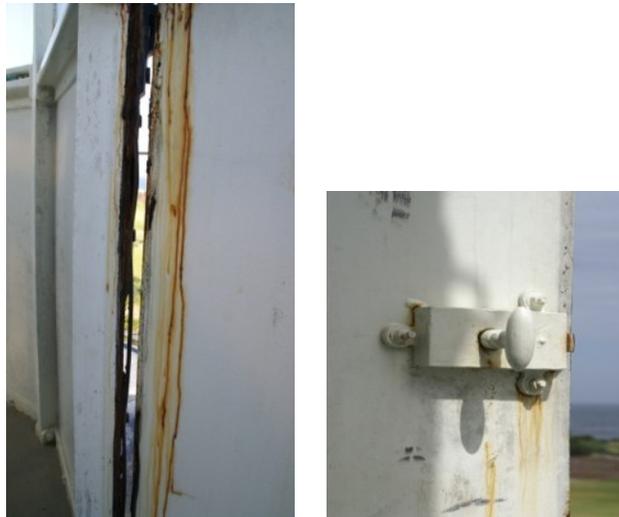
Figure# 11 & #12: Historic lock mechanism must be preserved and used.

Note: Historic latch system should be re-used if door is deemed to need to be replaced with new material.

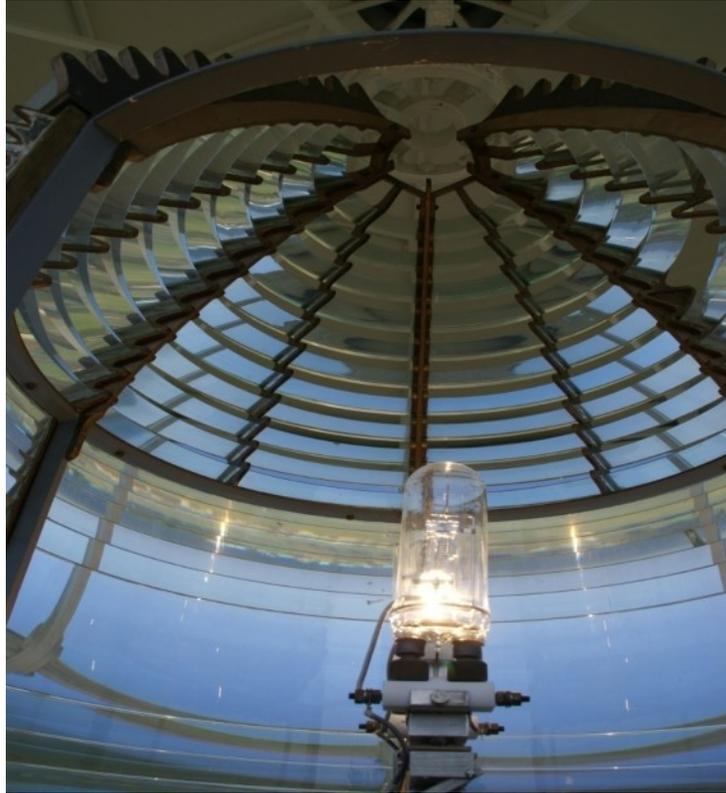
Figure # 13 : Historic 3rd Order Henry LePaute Lens.

The 3rd Order Henry LePaute Fresnel lens continues to function as an active aid to Navigation operated by the United States Coast Guard. Its importance and significance either in a navigational or historic context cannot be overstated or overlooked. Any activity which might affect the function of the lens as an active Aid to Navigation must be approved by the United States Coast Guard and possible discontinuance of that function even on a temporary basis must be coordinated through proper Coast Guard channels and using Coast Guard personnel. Because of the vastly historic value and because of the extremely delicate character of the lens and frame all measures must be taken to protect it on a daily basis but especially during any and all work activity in the Lantern Room. Proper protective barriers must be erected around the lens during extensive repair activities.
