POINT PINOS LIGHTHOUSE

PACIFIC GROVE CALIFORNIA

PRESERVATION PLAN

August 2009

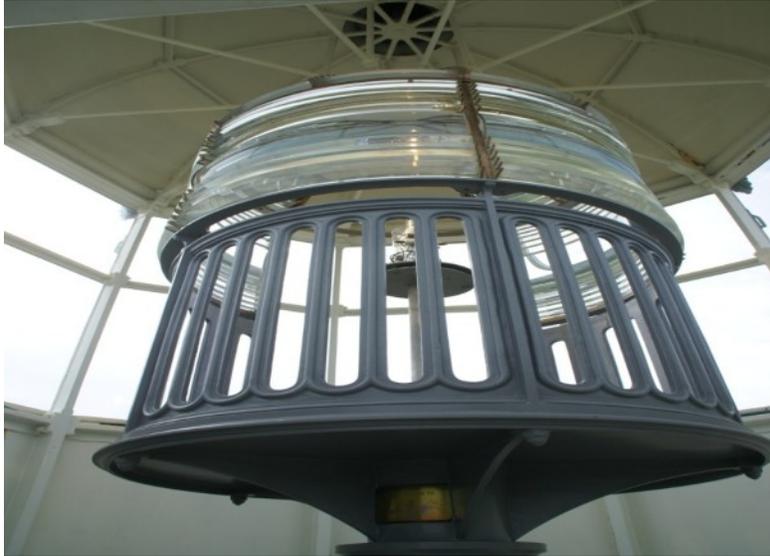
Figure #15: Historic 3rd Order Henry LePaute lens.

A professional Paint Consultant should be engaged to perform paint analysis on areas such as the iron Lens Housing and pedestal. Typical colors used on these areas differ than those currently in use. A standardized green has been found not only on United States lens systems but in Europe as well.

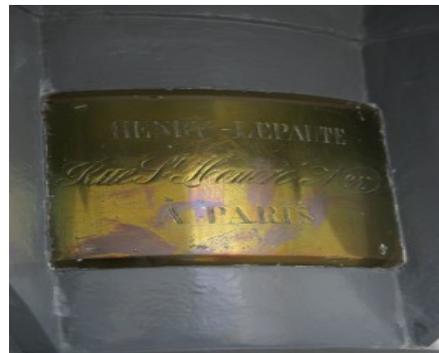
Figure #16: BRASS PLATE

Cleaning of the brass manufacturer's plate should be limited to wiping with a dry cloth. If cleaners are used make certain that they are not abrasive or harmful to the soft brass or erode the important information provided on the plate.

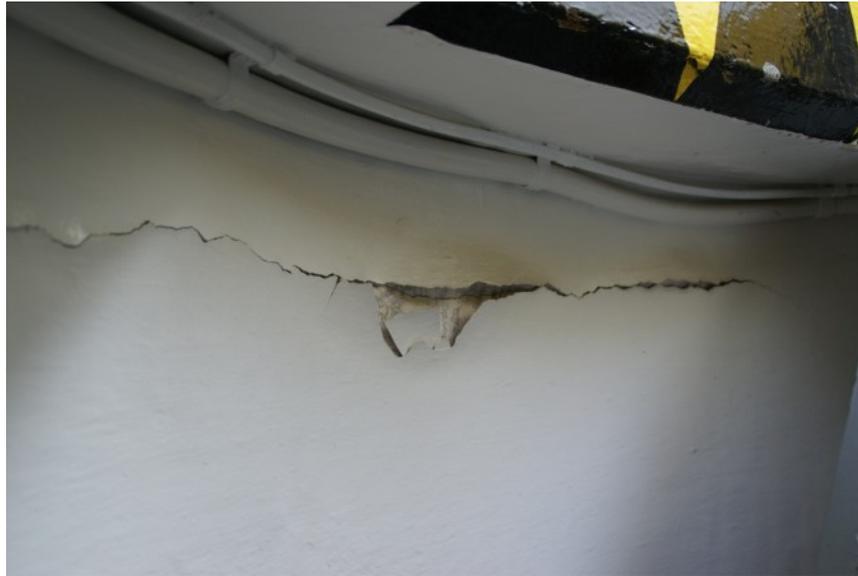
Figure# 17: STAIRWELL BELOW LANTERN ROOM.

The crack which has occurred in the support cylinder area just below the Lantern Room more than likely is related to the corresponding crack located on the exterior of the support cylinder. Further professional investigation is recommended. Loose plaster should be carefully removed to expose crack and concrete hidden by plaster in order to better determine cause and extent of damage. Staff/volunteers should measure length, depth, and width of crack and record. An elastomeric caulking should be inserted into the crack only to prevent moisture entry into interior. Any material used must be reversible and these recommendations are based on the concept that additional repair work will be conducted at a new future date. **Note: Volunteers can be used to remove failed plaster, perform measurements and documentation, and apply caulking.**

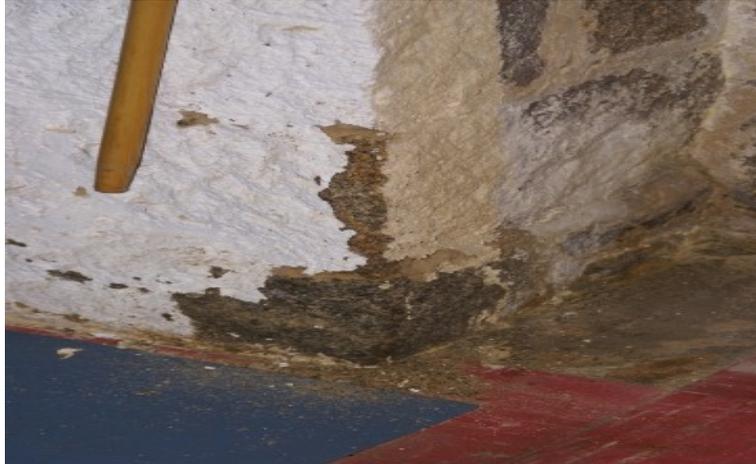
Figure #19: Stonework in Basement NORTH WALL.

The Overall condition of the stonework throughout the basement is rated as **GOOD** to **FAIR**. There is a concern regarding obvious moisture damage in isolated areas of the basement. Evidence of the damage is illustrated by yellowing of coating system, failure of coating system, discoloration of stonework, loss of mortar joints between stones and in rare areas actual loss of stone fabric. It is believed that the moisture creating the damage is from damp rising coming through the floor and lower stonewalls. Loose paint should be carefully removed to expose as much stone surface and mortar joints as possible. Moisture content readings should be conducted, dated, and recorded on a monthly basis to establish extent and frequency of moisture entry. Record weather occurrence on date or around dates of moisture reading. There may be a need to dig pits or make probes to the ground area on the exterior of the stonework to determine avenue and cause of moisture entry.

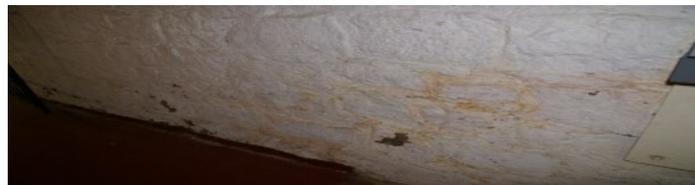
Figure #20: EXAMPLE OF MOISTURE DAMAGE WEST WALL.

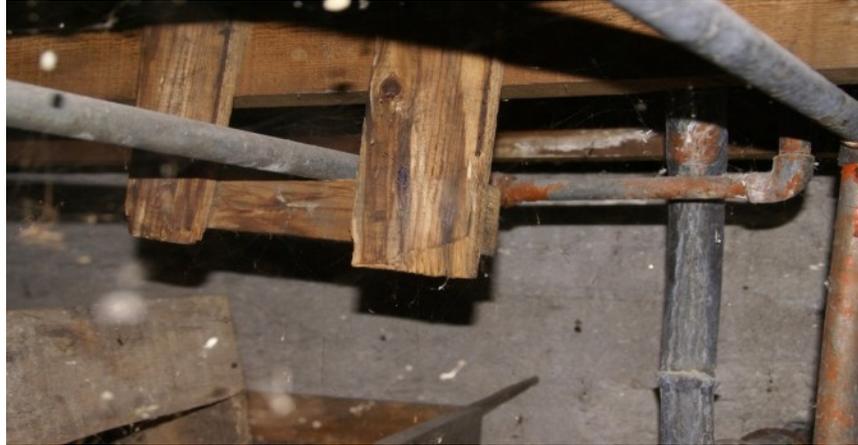
Figure #24: Leaking water pipe below bathroom.

Inspection of the crawl space below the bathroom area revealed a water pipe leak. Pipes below the bathroom are in poor condition with a high incidence of rust especially at areas where they make contact with the ground. If water use continues inside of historic building new pipes are highly recommended. Continuance of leaks will result in damage to wood and stone, and mold and mildew contamination. Periods of hard freeze will also increase extent of damage to stonework.

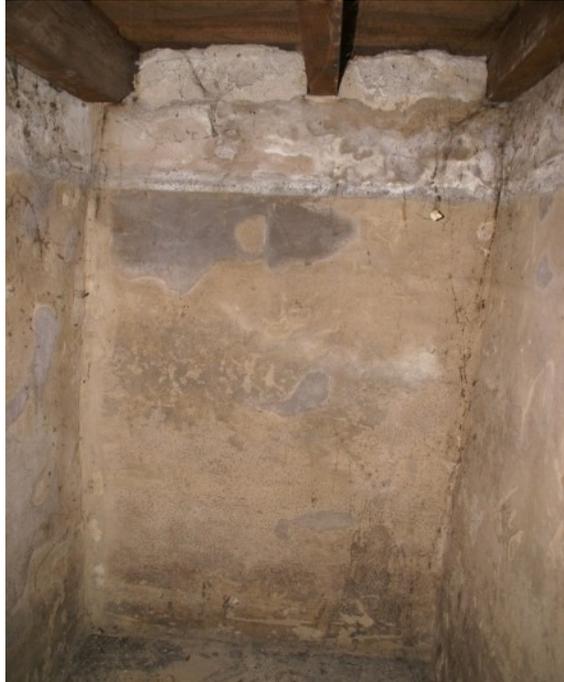
Figure #30: Water collection and storage cistern.

Access to the historic 1000-gallon cistern was gained by a small trap door in the floor of the north-parlor closet. The cistern is rated as **GOOD** but should not be relied upon for water storage. Photo documentation of this system should be used to interpret this significant system to visitors. There is a small amount of debris deposited on the cistern floor. Volunteers should carefully collect the debris, screen it and bag and tag any historic materials for identification and storage.

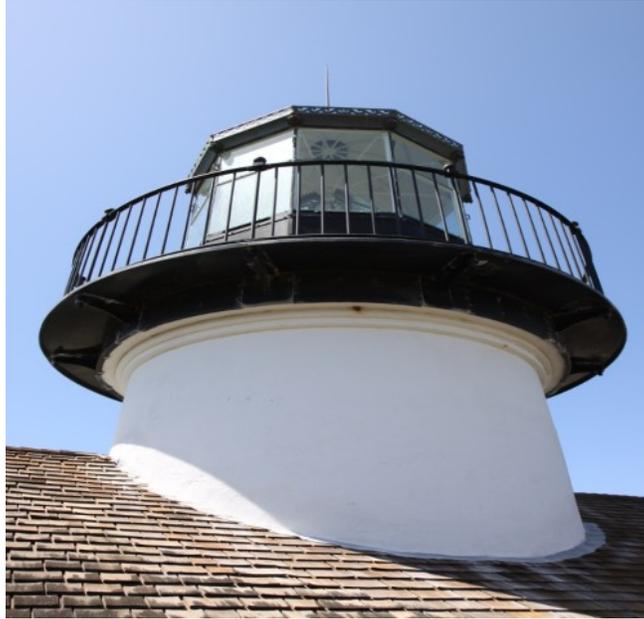
Photo: LR # 1.

QCR-GOOD-POOR - MDPR -SERIOUS TO CRITICAL

It is our findings that the numerous exterior wall panels have reached a level of failure that will necessitate extensive repair and replacement of several of the iron Lantern Room wall panels.

Due to the degree and extent of damage to the Lantern Room we recommend that this area receive the most immediate attention and funds to correct. While Staff and volunteers can remove failed coating systems clean exfoliated metal, and use selected metal filler and prime and repaint safely, the replacement of extensively damaged metal work on the Lantern Room and related support system require professional and skilled contractors.

Some Lantern Room sections can be cleaned, repaired, and re-coated while removed from top of the Lighthouse.

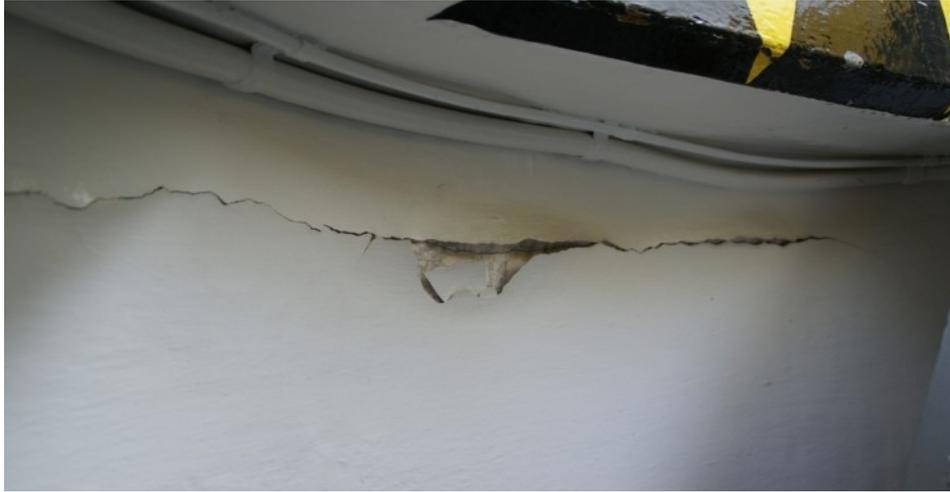
INTERIOR LANTERN ROOM SUPPORT CYLINDER

QCR- FAIR to POOR/ MDPR -SERIOUS - SEVERE.

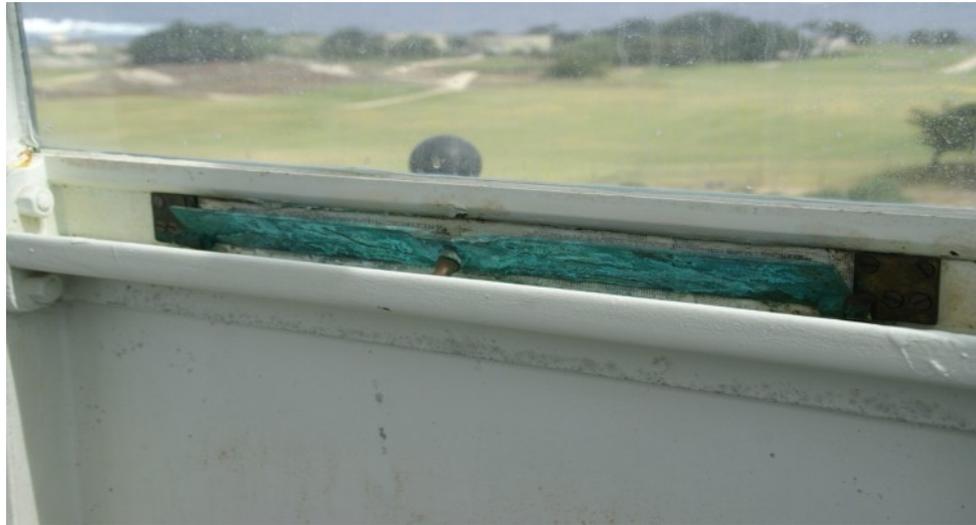
Photo: LRAEVG #1: Interior surface of Air Exchange Vent Grill.

QCR-POOR -MDPR- SERIOUS

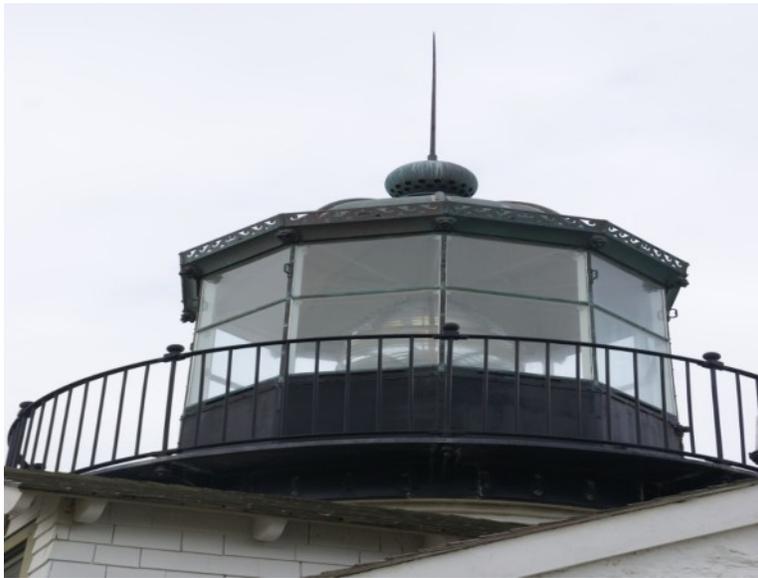
Photo: LRC&VB #1.

QCR- FAIR - MDPR -SERIOUS

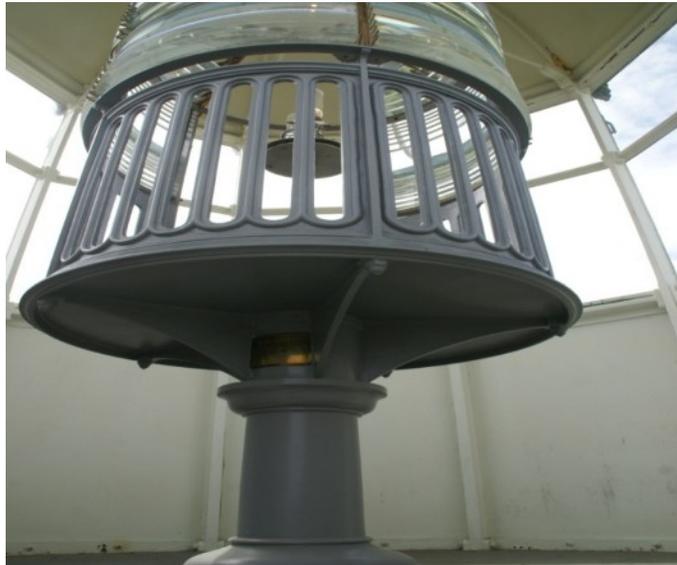
QCR- GOOD/MDPR-MINOR

Figure 12: Extreme care must be taken to protect historic optic and support during any work activity.

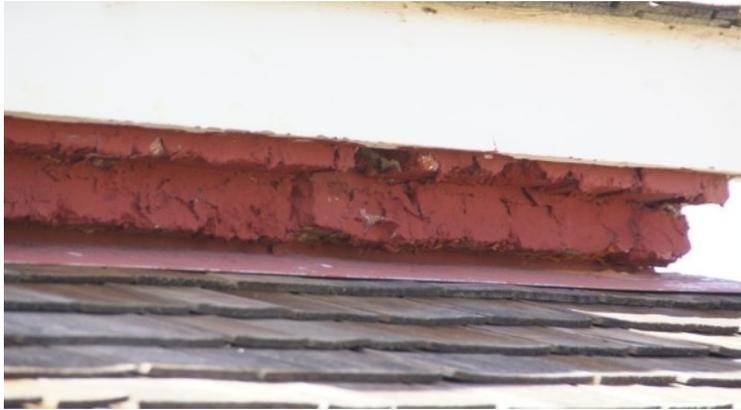
Photo: Brick corbel#2.

QCR-POOR / MDPR -CRITICAL to CATASTROPHIC

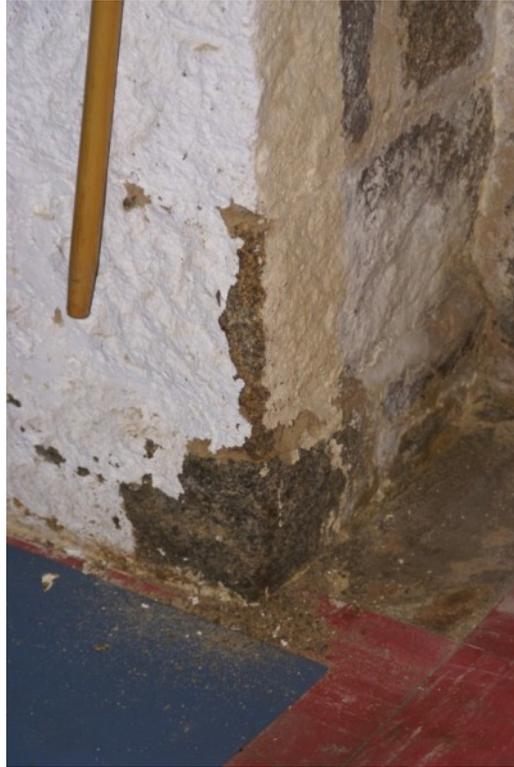
Photo: IBW#1.

QCR- GOOD to POOR/ MDPR -MINOR to SERIOUS
