REVISED LANTERN ROOM FLASHING 2-9-22

PT. PINDOS LIGHTHOUSE

Title:
LANTERN WALL SECTION FLASHING

Project:
POINT PINOS LIGHTHOUSE

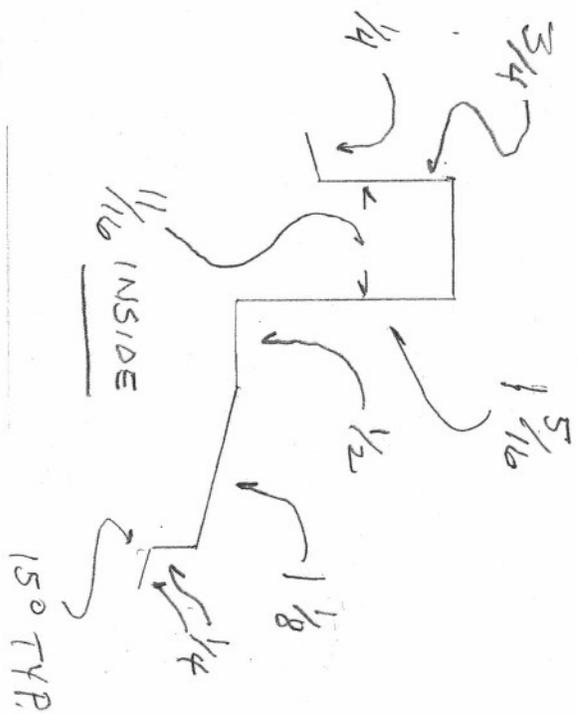
DOOR

240 ~~26~~ 1 NEEDED
36" G. MARLINE SS

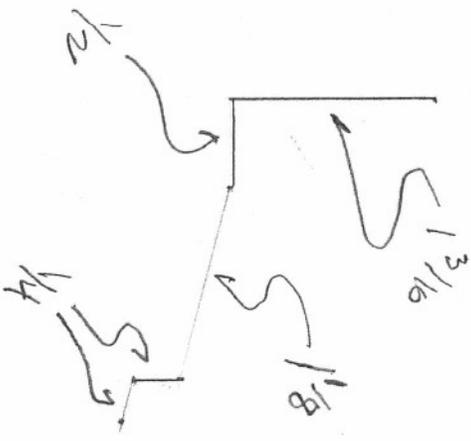
WALL

240 ~~26~~ 11 NEEDED
36" G. MARLINE SS

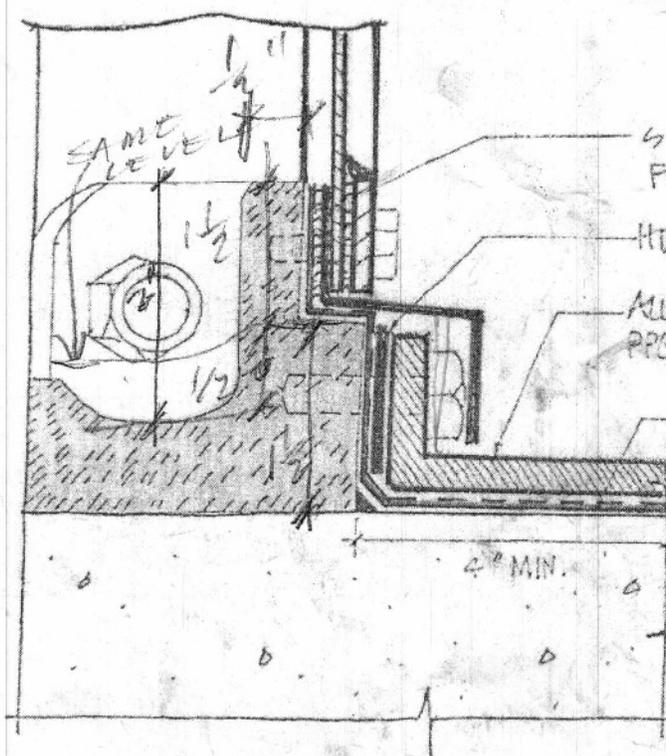
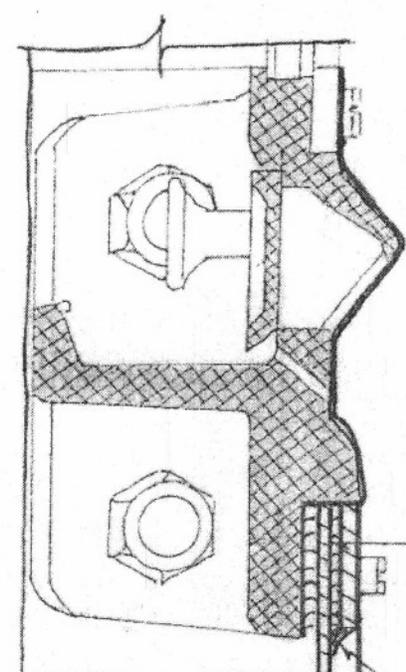
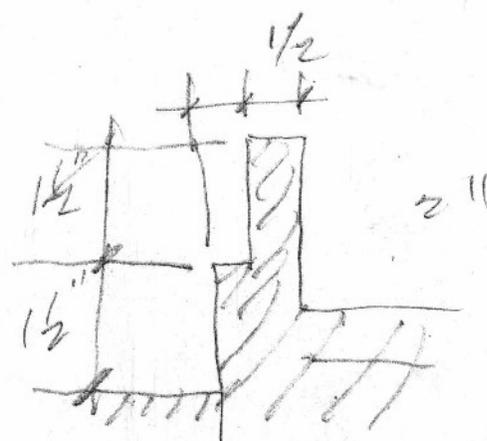
Sheet:
SKW-2

STEEL PANELS - PRIME WITH PPG AMERLOCK 2, PAINT WITH PPG PSX 700 OR 805. SET PANELS IN FULL BED OF SEALANT (TRENCO SPECTREM 2) AND DETAIL ALL JOINTS WITH SEALANT, TYP.

SEALANT JOINT - TRENCO SPECTREM 2, TYP.

S.S. FLASHING - MIN. 24GA WET SET IN FULL BED OF SEALANT

HDPE OR S.S. SPACER

ALUMINUM DIAMOND PLATE DECK - PRIME WITH PPG AMERLOCK 2, PAINT WITH PPG PSX 700 OR 805

CONCRETE LANTERN WALL FRAME - FABRIC REINFORCED CIM 1000 TYP. OVER SEALANT CNT. (CIM 1000TG)

4" MIN.

CONCRETE DECK

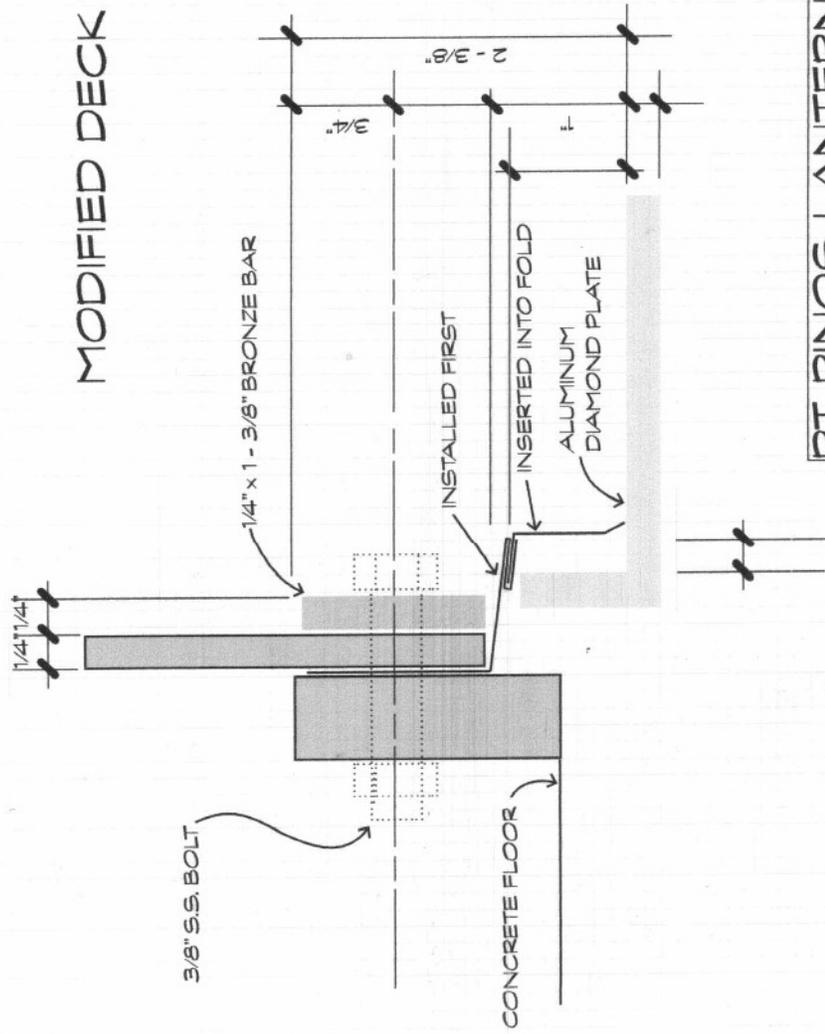
MODIFIED DECK FLASHING PROPOSAL

PT. PINOS LANTERN ROOM BASE

SCALE: APPROX. FULL SCALE, SPACES EXAGGERATED FOR CLARITY
