city long hungered for ownership of Pt. Pines
'07
Heritage Soc past + present board
reconstructed Whistledrop shelter at Ballenas
installed the Swan boat at Lovers Pt.

Preservation Plan
Lighthouse Preservationist, Savannah

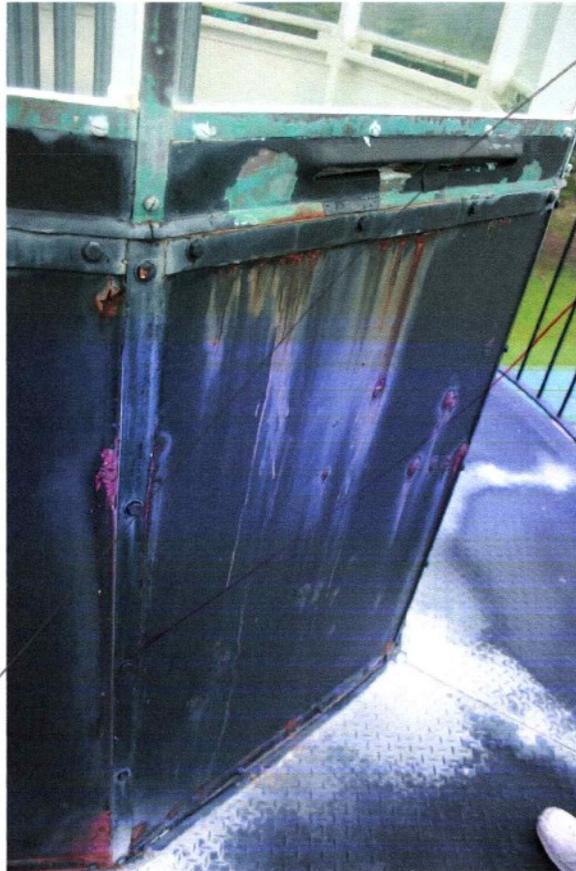
2-29-08i

Building assessment pointed out all the obvious problems, leaks in lantern room, repainting, roof condition, but a few that we would not have recognized - issues involving the concrete tower.

They also missed some significant problems, foundation, aluminum work done by the Coast Guard in 1990's

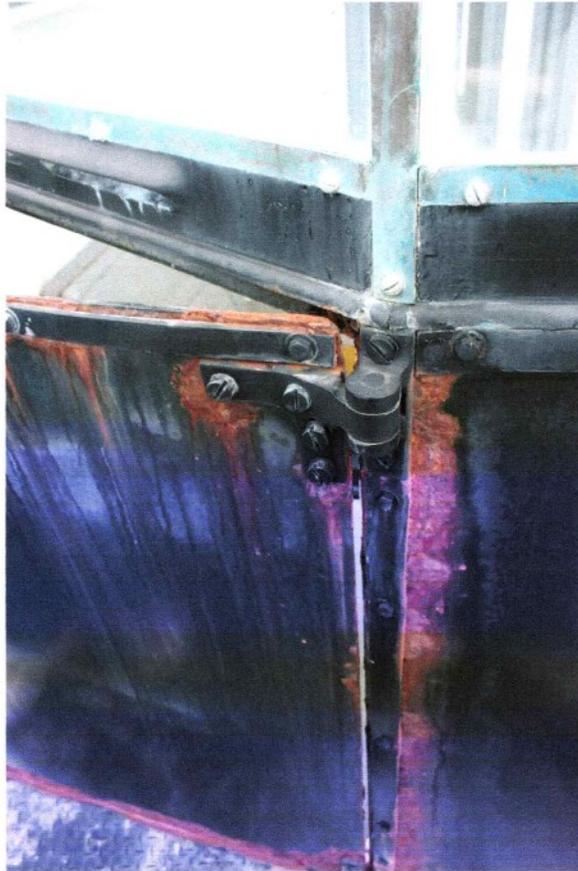
2-29-08 F

1st project get door to open!

Building assessment pointed out all the obvious
issues, leaks, repairs, roof conditions +
others we would have missed re concrete
condition. But missed signif problems
foundations, alum work.

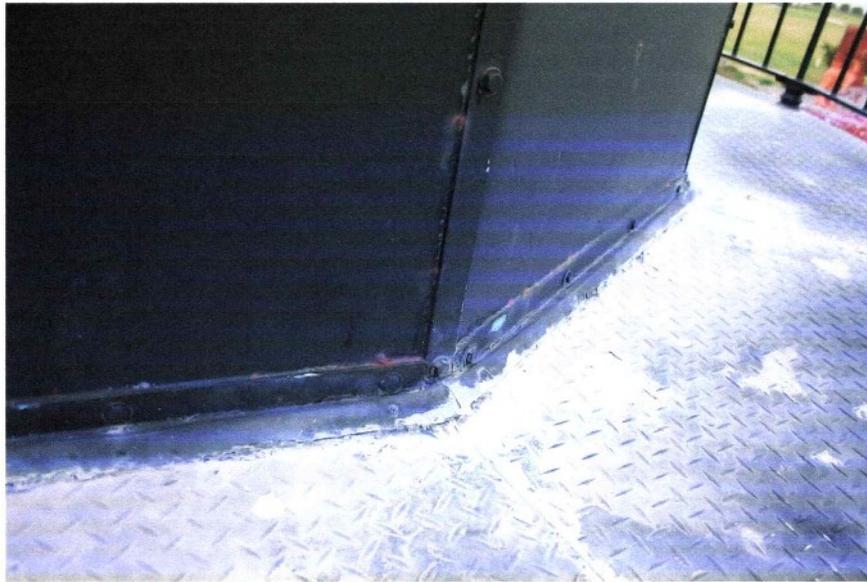
2-29-08

Next problem compromised leading connection where walkway meets the lantern room plates.

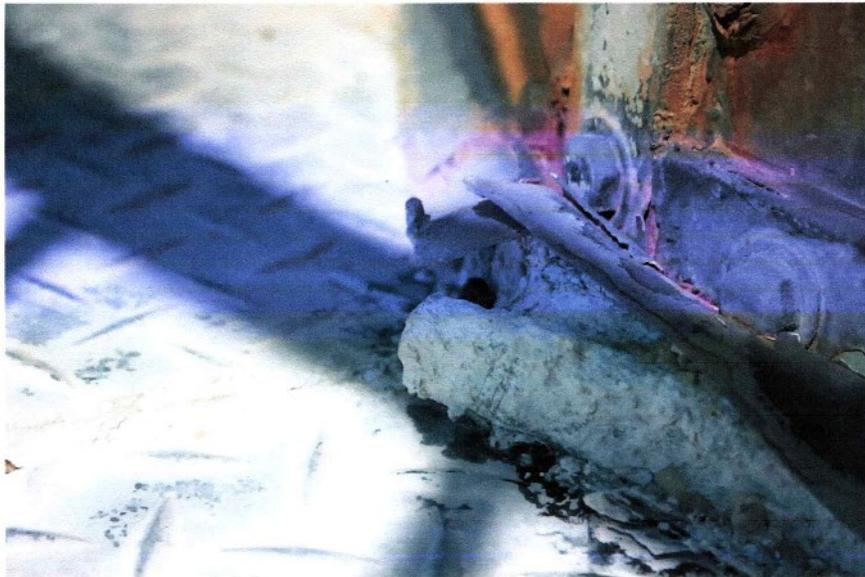
9-5-09 a

exp. close look

1) grit blast off
oxidation, 2) cut lip back 3) coat
with penetrating epoxy 4) install
neoprene gasket. Tedious + Time consuming

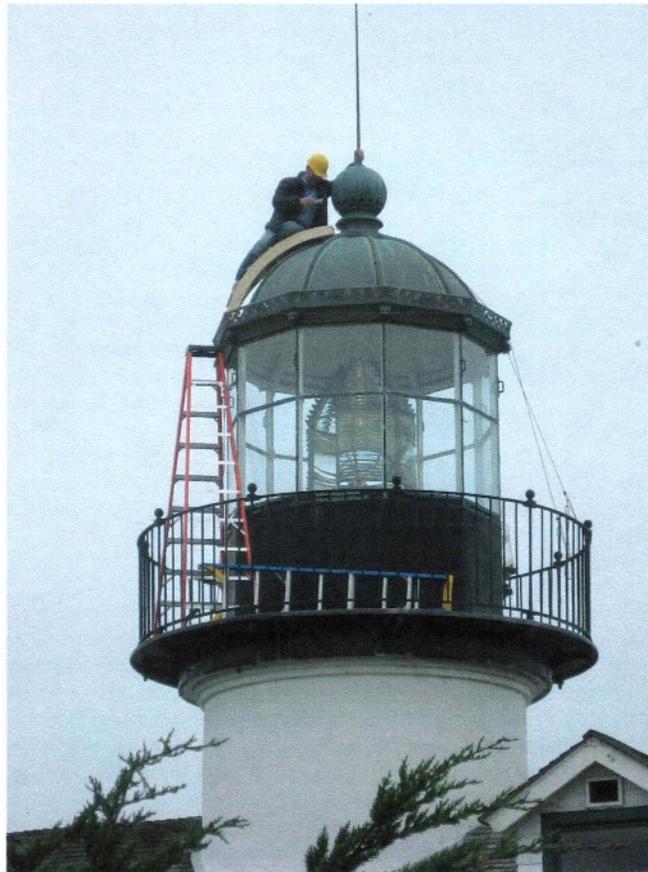
11-5-21a

roof leaks
Safety issues

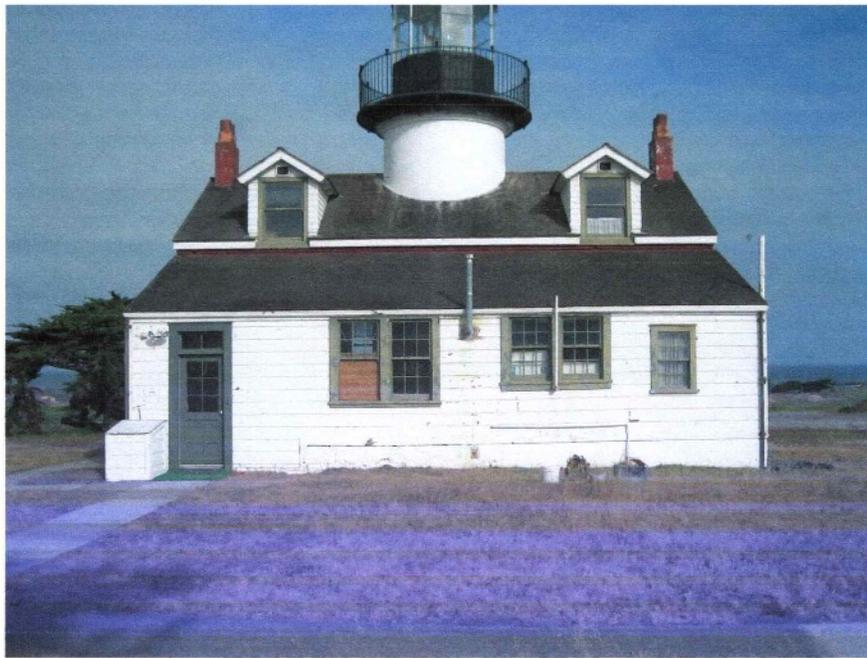
10-7-2
Paint prep

Bleeding iron
hundreds of rusty nails in wooden
additions.

Set nail below surface

Spot blast loose rust

Flood cavity + nail head with penetr. epoxy

Fill with restorint

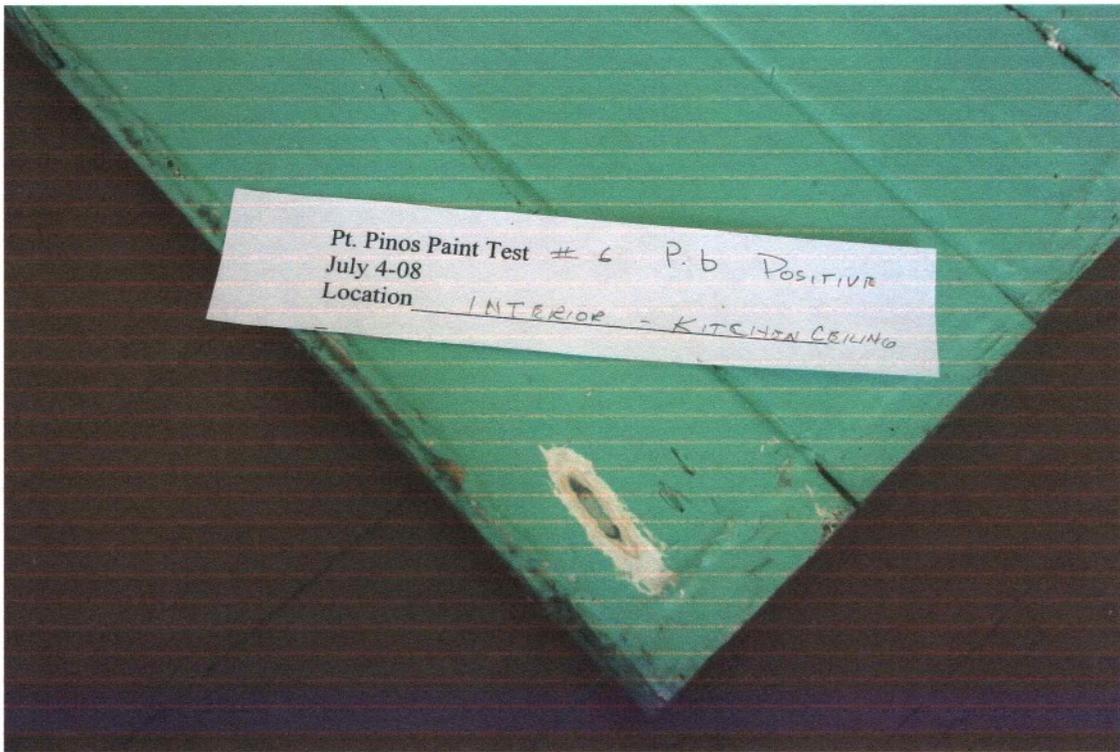
7-4-08 6

interior lead paint tests

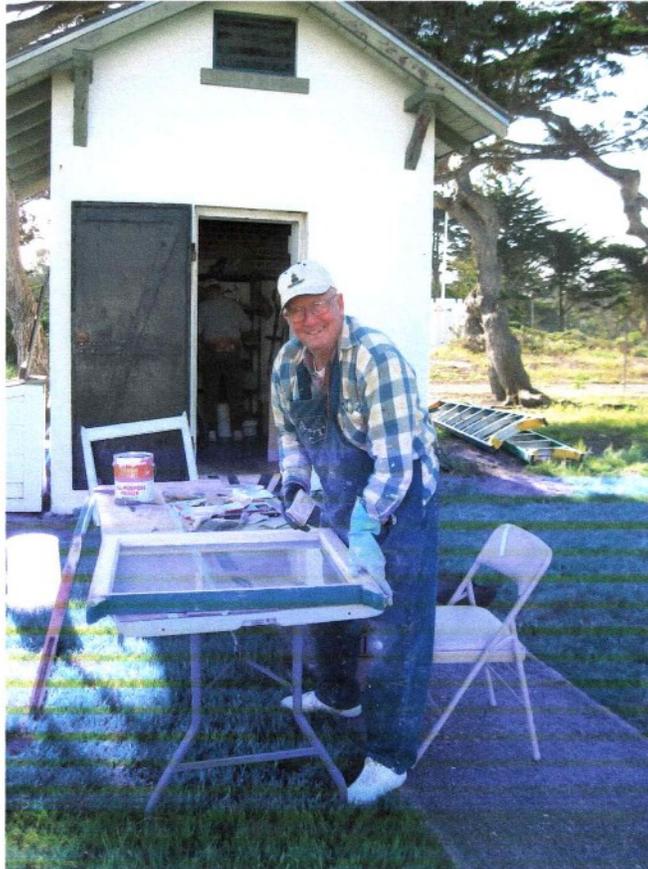
11-4-1
Don the Stripper

Don Slater 86 and going strong
The stripper was
Soy based stripper

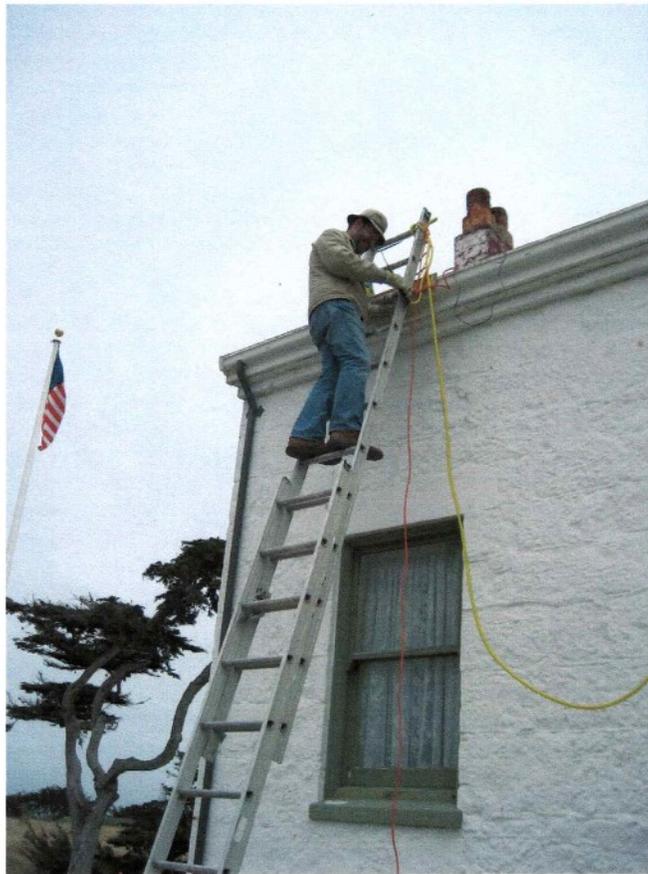
'10-7-2
gutter repair

odd developed technique to solder
lead lining of wooden gutters

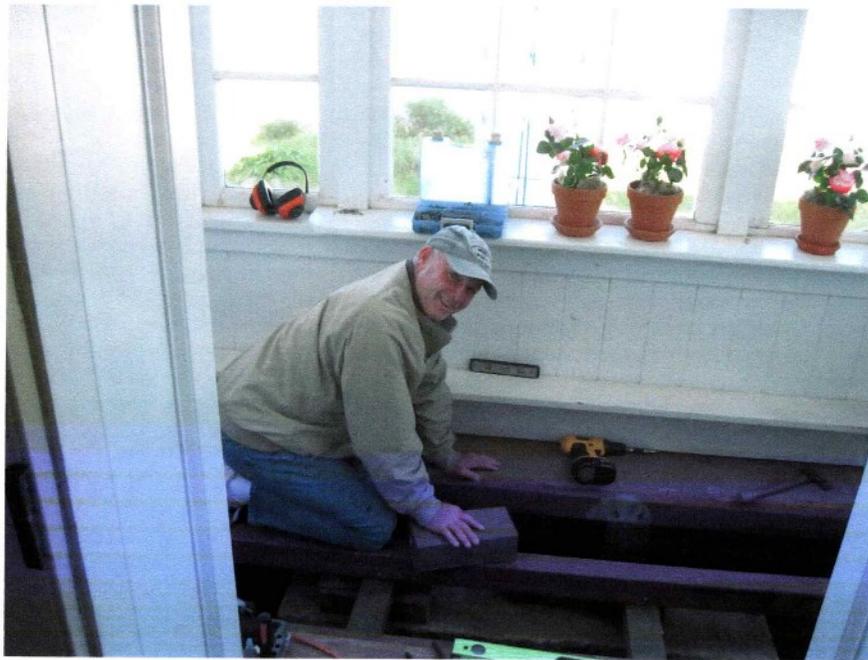
11-4-1
Steve

Front porch had been improved
with plastic pergo flooring. Steve
installed new long fir flooring
matched original?

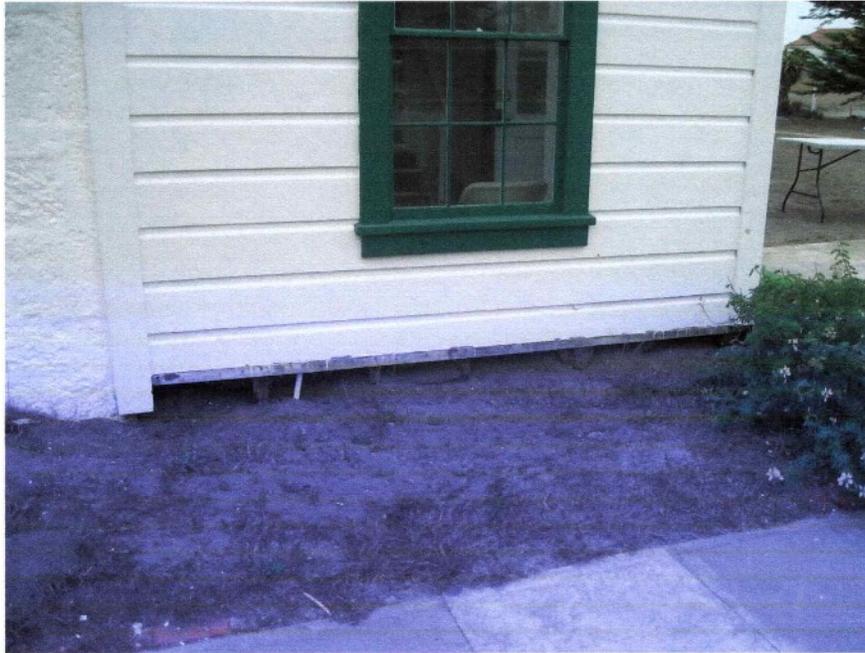
'11-9-3e

missed in sig building assessment
Perimeter foundation

T&G flooring.
